# Removing One of the “I’s” from Infiltration and Inflow

Frederick Bloetscher, Dominic F. Orlando, and Ronnie Navarro

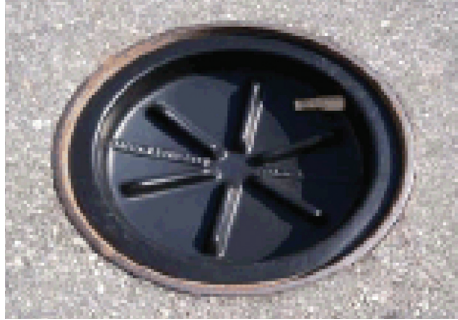
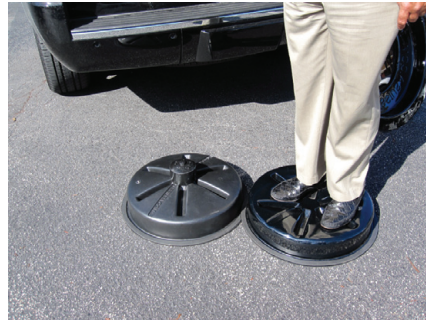
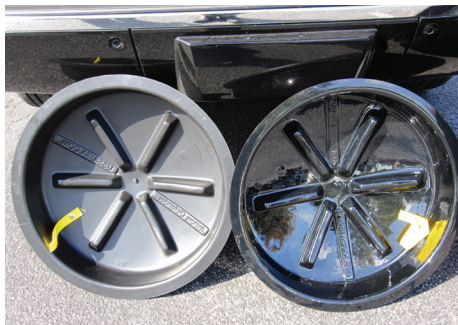
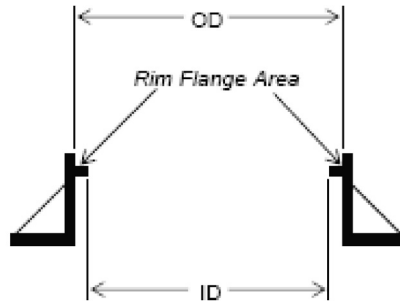
Figure 5. Inflow defender manhole rain dish showing installed dish, and both polycarbonate and polyethylene versions. Note the ribs and depth of dish that improves long-term strength. Note polycarbonate is required for newer, 30- or 48-in. manhole covers. Texas has mandated 30-in. holes for new manholes. Only stainless steel and polycarbonate are available in the larger sizes.

The next step is to put dishes into the manholes. One might think that only manholes in low lying areas get water into them, but surprisingly, every manhole dish, even one that is properly installed, has water in it. Hence, it must be assumed that all manholes leak water between the rim and the cover.

Most collection system workers are familiar with dishes at the bottom of the manhole, where they are of limited use. This is because those dishes deform when filled with water or are constructed in a manner that allows them to be knocked in when the cover is flipped. The solution is a deeper dish with reinforcing ribs and a gasket. Figure 5 shows two examples (note the man standing in the upside-down dish). The dishes shown are made of a polycarbonate (shiny) and a polyethylene copolymer material that meet the requirements of Underwriters Laboratories (UL) Standard 94-HB and American Society for Testing and Materials (ASTM) specification Prime HDPE 250 to be suitable for atmospheres found in manholes. The polymer-based dishes eliminate the dissimilar metals issues with stainless steel dishes and are available at a lower cost. The key is the appropriate reinforcing to prevent dishes from dropping into the manhole. The gasket seal should be made of a closed-cell neoprene material with pressure sensitive adhesive on one side for adhering to the dish body, and be a minimum of 1/2 in. wide and 0.125 in. thick. As the standards for manholes gets larger (Texas rules are now 30 in.), only stainless steel and polycarbonate are available options.

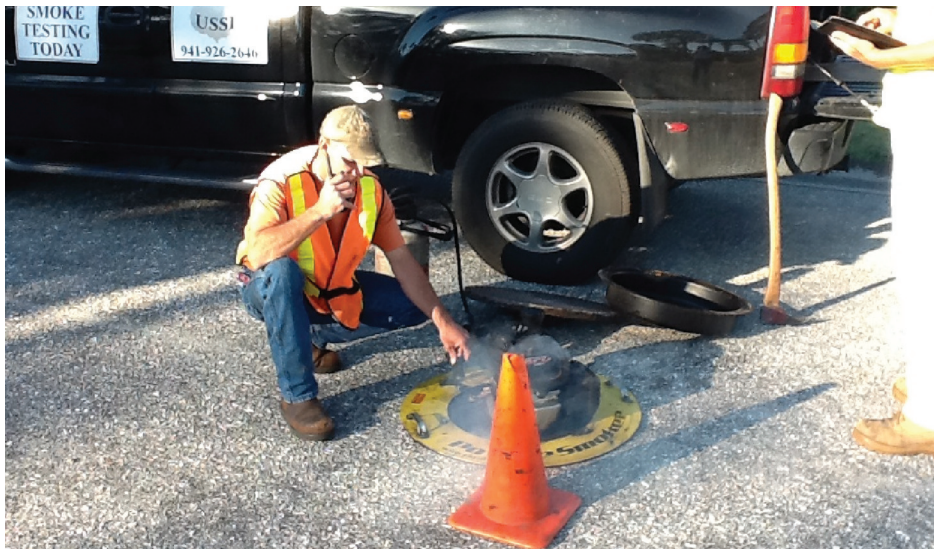
Figure 6. Smoke Test. (photo: USS1 Inc.)

Once the manholes are sealed, smoke testing can identify obvious surface connections (see Figure 6). The normal protocol for smoke testing will identify broken or missing cleanout caps, surface breaks on public and private property, connection of gutters to the sewer system, and stormwater connections. All should be documented via photograph, by associated address, and public or private location. The public openings at cleanouts can be corrected immediately using utility funds; the contractor can include this cost to make immediate repairs in the bid documents. However, if the cleanout is broken, it may indicate mower or vehicle damage that can occur again. If missing, the resident may be using the cleanout to drain the yard (more common than realized). In either case, the collection system needs to be protected. Utility Sealing Services Inc. (USSI) in Venice developed a solution, called the LDL plug, consisting of the following (see Figure 7):

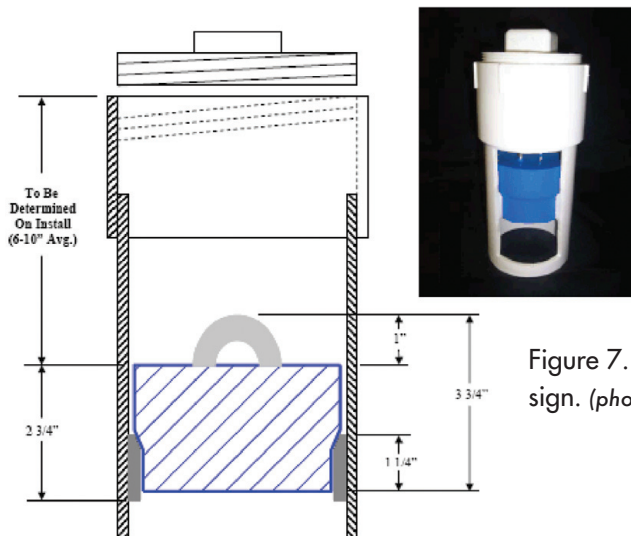
Figure 7. LDL Plug Design. (photo: USSI Inc.)

- ◆ A molded, one-piece, synthetic urethane polymer material plug body designed to align and seal the cleanout.
- ◆ Inner seal of the plug shall consist of a PVC material fabricated with an internal tapered, beveled seat, with a thickness of 0.187 in. and overall height of 1.25 in.
- ◆ Embedded retrieval hasp and hardware should protrude at least 1 in. above the plug body, have a thickness of 0.187 in., and have hardware molded into the plug body using corrosion-resistant material to allow removal by utility crews from the surface.
- ◆ Plug has embedded steel to permit surface detection by a metal detector.

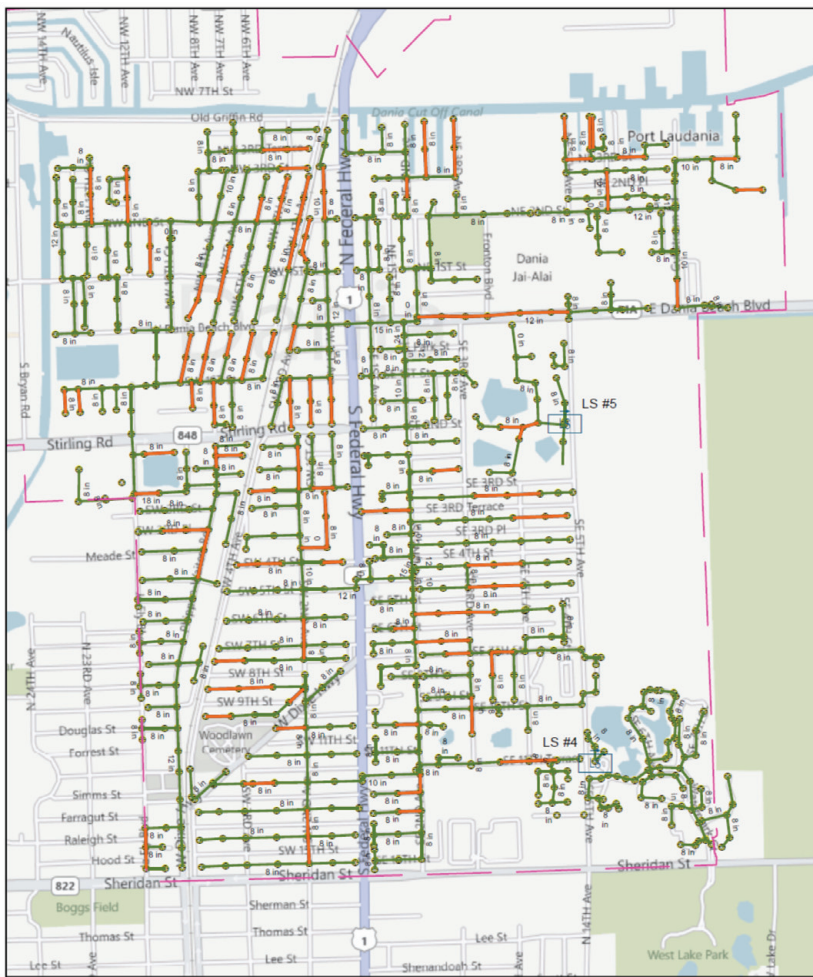
Figure 8. Areas where further infiltration investigation via televising is needed (only 15 percent of the system).

Figure 8 is an example from Dania Beach. After 20 years of no investigation, only 15 percent of the pipe segments indicated infiltration leakage. This reduced the

televising and lining portion of its lining program by over \$1 million, which more than paid for the inflow reduction project.

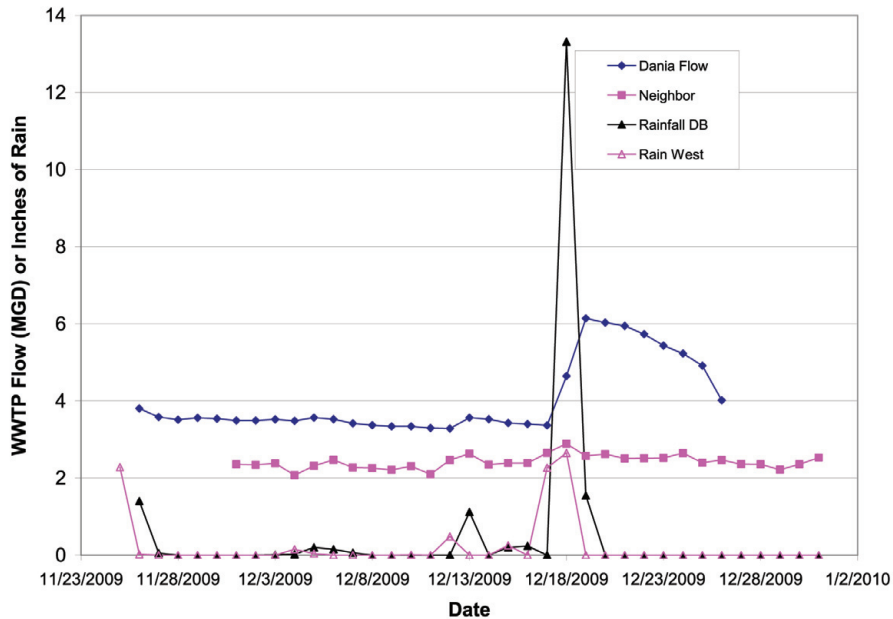
Figure 9. Comparison of flows in December of 2009 at Dania Beach and a neighboring system. Note the big spike after the rainfall that was not present on the system with limited rain (13 in. increased flows by over 2 mgd).

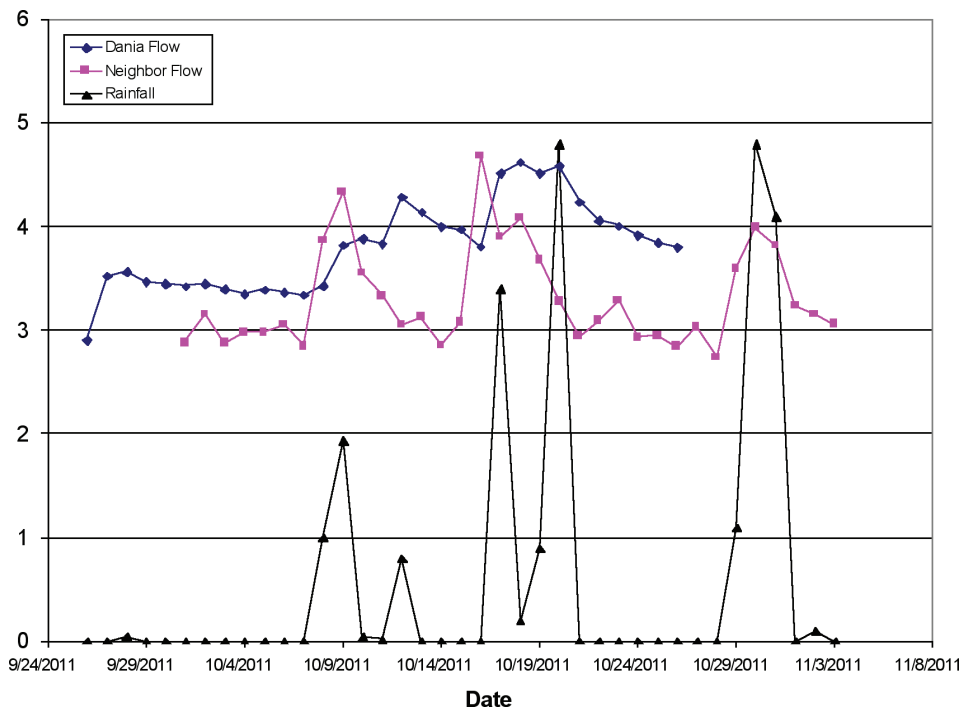
Figure 10. Comparison of flows in October of 2011 at Dania Beach and a neighboring system. Note the spikes on the same neighboring system versus the lack of large spikes in Dania Beach. The gradual upticks are likely groundwater levels creating infiltration. For Dania Beach, the 5-in. storm raised flows less than 0.5 mgd.

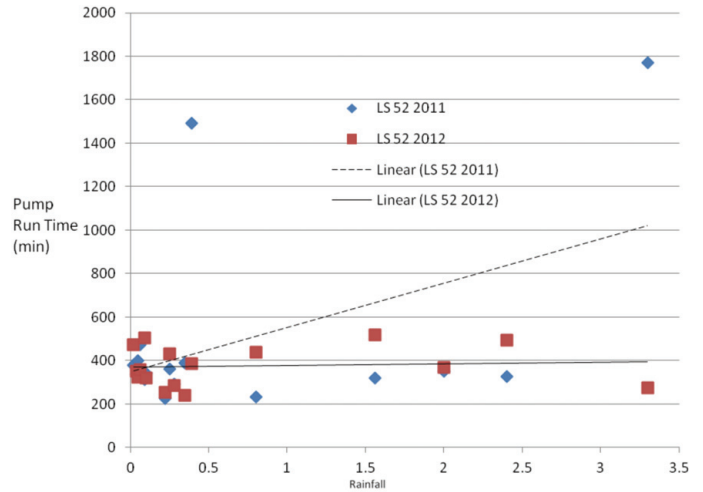
Figure 13. Comparison of rain events (in.) versus pump run times in 2011 and 2012 for Cooper City Lift Station 52. The slope of the lines show that the inflow correction substantially reduced inflow. The 2012 graph shows virtually no effect of rainfall on run times.

that for this basin, most of the inflow has been removed (Figures 13 and 14). In the lift station 54 basin, the 2012 line is nearly flat, and there does not appear to have been as much inflow in this basin in 2011. Still a change in the slope is noted (Figure 15).

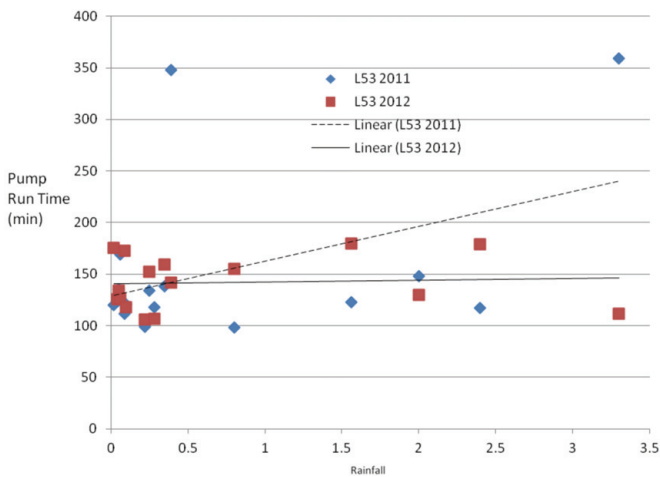
Figure 14. Comparison of rain events (in.) versus pump run times in 2011 and 2012 for Cooper City Lift Station 53. The slope of the lines show that the inflow correction substantially reduced inflow. The 2012 graph shows virtually no effect of rainfall on run times.

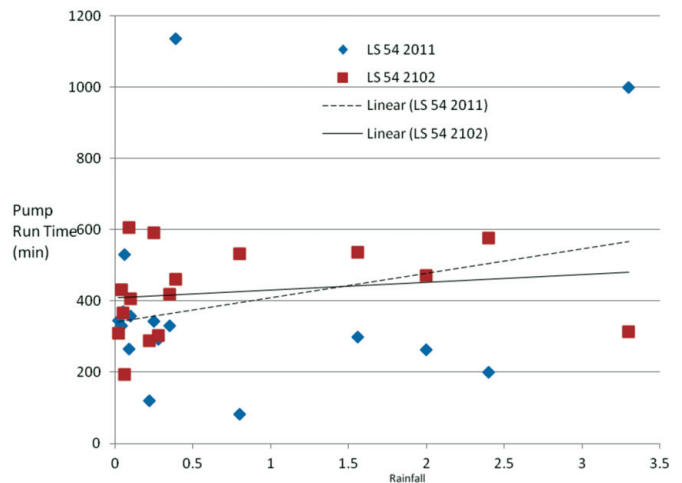
Figure 15. Comparison of rain events (in.) versus pump run times in 2011 and 2012 for Cooper City Lift Station 54. The slope of the lines show that the inflow correction reduced inflow.
