Innovative Cost-Effective Noninvasive Ultrasonic Testing for Utility Replacement

Weston Hagggen, Ed Gil de Rubio, Marc Cannata, and Matthew Grewe

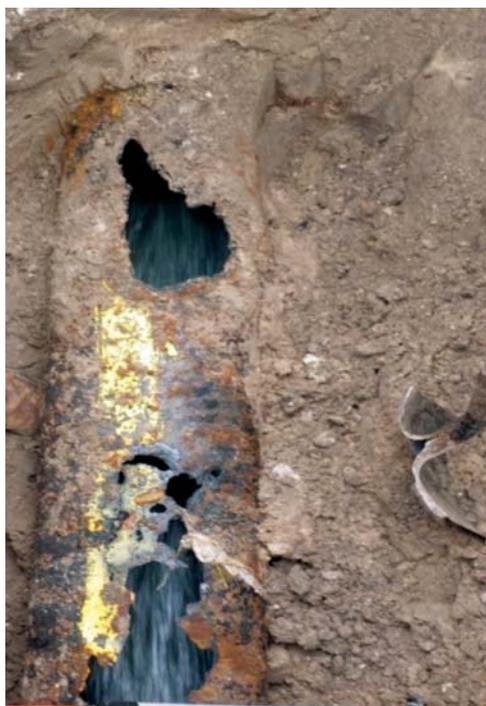
Ductile iron piping is subject to major corrosion, as shown in Figure 1. One of the primary factors of pipe corrosion in wastewater transmission systems is the production of hydrogen sulfide gas (H₂S). High points in the piping network can collect H₂S, making these areas more susceptible to corrosion. Air release valves (ARVs) are customarily located at the highest points in a force main piping system to avoid H₂S accumulation; yet, not every high point potentially vulnerable to air trapping contains an ARV. In addition, force mains do not always flow full, al-

Figure 1. Ductile Iron Pipe Corrosion

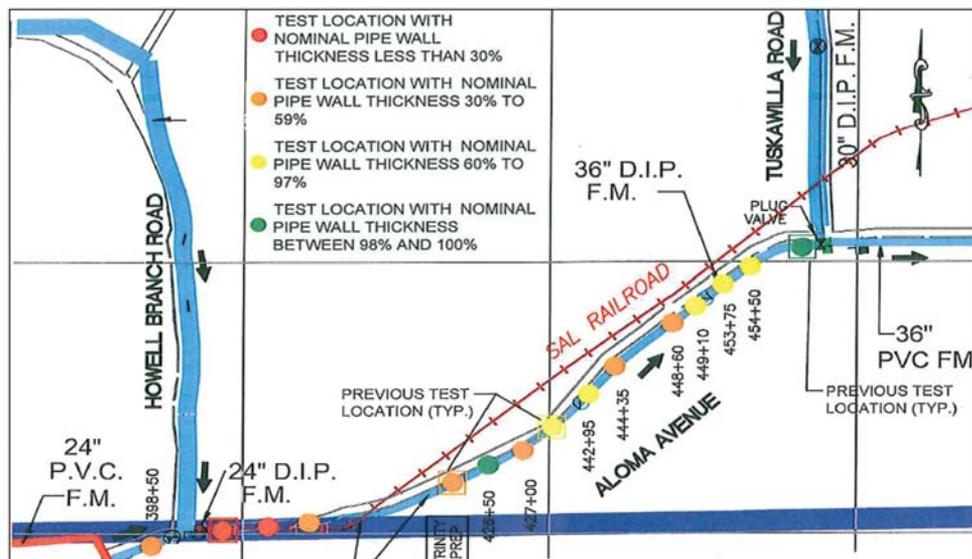
Figure 2. Previous Aloma Avenue Thickness Testing

In 2004 and 2007, previous studies were conducted to assess pipe integrity in a section of the transmission system owned by the Authority. The results, shown in Figure 2, indicated that the section of the force main located in the right of way (ROW) of Aloma Avenue, between Old Howell Branch Road and Tuskawilla Road, was severely corroded and needed to be replaced. The previous testing efforts did not provide any detail on methods used prior to and during the testing effort conducted on this force main section.

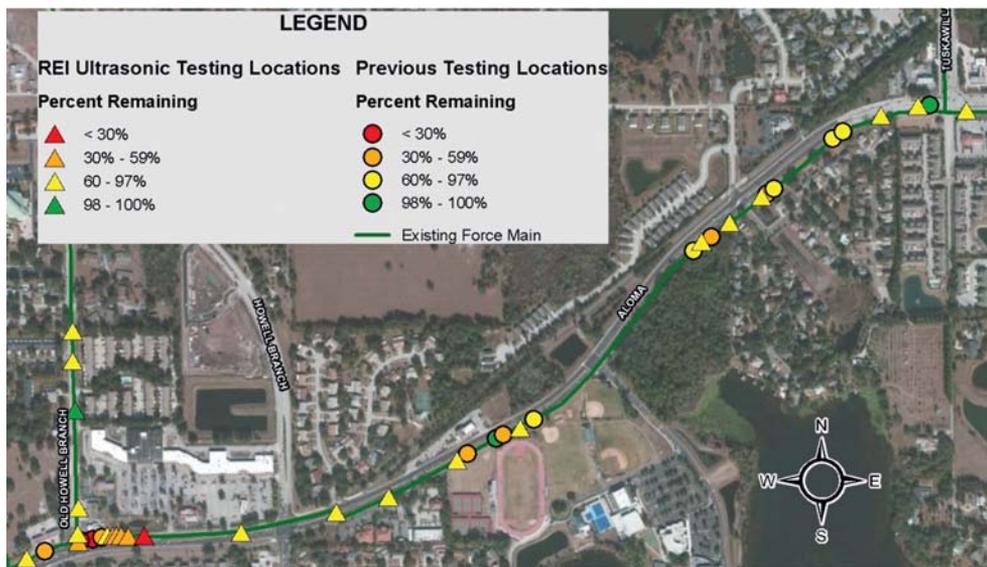
The percentage wall thickness remaining was calculated for each tested location by dividing the minimum reading measured by the original wall thickness. The results obtained are displayed in Figure 6, with the original study results represented with circles and the new results represented by triangles. The original wall thickness of the 36-in. force main and the 30-in. force main were measured at 0.51 in. and 0.45 in., respectively. The minimum reading was used because it represents the worst-case scenario.

The results indicated that, unlike what was previously determined in other studies, the state road force main only needed to be replaced along a small portion of transmission main; all other locations yielded results above 70 percent, indicating that they were in good condition. This assessment drastically contradicted the previous study, which concluded that the entire section of the state road force main measuring 5,550 lin ft should be replaced. Additionally, the study confirmed that a connection between the new pipeline in the state road ROW and the existing connector road force main could be completed.

Figure 6. Comparison of REI and Previous Testing

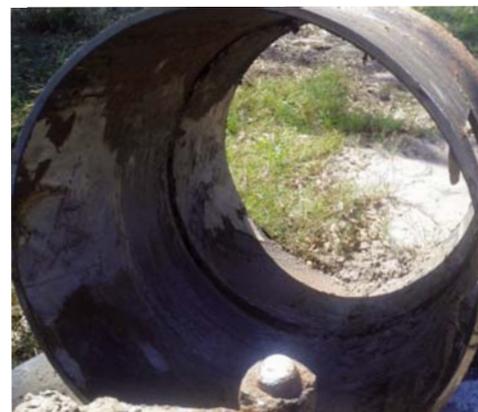
Figure 7. Section of Removed Pipe

The results of these tests were also confirmed with the completion of the state road force main construction with coupons and re-

moved pipe confirming results from this study, as shown in Figure 7. The section of the replaced state road force main is shown in Figure 8.

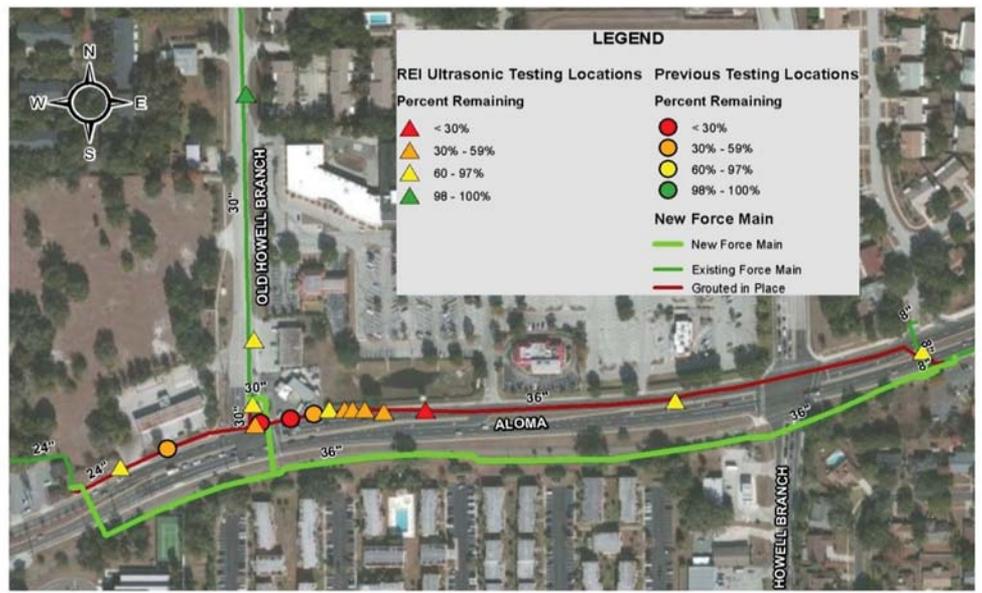
Figure 8. Replaced 36-in. Force Main on Aloma Avenue
