Lessons Learned in Operation of an Aboveground Reservoir at the Peace River Facility

Mike Coates, Sam Stone, and Noah Olenych

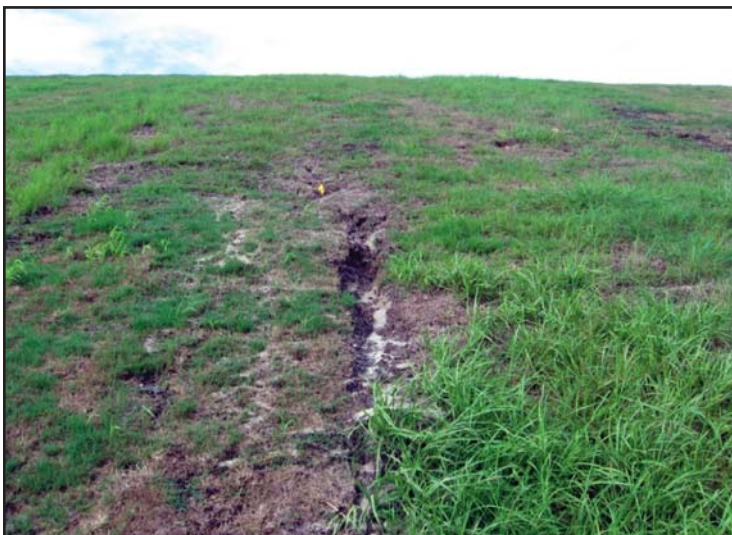
Figure 3. Erosion

this grass has remained in a serviceable condition, large areas of the turf stopped growing and were being naturally replaced by less desirable, weedy vegetation. In spite of recommendations by turf experts visiting the site, herbicide and fertilizer applications produced little improvement. Erosion (Figure 3), primarily resulting from heavy wet season rainfall in these areas, has been an ongoing maintenance issue and repairs often must be made by hand due to soggy embankment conditions, which preclude use of most equipment on the slope. An additional challenge has been to secure the repair areas so that water from upslope doesn't cause another washout at the same site before the repairs take hold.

Early erosion repair efforts often required multiple attempts. Current repair methods have been far more successful and include good compaction of fill material, careful sod placement (eliminating gaps), installation of temporary sod strips above the repair areas to divert water from upslope, and regular watering until the repaired sod is established. All repairs since the initial sod installation have been done using Bahia rather than Bermuda sod, as experience has shown that Bahia grass provides superior coverage and erosion resistance under the well-drained embankment conditions.

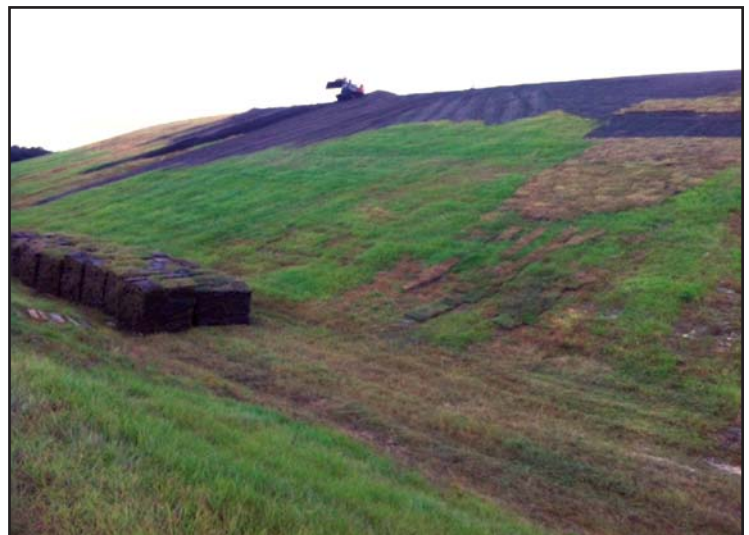
Figure 4. Sod Replacement

In 2012, the Authority began a proactive program to convert all areas on the embankment to Bahia grass. The resodding effort was conducted in the fall when the embankment was not too wet for light equipment but will still receive some rainfall to aid in turf establishment. Figure 4 shows the ongoing sod replacement effort.

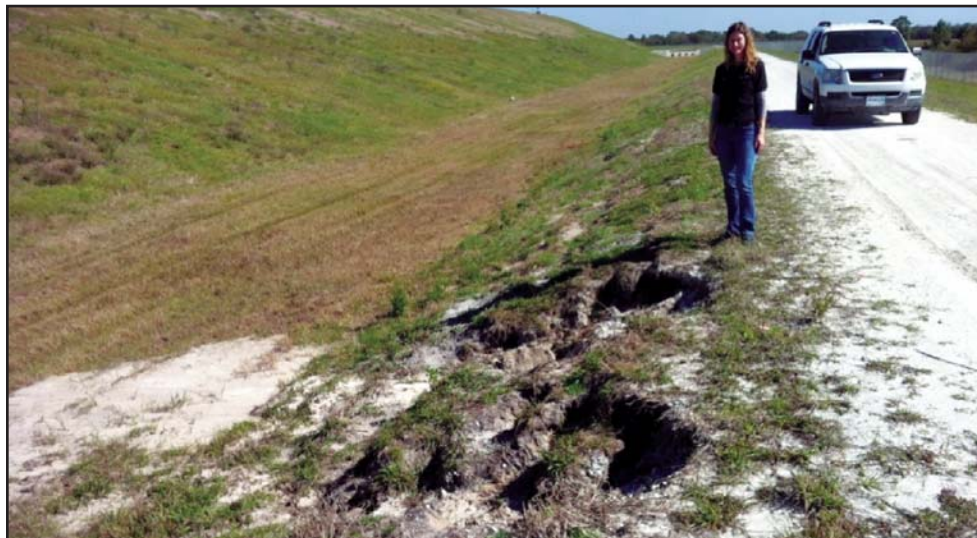
Figure 5. Interior Slope Washout

Approximately 5 mi of roadway are maintained in conjunction with the reservoir. This includes 4 mi of reservoir perimeter roads and a 1-mi access road. The road surface is marl/shell material. The perimeter roadway is elevated 2 to 8 ft above the bottom of the toe ditch at the base of the embankment and the surrounding land surface. Steep side slopes on the embankment between the toe ditch and perimeter road and poor sod establishment/coverage along the

roadway edge have required considerable maintenance, as heavy rains tend to wash out sections of this interior slope (Figure 5).

At several of the worst erosion locations, permanent low-profile gravel discharge structures have recently been installed to deliver water directly from the road to the toe ditch. While gravel discharge structures are not feasible everywhere, Authority reservoir management staff has learned through experimentation that successful repair on the interior slope of the roadway can be accomplished by notching the road at the edge of the shell and filling the notch with quality soil and then with Bahia sod so that it is level with the shell road when complete. While repairs continue, a multiyear program to make these changes around the entire perimeter road is underway.
