Developing an Approach to Diagnosing & Correcting Capacity Problems on Distribution Infrastructure

Julian Deleon, Edward Sierra, and Willie Shelton

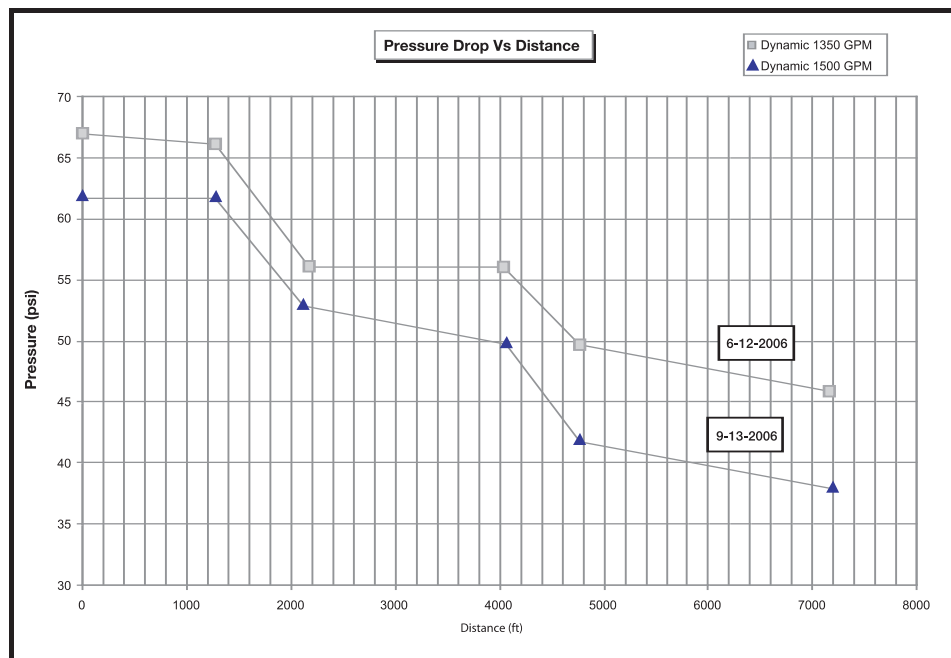
Figure 1

or pinpoint the problem in 9,000 feet of pipe, we measured residual pressures along the transmission main and plotted these measurements, as shown on Figure 1. As can be noted from the figure, relative to distance, we had excessive losses on the C-17 directional drill and the Interstate 95 directional drill segments.

Next, staff members requested and examined the field report and drill log for the directional drilling. We found that the project specifications had maximum allowable entry and exit angles of 15 degrees for the HDPE pipe. According to the drill log, the drilling contractor had at times exceeded 25 degrees. The utility staff theorized that the pipe had possibly buckled due to the tighter entry and exit angles, but we knew that an actual inspection had to be conducted to be conclusive about the transmission problems.

The HDPE pipe was scheduled for an inspection, and the staff proceeded by removing one of the valves to insert a camera. Upon inspection of the valve assembly, we discovered that the contractor had installed the 16-inch butterfly valve following the DIP fusion to the HDPE pipe. This valve installation problem proved to be the transmission problem; thankfully, no buckling had occurred as initially theorized.

In essence, a butterfly valve opens inside the pipe diameter. Since the inner diameter of the 16-inch HDPE pipe was 14.75 inches and the valve was sized for a true 16-inch DIP pipe, the butterfly valve, which depends on the inner pipe diameter for its successful operation, was only partially functional.

state. Staff members were not able to find this valve problem because they only closed back three turns on the valve to determine whether the valve was actually in the open status and assumed everything else was acceptable. The same valve problems were found at the HDPE I-95 crossing. We corrected these problems by simply changing the butterfly valves to gate valves.

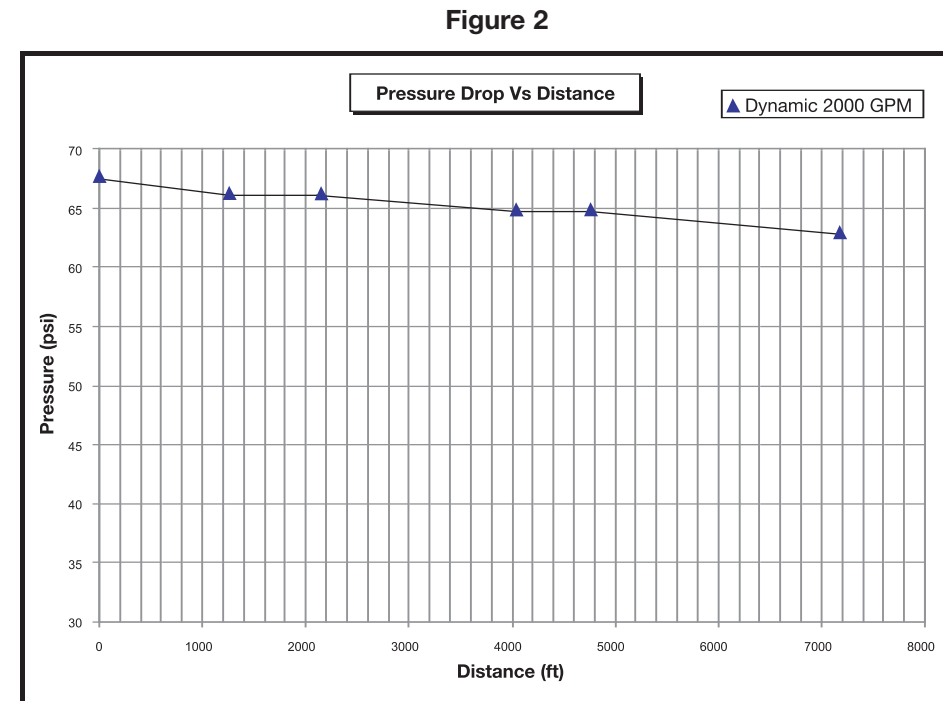
Figure 2

From this experience, we have now implemented procedures to test new pipeline facilities to ensure that they perform to their rated capacity. As can be noted from Figure 2, our system has greatly improved after the described corrections were implemented, and we avoided the construction capital costs of a second water treatment plant with its annual operations and maintenance costs.
