Hillsborough County's Innovative Pipe Inspection Program Adds Efficiency and Accuracy

Richard Cummings and Michael Condran

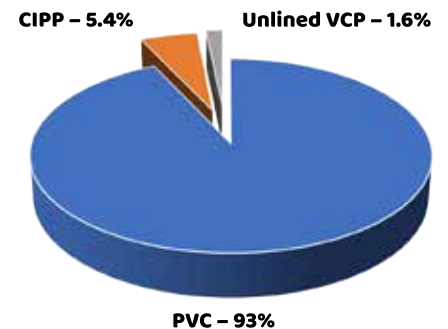
Figure 3. Dale Mabry Collection Basin focused electrode leak location inspection length by pipe material type.

Figures 3 and 4 summarize the breakdown of pipe material type inspected and the corresponding potential I/I flow rates, respectively.

These summary data show that unlined VCP installed in the 1970s and '80s, and relatively newer CIPP liners, represented only 7 percent of the total inspected length, but contributed over 22 percent of the potential I/I for the pipes inspected. Targeted rehabilitation can now be focused on these pipe classes as a priority.

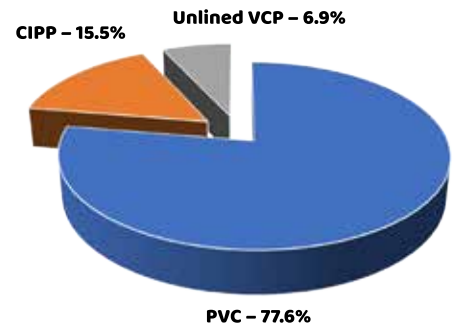
Figure 4. Dale Mabry Collection Basin focused electrode leak location inspection potential inflow and infiltration by pipe material type.

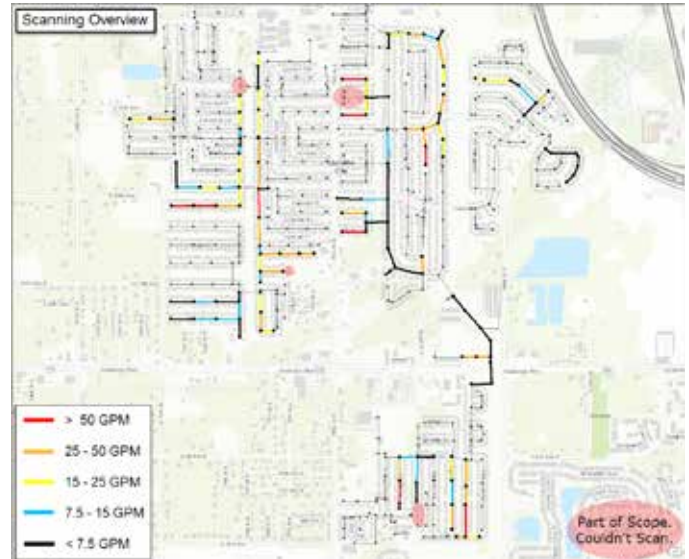
Figure 6. Clair-Mel electrode leak location inspection results showing individual pipes with greatest potential defect flow rates contributing to inflow and infiltration.

Figure 6 shows individual pipe segments using a color-coded summary. It indicates the potential I/I defect flow rates relative to all the pipe inspections ranked into the following five flow rate categories:

- ◆ Potential I/I rate more than 50 gal per min (gpm)
- ◆ Between 25 – 50 gpm
- ◆ Between 15 – 25 gpm
- ◆ Between 7.5 – 15 gpm
- ◆ Potential flow rate less than 7.5 gpm

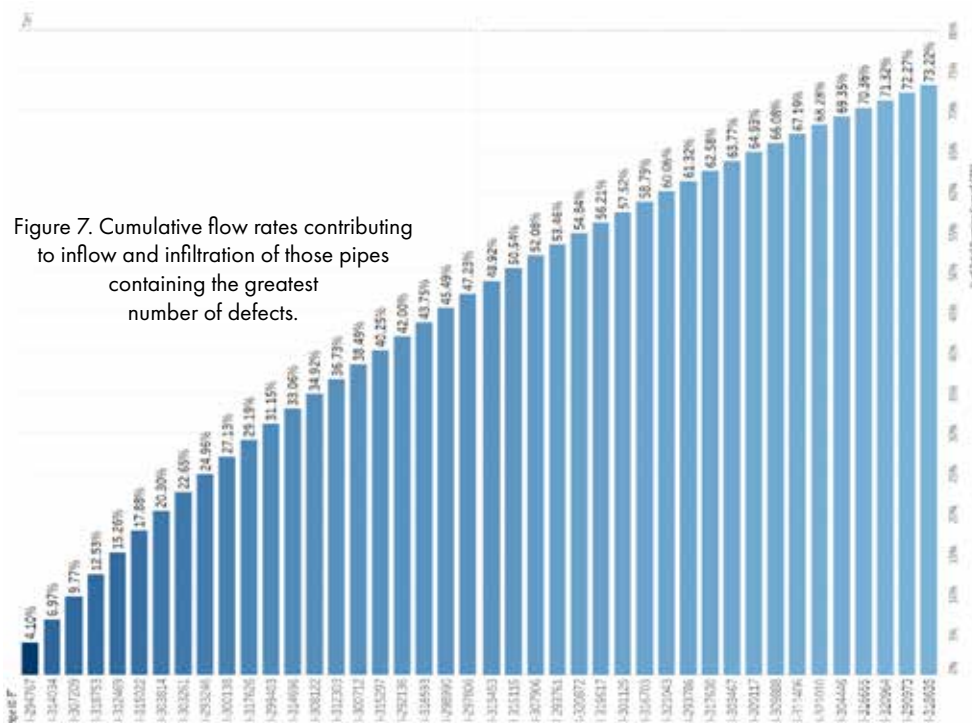
Figure 7. Cumulative flow rates contributing to inflow and infiltration of those pipes containing the greatest number of defects.

Figure 7 graphically depicts the cumulative potential I/I flow rate for the 35 percent of all pipe inspections and reveals that these pipes collectively contribute nearly 75 percent of the potential I/I of those inspected across the Clair-Mel network. This allows the county to make targeted decisions on how to focus a rehabilitation program to maximize I/I reduction at the lowest possible cost.
