Improving Operational Efficiency at an Aging RO Water Treatment Plant through Replacement & Rehabilitation

Jerry LeBeau and Mark D. Miller

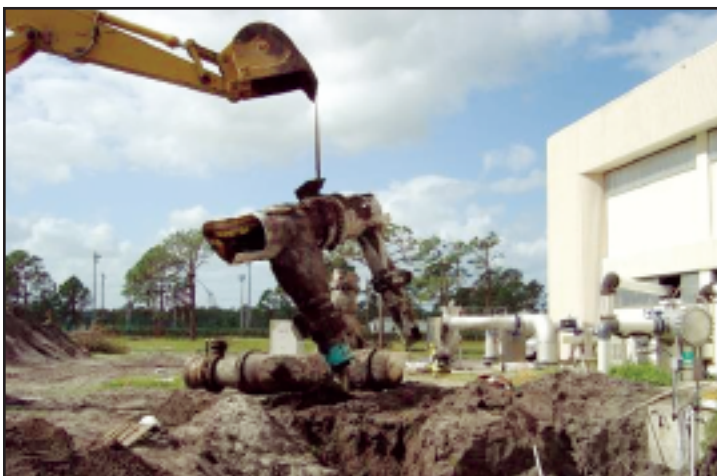
FRP. The trench piping within the process building was also constructed of FRP, including the feedwater, permeate, and concentrate piping. Frequent failures of both piping systems resulted in the decision by Indian River County Utilities to replace the FRP pipe with HDPE pipe. The difficulty in replacing this pipe came from the requirement that the plant stay fully operational with minimal shutdowns.

Figure 1. Removal of FRP Piping

Temporary piping headers were constructed to allow raw water to enter the feedwater pumps, while allowing removal of FRP pipe sections (see Figure 1 and Figure 2). An additional chemical injection assembly with stainless steel static mixer was constructed to allow removal of the existing FRP static mixer assembly. Full sections of pipe that had to be replaced in identical locations were phased in sections to minimize plant shutdown durations.

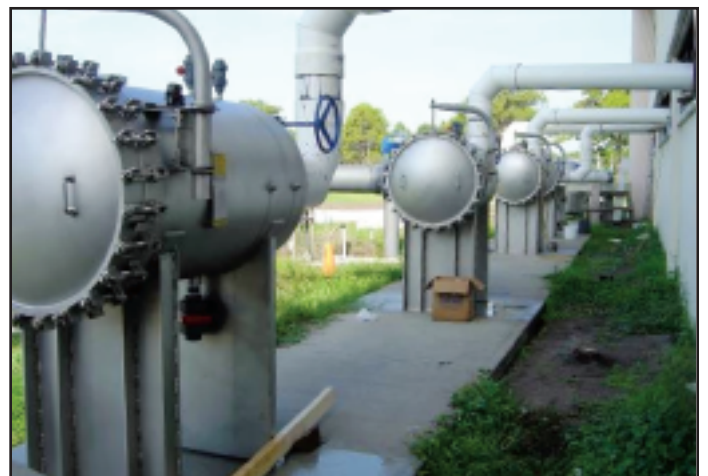
Figure 2. Temporary Cartridge Filter Header

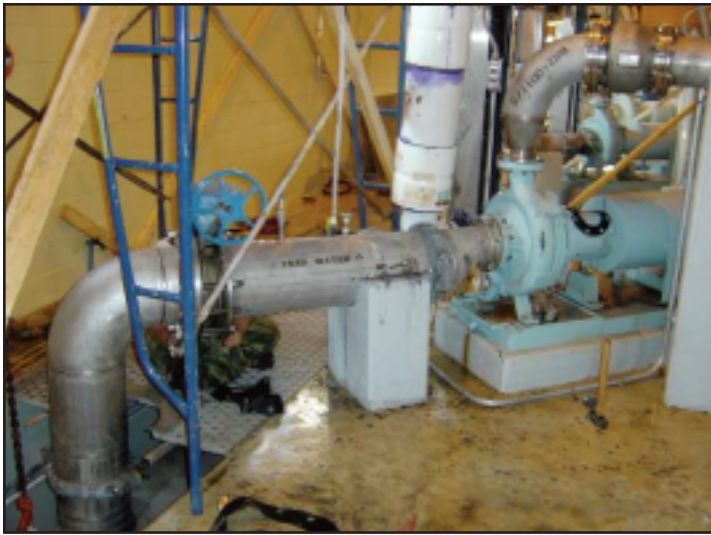
Figure 3. New Stainless Steel Feedwater Pump Header

All of the underground FRP was replaced with HDPE pipe and the interior process piping with 316 stainless steel (see Figure 3). Grooved type couplings (Victaulic style) were used to help in expediting pipe installation, since they were much easier and quicker to install and allowed some flexibility in pipe alignment.

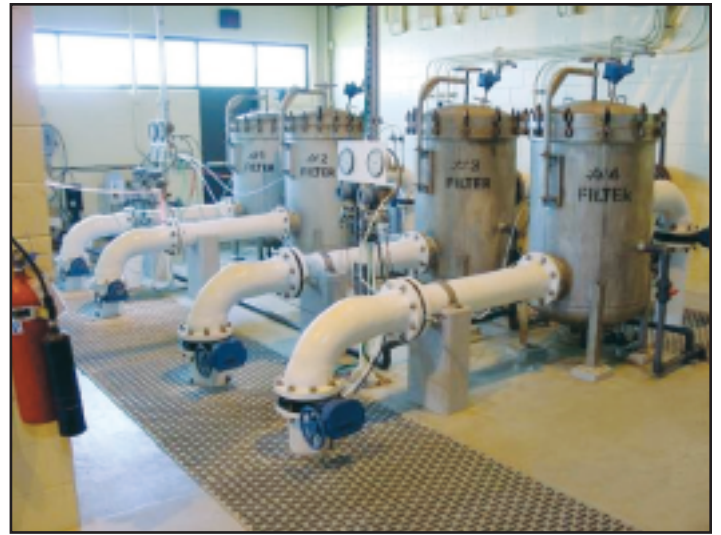
Figure 4. Old Filter Vessels

The original pretreatment filters were vertical-style cartridge filter vessels (see Figure 4). The cartridges were not only difficult to replace, since a ladder typically was required to allow easier cartridge removal, but historically allowed sand or filtered material to settle in the discharge pipe during cartridge element replacement.

The plant had a history of sand intrusion from a collapsed well to the membrane system. With the added disadvantage of vertical-style filter vessels allowing some of the settled sand within the vessels to migrate to the membrane system, sand intrusion to the membrane system was difficult to prevent.

In order to prevent any potential of sand intrusion, a "belt and suspenders" approach was implemented by the utility. A sand separator was installed on the raw water main and the vertical cartridge filter vessels were replaced with horizontal vessels, allowing easier access for cartridge replacement and a more efficient means of cartridge removal.

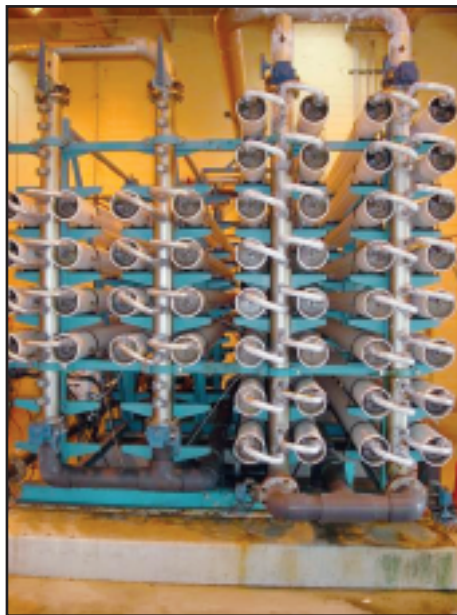
Figure 5. Typical RO Train Array

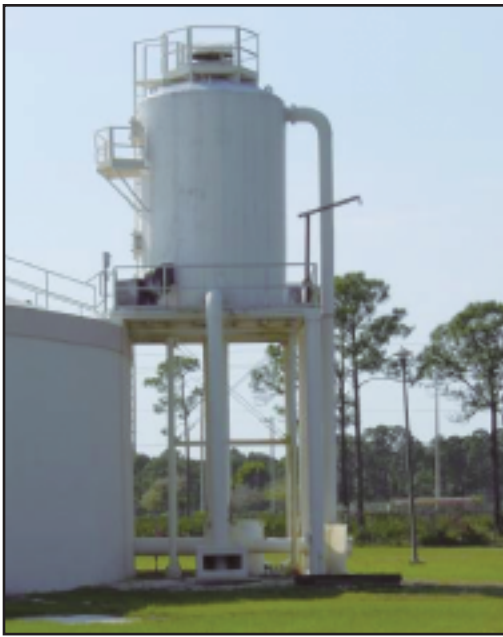
Figure 6. Existing Degasifier

- ◆ Maintenance of the system was more difficult and routine inspection of the equipment was less frequent.
- ◆ The water quality of the effluent, such as pH and chlorine residual, was difficult to monitor because these parameters could be measured only at the POE, giving little time to react and make changes to the treatment process.
- ◆ No odor control system existed, which caused heavy corrosion of the equipment surrounding the degasifiers and odor complaints from neighboring properties.

Since the degasifiers had reached the end of their useful life, a new post-treatment system was installed to replace them. The system included a clearwell, transfer pumps, forced-draft degasifiers, two-stage off-gas scrubber system, chemical injection, and monitoring. Key advantages to the new system are the ability to maintain consistent treatment of the product water, the ability to improve mixing and blending of raw water, and the ability to improve monitoring of the

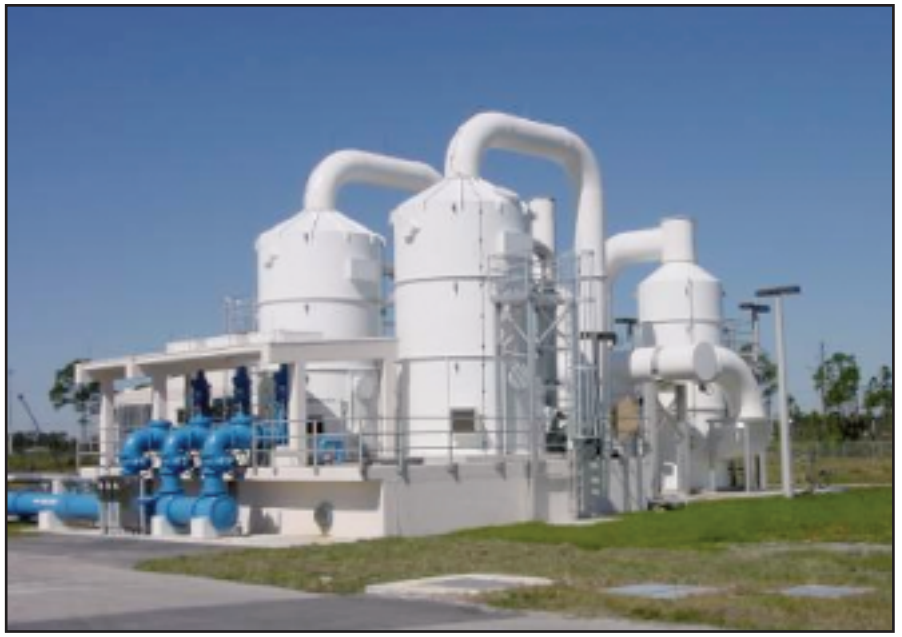
Figure 7. New Post-treatment System
