Polyethylene Encasement for External Corrosion Control for Iron Pipelines

Dan Mathews and Allen H. Cox

The results of three recent field investigations conducted by the Miami-Dade Water and Sewer Department (MDWSD) and the Ductile Iron Pipe Research Association (DIPRA) of some of the oldest installations of polyethylene-encased ductile iron pipe in the Miami-Dade area will be discussed. These and other physical excavations and inspections of in-service iron pipelines have demonstrated the overall effectiveness of polyethylene encasement as a means of external corrosion protection for iron pipelines.

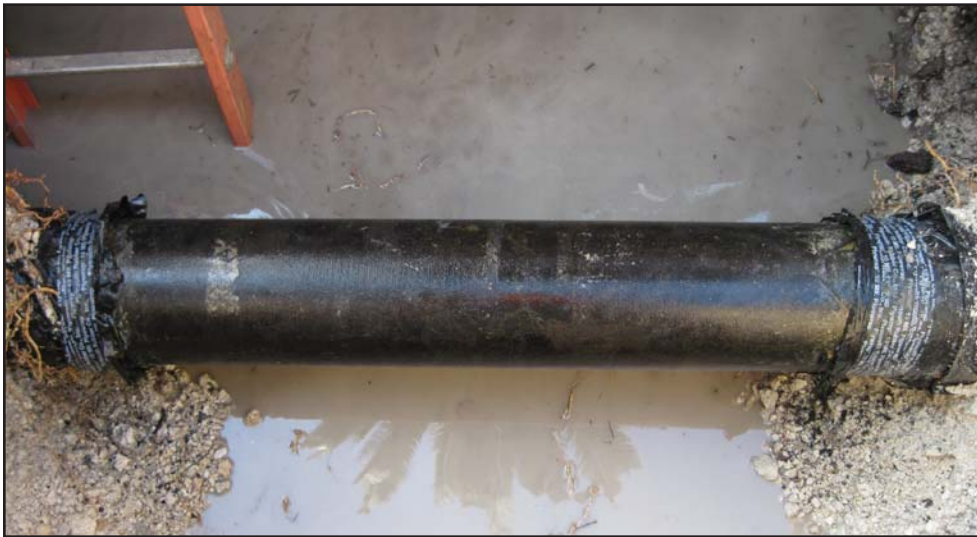
Upon full exposure of the pipe, it was found that not only was there some moisture, but some of the native backfill had been trapped between the protective barrier and the pipe. The amount of soil was such that there was not enough of this material to test for its aggressiveness. Also, during this portion of the investigation, it was noted that oxidation appeared to be over most of the exposed pipe barrel. However, as the outside surface of the pipe was cleaned with water and the previously referenced instruments, it was quickly seen that this rust was superficial in nature and that much

of the asphaltic shop coating was fairly well intact (Figure 1). As the inspection continued, the exposed pipe surface was completely sounded and probed for evidence of galvanic action, and it was noted that the pipe had suffered no pitting and/or graphitization after some 20 years of service.

Figure 1. NE 57th St., Miami, after cleaning and inspection of pipe surface. Pipe exhibited no evidence of corrosion pitting or graphitization after 20 years of service.

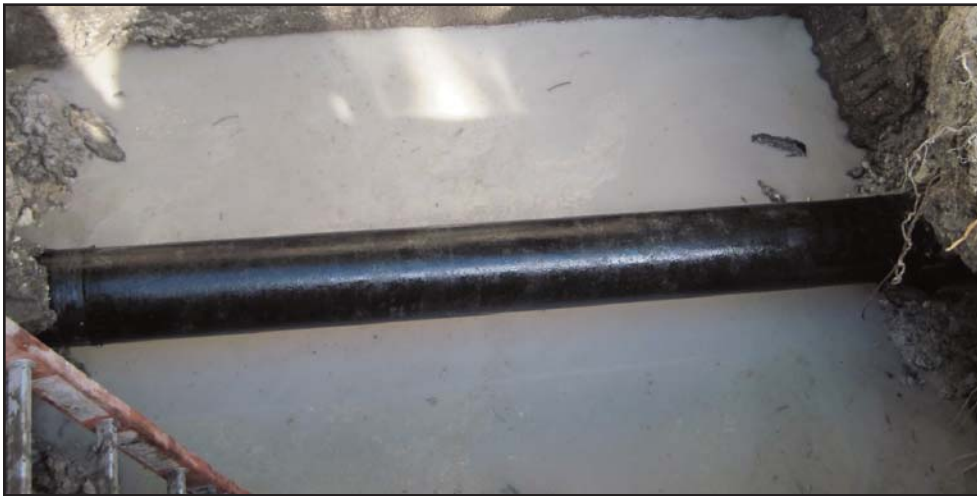
Figure 2. NE 58th St., Miami, after cleaning and inspection of pipe surface. Surface of pipe is free of corrosion pitting or graphitization after 47 years of service.

As the polyethylene was being removed, the pipe was immediately found to have very little, if any, surface oxidation along its fully exposed circumference. As the outside of the pipe was cleaned and completely sounded and probed for evidence of external corrosion, it was further found that no electrochemical action, pitting, and/or graphitization, had taken place (Figure 2).

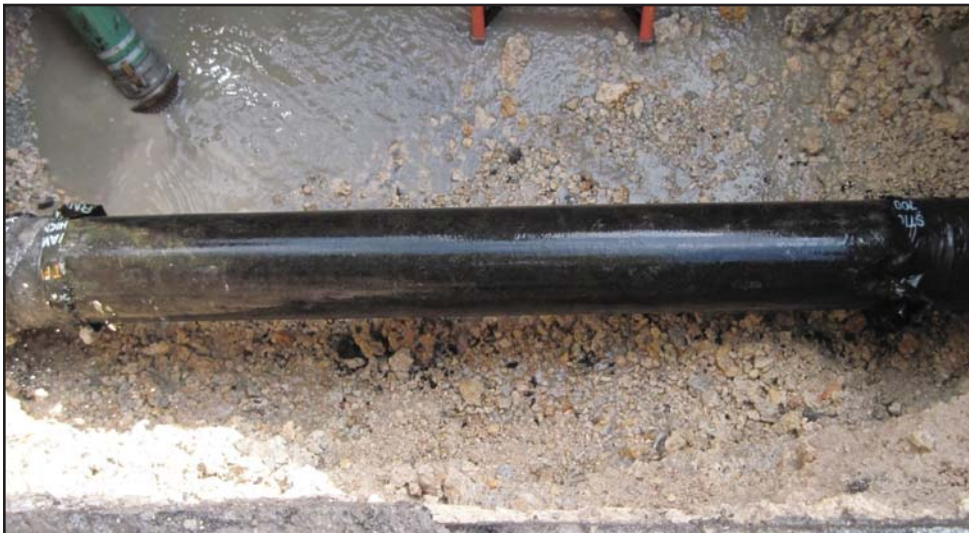
Figure 3. NE 87th St., Miami. Surface of pipe is free of corrosion pitting or graphitization after 11 years of service.

Also, during this portion of the investigation it was noted that surface oxidation looked to be over most of the exposed pipe barrel (Figure 3). However, as the outside surface of the pipe was cleaned with water and the referenced instruments, it was quickly seen that this rust was superficial in nature and that much of the asphaltic shop coating was fairly well intact (Figure 3). As the inspection continued, the exposed pipe surface was completely sounded and probed for evidence of galvanic action, and it was noted that the pipe had suffered no pitting and/or graphitization after some 11 years of service.

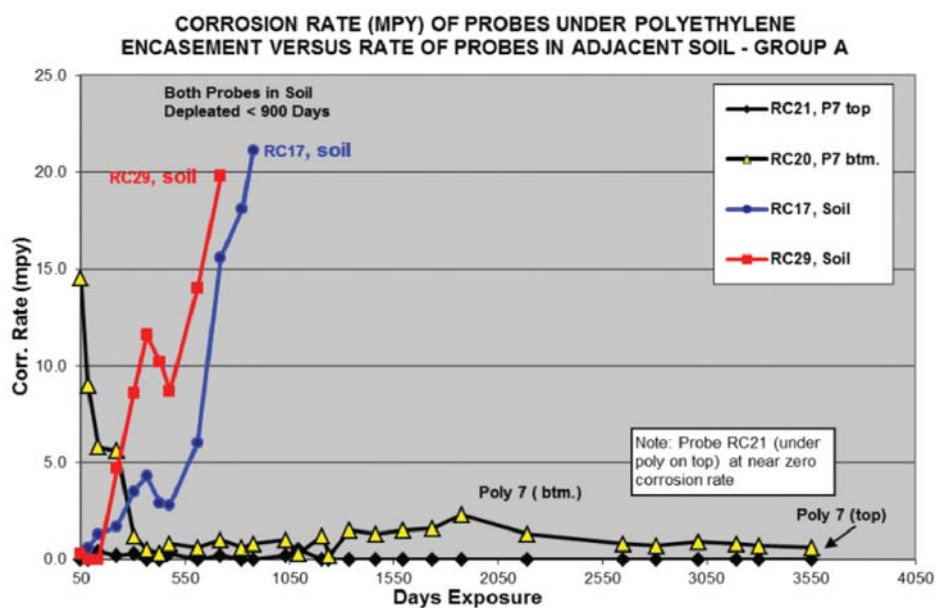
Figure 4. Corrosion rates of probes under polyethylene encasement versus corrosion rates of probes in soil adjacent to the test pipe.

under the wrap was initially high, but then rapidly decreased, which is more than likely due to polarization, as the oxygen in the moisture under the encasement was depleted. As seen in Figure 4, the decreasing corrosion rates of the probes under the plastic wrap in this study is consistent with past observations. Corrosion rates on probes covered by the encasement dropped to low levels after approximately three months of exposure. If one were to discount these initial three months of exposure, average corrosion rates under the loose protection at the 6-o'clock position were lowered to an average rate of 0.7 mils per year (mpy), down from 1.2 mpy (Figure 7). This compares to corrosion rates as high as 30 to 40 mpy on adjacent unprotected pipe (Horton and Ash, 2013)

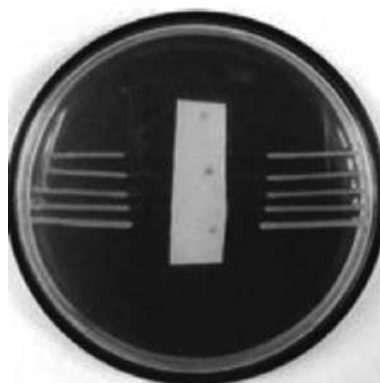
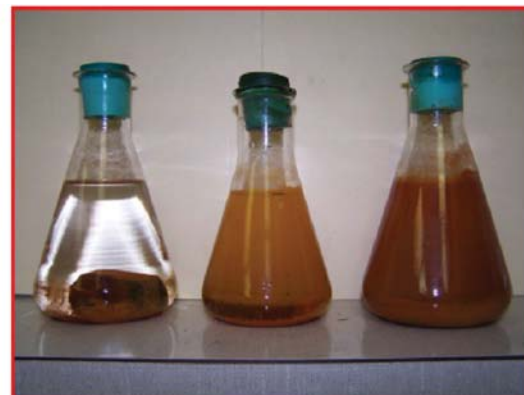
Figure 5. Left photo: Petri dish showing effectiveness of biocide component after more than four years of burial in the Everglades with 100 percent kill rate. Right photo: Flasks showing effectiveness of inhibitor with three ductile iron (DI) samples in 5 percent salt solution after five years. The flask on the right is bare DI, the flask in the middle is bare DI wrapped with conventional polyethylene encasement, and the flask on the left is bare DI wrapped in enhanced (with biocide and inhibitor) polyethylene film.

Some of the initial experimental efforts with V-Bio™ began at an Everglades testing ground and in a laboratory. The biocide and inhibitor were tested over a four- and five-year term, respectively. The results showed a 100 percent kill rate for the biocide component at the Everglades site, while the inhibitor with biocide produced, in essence, no corrosion and virtually zero rusting over a five-year period with iron specimens in a 5 percent salt solution (Figure 5). Some other fields that work with V-Bio™-wrapped ductile iron pipe specimens have disclosed some additional very promising results. The V-Bio™-encased pipe exhumed after only three years and eight months of installation shows no pitting and/or graphitization, in conjunction with virtually no superficial oxidation (Figure 6). This can be compared with some unprotected ductile iron pipe segments with only six months of installation (Figure 6).

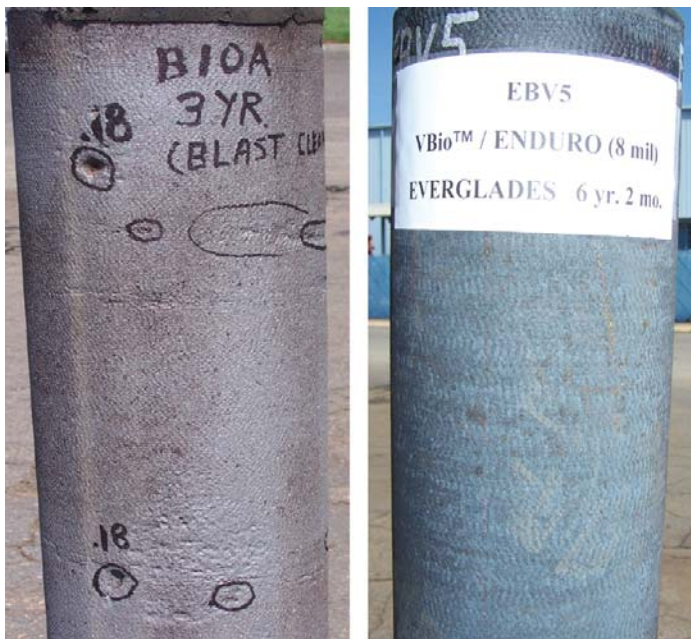
Figure 6. Left: Bare DI pipe after three years burial with corrosion pits up to 0.18 in. Right: Bare DI pipe with polyethylene encasement containing biocide and corrosion inhibitor after six years burial in the Everglades with zero pitting.

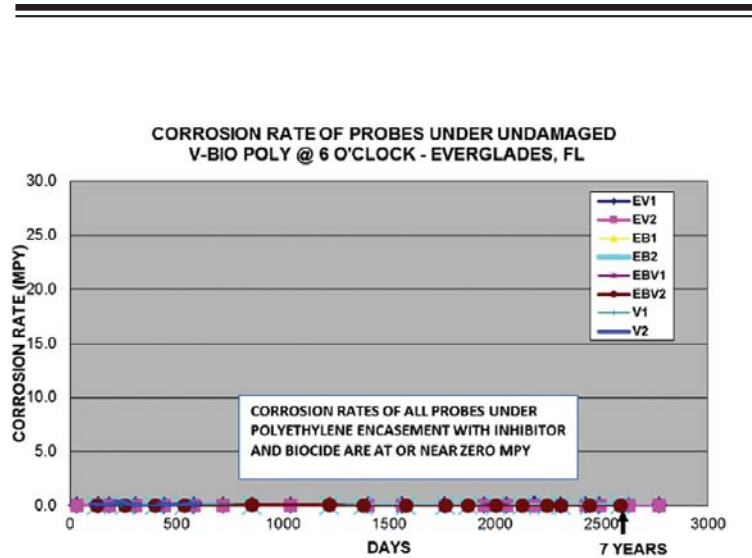
Figure 7. Corrosion rate (mpy) of probes under undamaged V-Bio™ Poly at the 6-o'clock position showing zero or near-zero corrosion rate during the test period. Corrosion rates of probes under V-Bio™ with cathodic protection were also at zero corrosion rate during the test period.
