# Horizontal Directional Drilling an Emergency Water Main Replacement under Matlacha Pass – Challenges & Innovation

Mike McGee, Iqbal Hossain, Brian Dorwart, Jeff Wilson, and Bill Thacher

In October 2005, Hurricane Wilma severely damaged a portion of the existing 12-inch, sub-aqueous water transmission main under the Matlacha Drawbridge, resulting in the water main being breached, isolated at the bridge, and taken out of service. The GPIWA service area east of the bridge was provided temporary domestic potable water via an emergency interconnect from the city of Cape Coral.

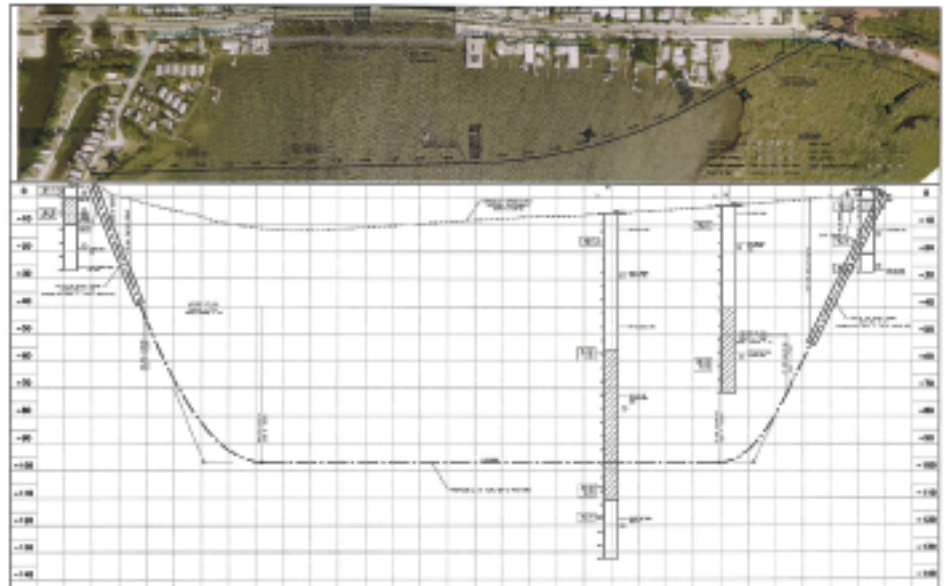
Figure 5 – Drill Path Plan and Profile

A summary drill path design is shown in Figure 5. As part of the drill path design, the geotechnical baseline reports were used to develop an annular pressure curve (with tolerances) and a formation confining pressure curve for the geological conditions expected below the mud line. These curves are shown in Figure 6.

As shown in Figure 5, this significant HDD project encompasses a total length of approximately 2,915 feet and was designed with a depth of cover below the mud line of 97 feet below the Matlacha Pass waterway.

The east end of the drill path had insufficient capacity up to a rod distance of 93 feet, or a minimum depth of 19 feet, so the design included installing a 36-inch casing pipe and drilling through the casing pipe with an intersecting drill and BAT steering and tracking elements to virtually prevent frac-out and subse-

The west end was more susceptible to hydraulic fracturing because it was further from the drill rig; therefore, more pressure was required to move the drill fluid back to the rig. The problem started to occur at approximately 200 feet from the west end drill site.

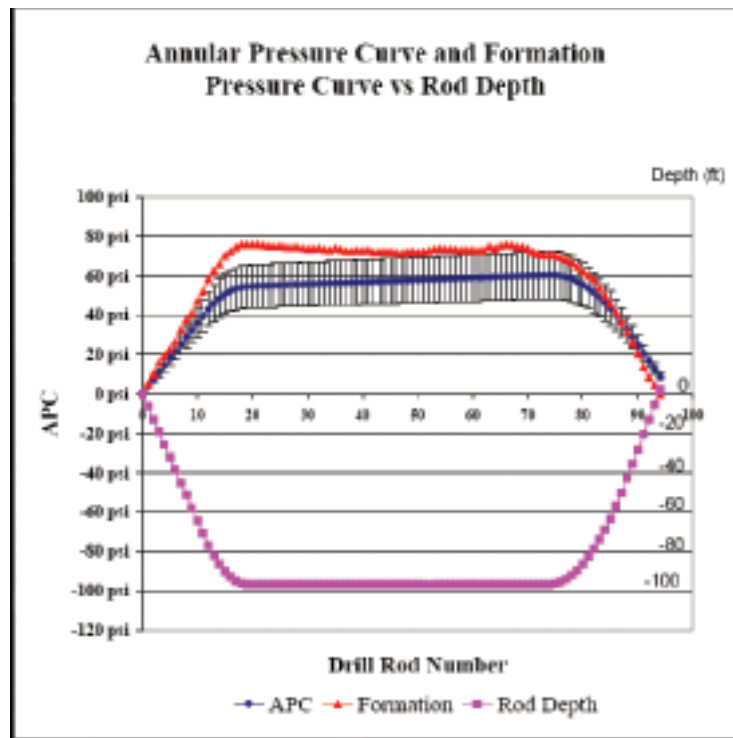
Figure 6 – Drill Fluid Management Curve

The depth of the drill path was assessed for frac-out potential by analyzing the anticipated annular pressure curve of the drill fluid. To prevent hydraulic fracturing, the depth of the drill path (approximately 50 feet below the majority of the mangroves and 97 feet below the waterway itself) was acceptable, and posed minimal risk of frac-out along most of the drill path trajectory; however, toward the ends of the drill (near

During the design phase, drill fluid management curves were prepared (Figure 6). During construction, drill fluid loss due to hydraulic fracturing was controlled by keeping drilling pressures below the formation confinement pressures.

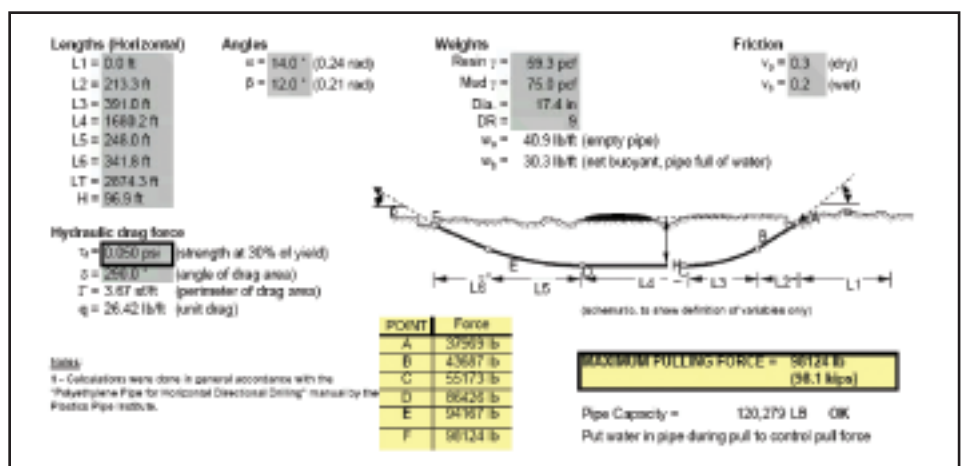
Figure 7 – Anticipated Maximum Pull Load Calculation

Although the actual pull-back force (Figure 7) is less than the safe pull-back load, it was recommended that the pipe be full of water to reduce the force sufficiently to install without exceeding the structural capacity of the DR 9 pipe. Because the pull occurs relatively quickly, a contractor is typically provided with this analysis and may select to pull the pipe dry until the pull force approaches the critical value, at which time the contractor will start adding water to reduce the buoyancy and pull force required. The results of the long-term assessment, however, indicated that the pipe must remain full of water to remain at a stress level less than the pipe capacity.

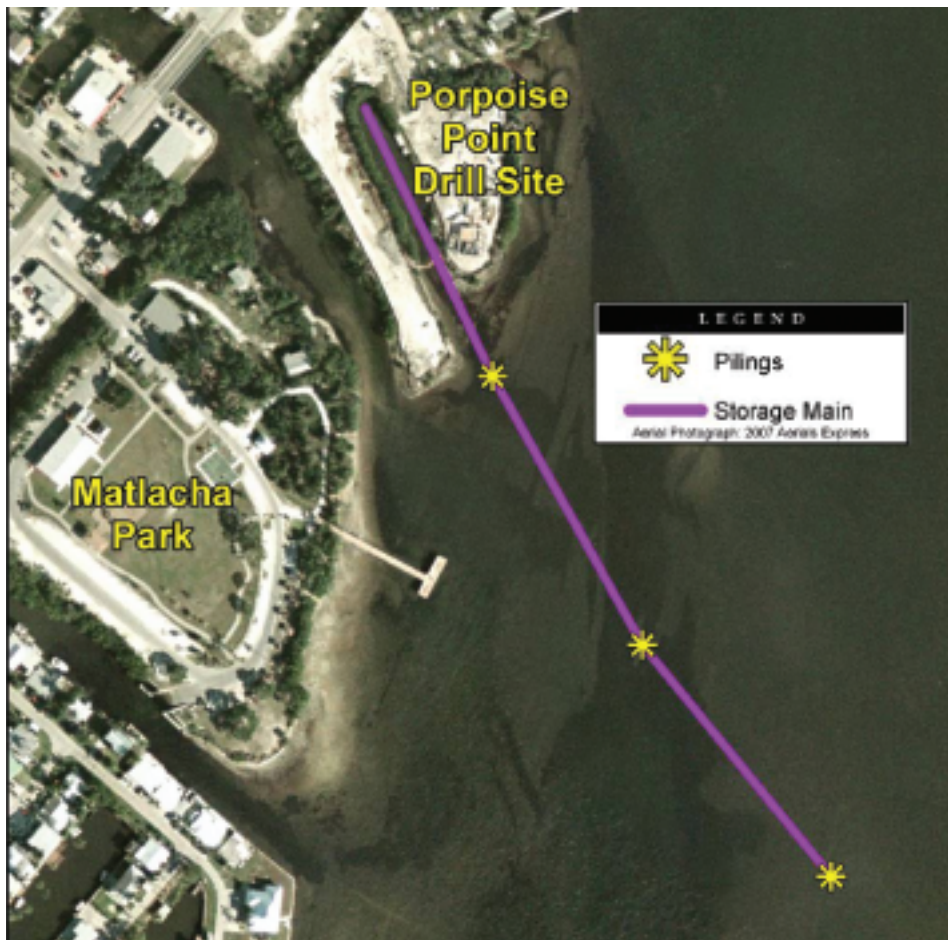
Figure 8 – HDPE Pipe String-out in Open Water

The temporary pilings were designed at 500-foot intervals, for a total of 1,000 feet to be used as an anchor for pipe pullback

through the borehole (see Figure 8). The team worked with the Coast Guard to develop the navigation lighting requirements for the pilings and the floating pipe string-out to ensure there would be no public safety or navigation hazards.
