Prestressed Concrete Cylinder Pipe Rehabilitation, Repair, and Replacement: Large Diameter Success Stories

R. Timothy Ball, W. Garland Moore, Doug L. Smith, Neal D. Stubblefield, and Ray W. Wahlquist

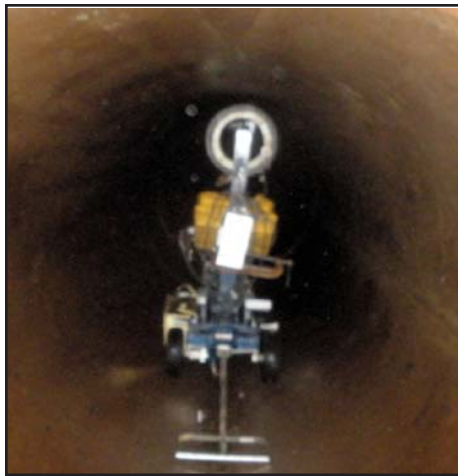
Crawler mounted RFEC/TC and video

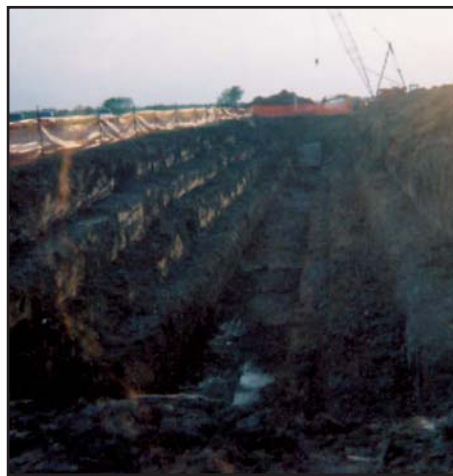
Stepped excavation during PCCP replacement

As a result of the RFEC/TC survey, DWU elected to replace 215 segments, which included pipes with 15 or more wire breaks per segment and adjacent pipes where there was little separation between distressed and non- or minimally-distressed pipes, as an economy of construction. Because pipe maintenance, including major repairs and replacement, is normally executed by DWU during the winter season (between October and May) when there was reduced system demand as well as limits on lake drawdown, it was decided to execute the project immediately following the inspection. The third-party construction management project included work designed by two separate design consultants and performed by three different construction contractors. The fast-track project (less than two months from start to substantial completion) included additional work scope that was also finished on schedule and under budget, while additional pipeline inspections and system upgrades during a rainy weather season in northeast Texas were undertaken. Replacement of pipe segments was facilitated by ECP and involved 10 to 15 sticks of pipe at each mobilization. Repairs and rehabilitation to the pipe included full-joint replacement and external repair clamp installations based on the RFEC/TC inspections. Pipe removed during the pipe replacement operation was stockpiled for later investigation, and no additional forensics evaluation was undertaken.

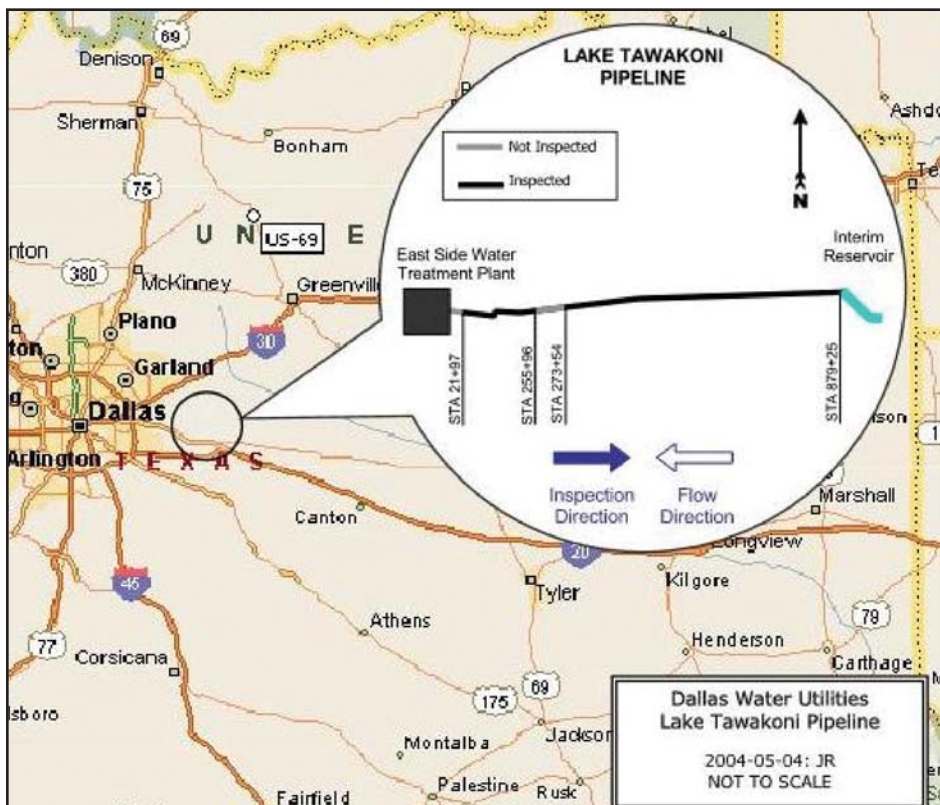
Figure 1. 2004 Lake Tawakoni Pipeline Condition Assessment

The pipe was isolated from the system as the WTP could be fed by an alternate raw water main and the dewatered pipe was inspected in the opposite direction of flow. The 72-in. line exhibited no breaks detected by the RFEC/TC, but of the 4,223 pipe segments (nominal 20-ft pipe sticks) inspected on the 84-in. line, 285 (6.75 percent) contained wire

breaks ranging from five to 215 wire breaks per segment.³ Of note is that none of the pipe had electrical bonding (“shorting”) straps. Both pipe diameters were suspected to contain Type IV prestressing wire.

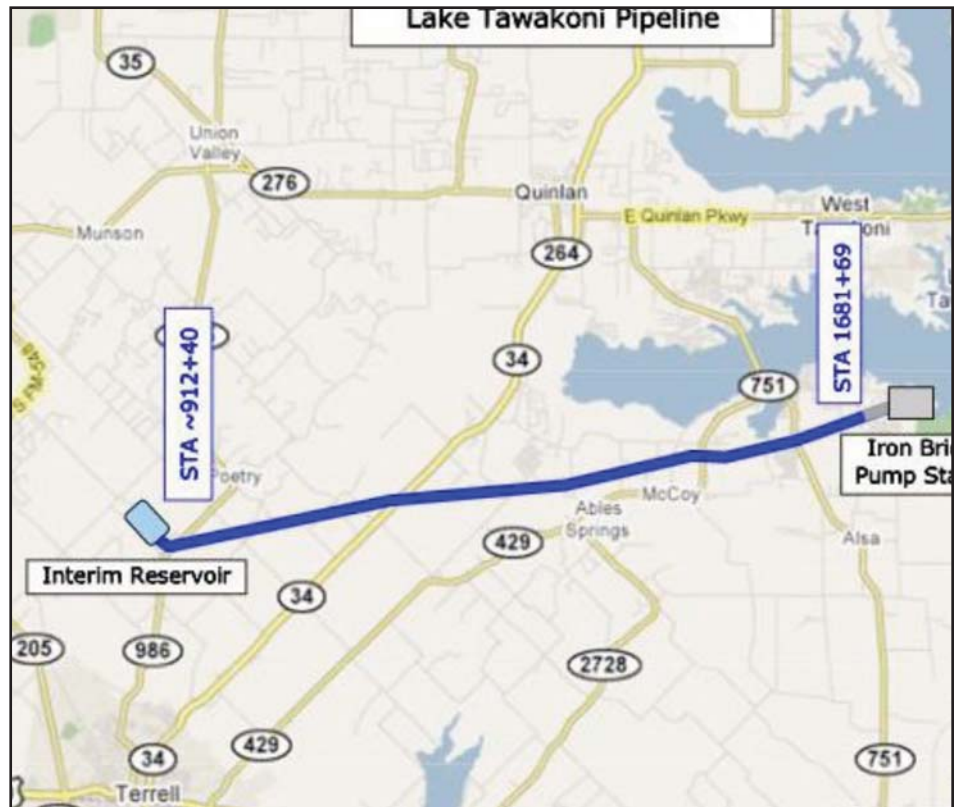
Figure 2. 2008 Lake Tawakoni Pipeline Condition Assessment

active corrosion protection system, which included cathodic protection. A subsequent inspection by PPIC was conducted in 2008 that re-analyzed and revised data from the 2004 study based on updated technology and the construction completed in 2004. The results indicated a minor increase in the number of distressed pipes in the previous inspection; about 10 percent of the previously diagnosed distressed pipe exhibited an increase in wire breaks over the four-year period, up to 55 more breaks in one segment. The 2008 effort also extended RFE/TC inspection of the raw water main from the Interim Reservoir eastward to Lake Tawakoni, nearly 14.6 mi, with almost all 84 in. of pipe. Of the 3,997 segments inspected on the 84 in. of pipe, 7.1 percent were found to be distressed, with 7 percent of that amount having 25 or less wire breaks per segment. Although only six sticks of 72 in. were inspected, one pipe segment exhibited up to 50 wire breaks.⁴

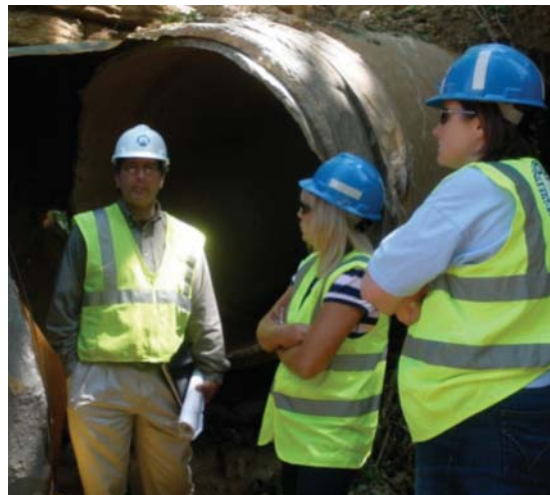
Vehicle-sized hole in 60" PCCP

The pipe locations, with the more obvious deficiencies (determined by the visual and RFE/TC reconnaissance,) were excavated and examined. In each instance, the location of either partially or fully deteriorated wires was pinpointed. At the failure site, less than 25 percent of the LCP was left intact and ap-

peared to be in compression, showing actual wrinkles in the metal. This section of main was on a fairly steep grade and the line may have been pulling apart and sliding down the hillside. Wires that were inspected visually appeared to be in good to excellent condition with very little corrosion.

The damaged areas were patched with cement mortar, fitted with external steel collars (or tendons), and fully encased in cement rich grout.

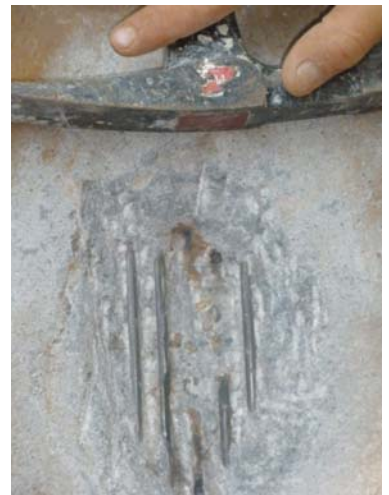
Broken prestressing wires

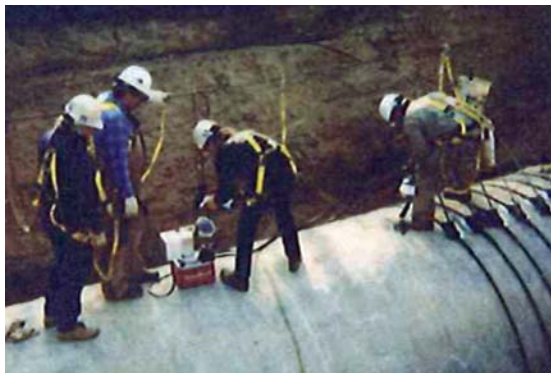
Steel tendon installation on PCCP

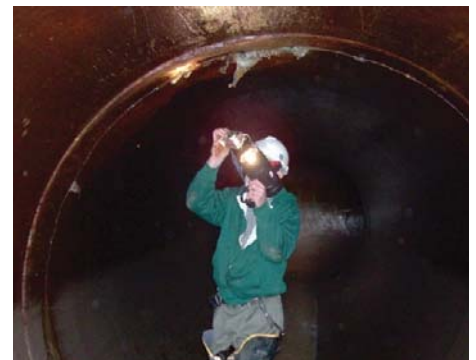
A man-entry inspection, which included photographic evidence, of an 84-in. PCCP-finished water line revealed a circumferential break in the pipe near a bell and spigot joint between the existing finished water clearwell number 1, and a future clearwell, number 2. The failure was widest at the pipe’s crown and ran to the springline on both sides. The proximity of the crack led the inspectors to suspect the weld at the bell ring had failed due to possible point loads during installation. Hairline circumferential cracking was also found

Inspection of PCCP Joints

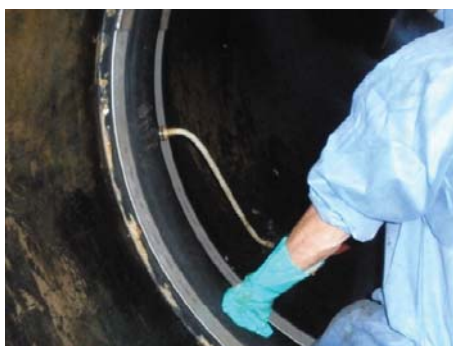
Injecting internal seal adhesive

- ◆ The joint or crack was packed with hydraulic cement to eliminate voids behind the rubber seal.
- ◆ The pipe wall was coated thoroughly with a food-grade lubricant.
- ◆ The seal was centered over the joint or crack.
- ◆ The stainless steel bands were jacked into place on either side of the seal.
- ◆ An air test was performed to assure a tight seal between the pipe wall and the rubber seal.

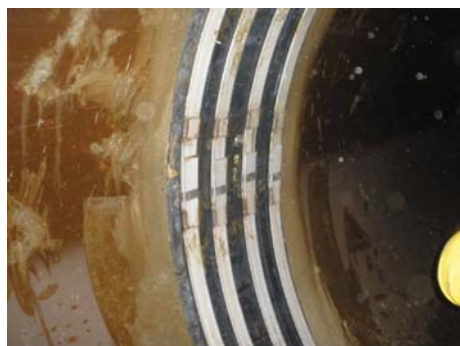
Completed internal seal installation

An internal joint seal was determined to be an acceptable solution, and Miller Pipeline Corp. was retained to install an internal joint seal (WEKO-SEAL®) to repair the pipeline. The internal joint seal is a flexible rubber, internally applied, leak clamp that ensures a noncorrodible, bottle-tight seal around the full inside circumference of the pipe-joint area. This type of seal is routinely used for sealing leaks at pipe joints; however, its use in this instance away from the joint was considered an appropriate application. The rubber seal is held in place with stainless steel rings that are jacked tightly against the seal, forcing it against the pipe wall.

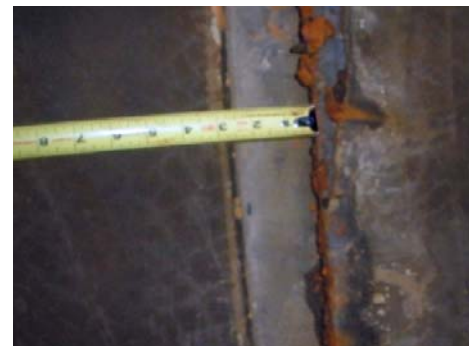
Measuring joint deflection in 54 in. pipe

About 900 lin ft of the 84 in. was surveyed internally and one joint seal applied. Similar deflection issues were evident in a 54-in. ductile iron pipe (DIP) segment that connected to the 84-in. PCCP; after joint deflection and gasket positions were verified in a 300 lin ft run, three internal joint seals were applied. The leaks and associated soil foundation erosion appears to have been halted in both pipes.
