Proactive Emergency: Replacing Daytona Beach's Most Critical Water Pipe

Scott Richards, Eric Smith, and Mark Abram

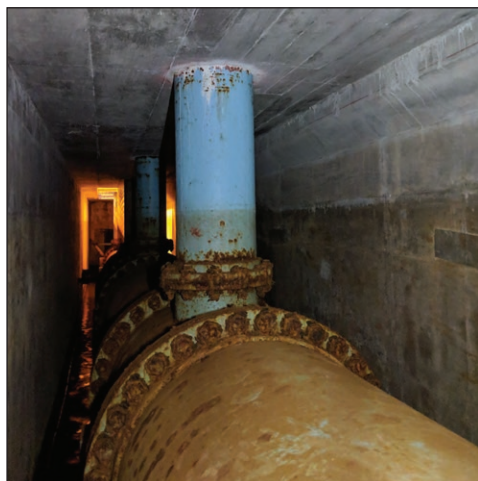
Figure 1. Discharge header pipe tunnel.

Located in a humid tunnel (Figure 1), the exterior of the 36-in. pipe became heavily corroded over its 45-year life span (Figure 3), posing a greater failure risk. Upon an operator inspection of the high-service pump station (HSPS) discharge header, the city decided to further evaluate the pipe, which ultimately led to identifying reliability improvements to the HSPS discharge header. Because it's critical to maintain operation of the pump station (and the pipe) to provide supply to the city, the project was viewed as critical and placed on a rapid schedule.

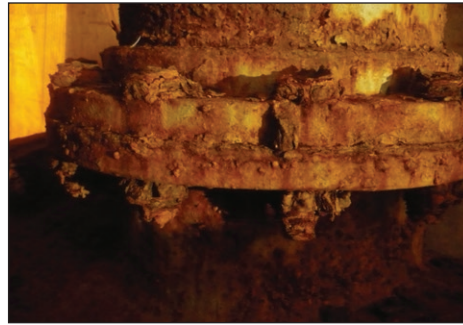
- ◆ The 45-year-old DIP had excellent wall thickness results.
- ◆ There were no leaks.
- ◆ The exterior was highly corroded, believed to be due mainly to the initial design and environment, which created a humidity trap and sweating pipe.
- ◆ Flange bolts were heavily corroded and significantly deteriorated.
- ◆ “Line taps” that included corroded galvanized pipe posed a risk of failure.
- ◆ Air release valves were installed on steel saddles, with couplings that were highly corroded.
- ◆ Only one valve was installed in-line and was inoperable.

Figure 3. Corroded flange and bolts from a high-service pipe into a header.

environment for high corrosion potential on the pipe. With the bolts and tapping saddles showing the greatest corrosion, along with a lack of operational valves in the header, it was determined to replace the entire “exposed” header that existed within the tunnel. The exterior buried pipe was anticipated to be in

The team considered potential ways to isolate sections of the pipe, but safe accessibility remained a major issue that could not be resolved. Thus, it was determined that replacement of the header pipe would be the safer, lower-risk, and best long-term solution.

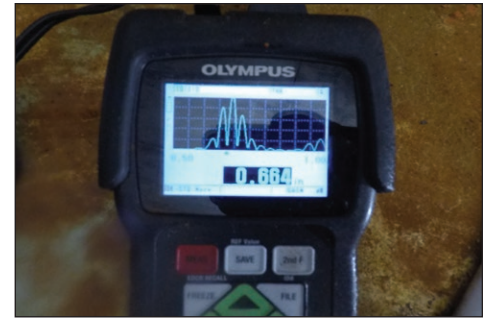
Figure 4. Ultrasonic thickness meter.

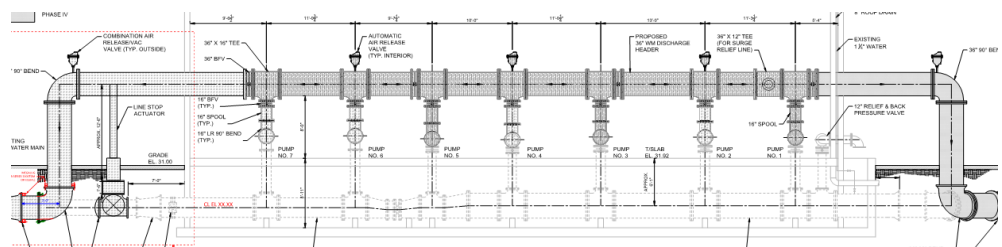
Figure 6. Replacement header draft layout.

Based on the investigation effort, it was determined very early in the process that the best (and viewed as the only) option to replace the existing header, while maintaining water supply, was to construct a new header pipe “overhead” of the existing HSPS. This allowed for separate construction of a new pipe and sequenced tie-in to the existing pipe outside of the building and underground. An option was considered to replace the pipe in the existing tunnel, but this required building a temporary partial header. This additional work, along with the challenging accessibility, was anticipated to increase cost and risk to the project.

Based on the initial agreed-upon layout (Figure 6), key items were established to be addressed in the design. The items have been grouped based on subject.

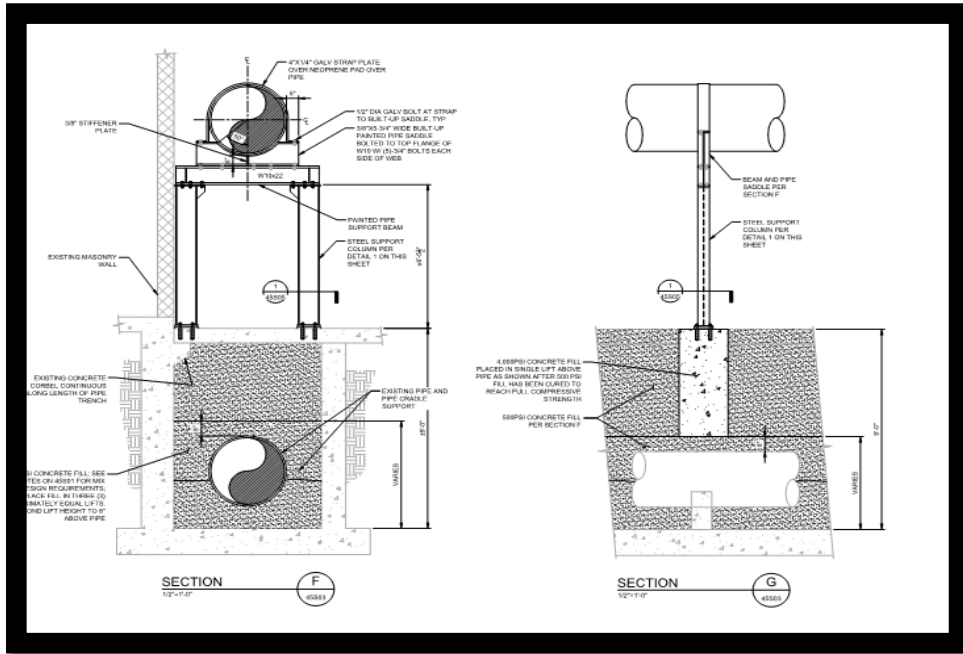
Figure 7. Structural encasement and new header pipe supports.

Based on the key items discussed, the most critical one was protecting the existing pipe. To provide support for the new header pipe, the column supports could not rest directly on the tunnel ceiling without providing more support below. Cutting out and accessing the tunnel was considered a risk to damaging the existing pipe; therefore, the tunnel was filled with concrete to protect the pipe, while also providing a base to build the new supports (Figure 7). Essentially, the existing header was “buried alive” while in service.

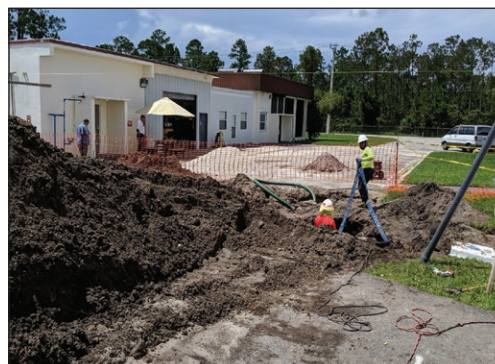
Figure 10. Phase 1 – Investigation.

Phase 1 began early in the project to prepare for the new header pipe (Figure 10). While this phase was the longest, the least amount of operational changes was required. The filling of the tunnel with concrete was the most important item in this phase to prepare for the new header pipe (Figure 11). To protect the existing header pipe, while minimizing settlement potential, a “lightweight” concrete mixture was used to fill the tunnel. It was well-planned, thoroughly discussed, and a success. With the header pipe encased, the tunnel was prepared for overhead construction of the new header pipe.

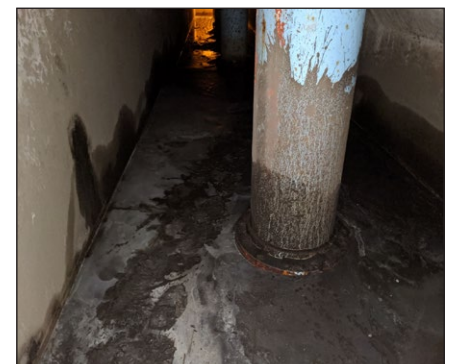
Figure 11. Phase 1 – Concrete fills the existing tunnel.

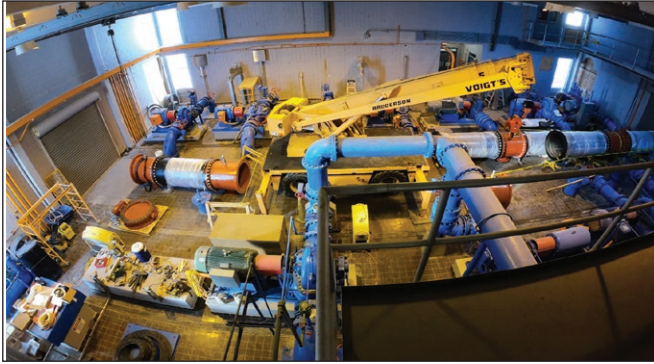
Figure 12. Phase 2 – Beginning of header pipe construction.

Phase 2 kicked off with the major equipment arrival (Figure 12), and the bulk of construction starting as the holiday season approached, adding yet another challenge to personnel. For this phase, the just-in-time delivery of key components (piping, valves,

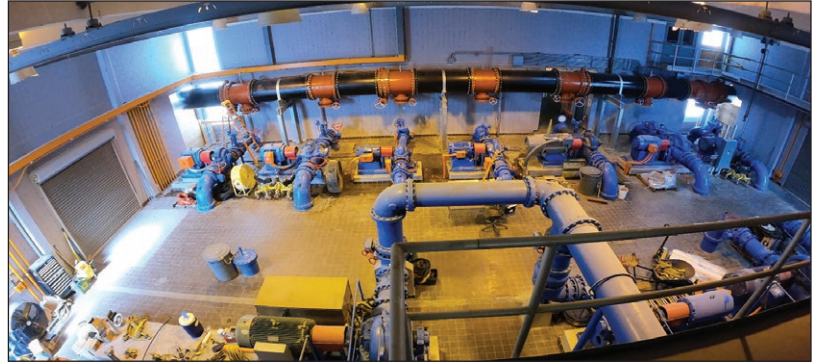
Figure 13. Phase 2 – Header pipe construction.

The greatest challenge in this phase was fabricating and installing the new piping overhead the existing HSPs, which were in active operation. The construction team proposed a construction method to fabricate the new header pipe, while minimizing risk to the operational pumps below (Figure 13). Special rigging equipment was implemented, including a 15-ton Broderon IB 200 carry deck crane, which was carefully placed in the middle of the HSPS room. As shown in the construction phasing photos, this was the key to safe installation of the pipe segments, while also maintaining operation.

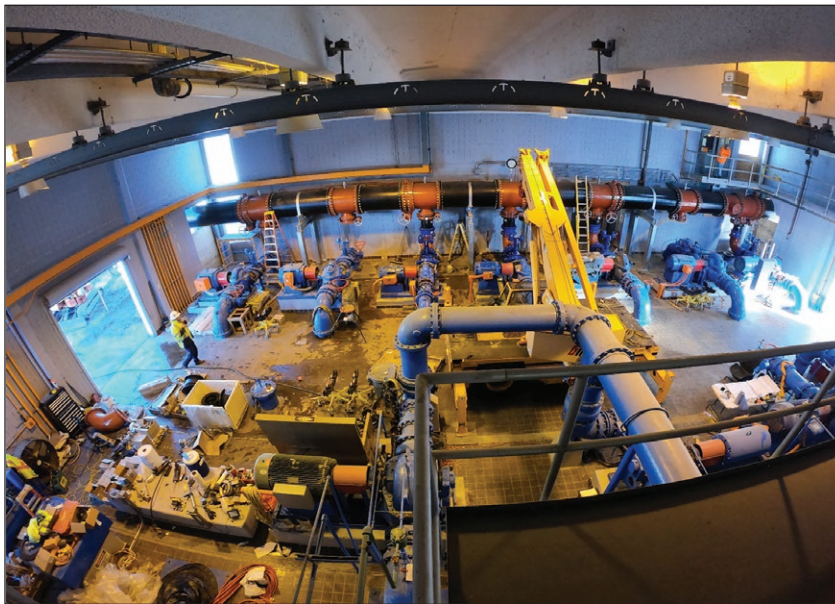
Figure 14. Phase 3 – Tie-in of pumps to header.

required (Figures 14 and 15). If this were to fail, the entire city would be without water. For this reason, all hands were on deck. The city had a well-organized contingency plan in place. Additionally, the work occurred overnight, when water demands were at their lowest, for purposes of lowering velocities and pressures and minimizing the potential need of interconnects.

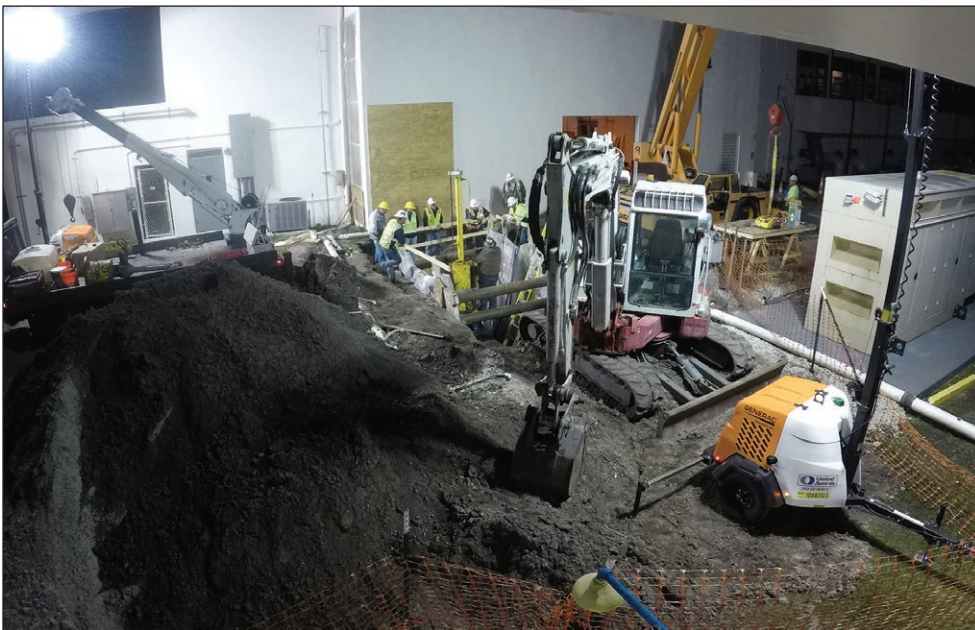
Figure 15. Phase 3 – Line stop at west discharge point.

The construction team had fully and safely prepared piping underground access, checked all piping restraints, and poured pipe supports and thrust rods in place. The line stop event was successfully completed, which allowed for the new header pipe to be connected into the existing west discharge main in the coming days. With the line stop and transition of pumps, both the old and new headers remained in service at the same time.

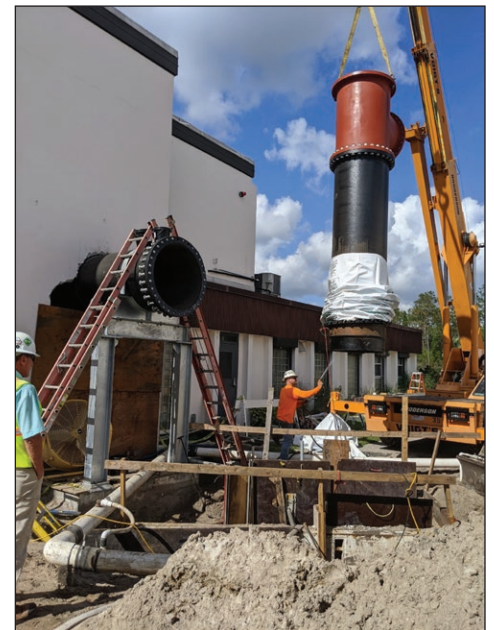
Figure 16. Phase 4 – Eastern tie-in.

Phase 4 followed, completing a similar tie-in on the east piping (Figure 16), but with the new header in service the old header could be isolated, so a line stop was not required.

This connection was a “measure twice, cut once” approach due to the alignment and rotation of the underground elbow. For this reason, extra piping and adapters were ordered; however, with proper planning, the piping dropped in as planned and the additional components were not required. Upon completion of Phase 4, substantial completion was achieved on schedule.

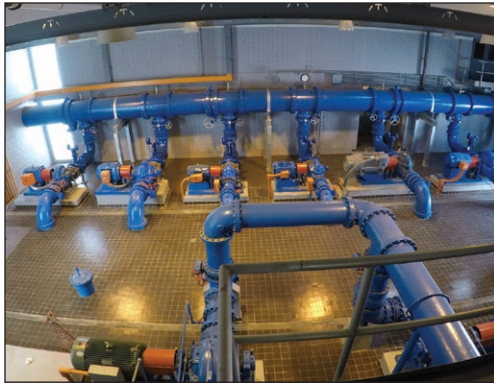
Figure 17. Phase 5 – Completion of the project.

Phase 5 included multiple wrap-up items, including painting, paving, and safety features (Figures 17, 18, and 19). This included some unforeseen challenges, including floor repair that required removal of brittle base/grout material that was installed during original construction, but given that there was now “pressure in the new pipe,” the pressure was off at this point.

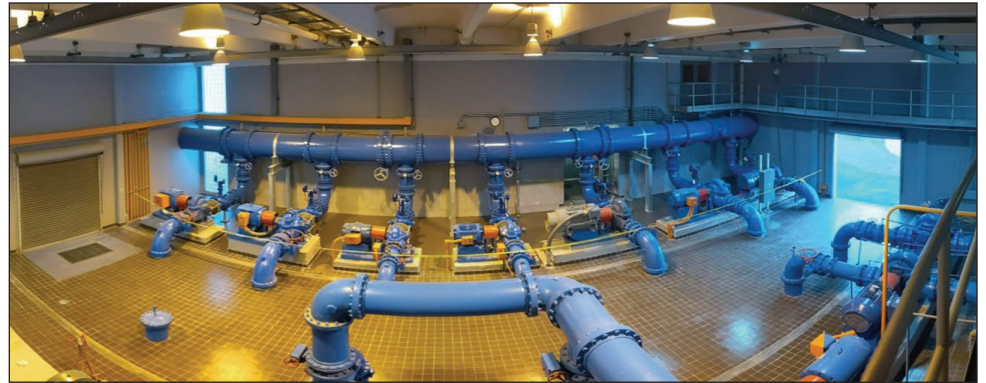
Figure 18. Phase 5 – Completion of the project (full view).

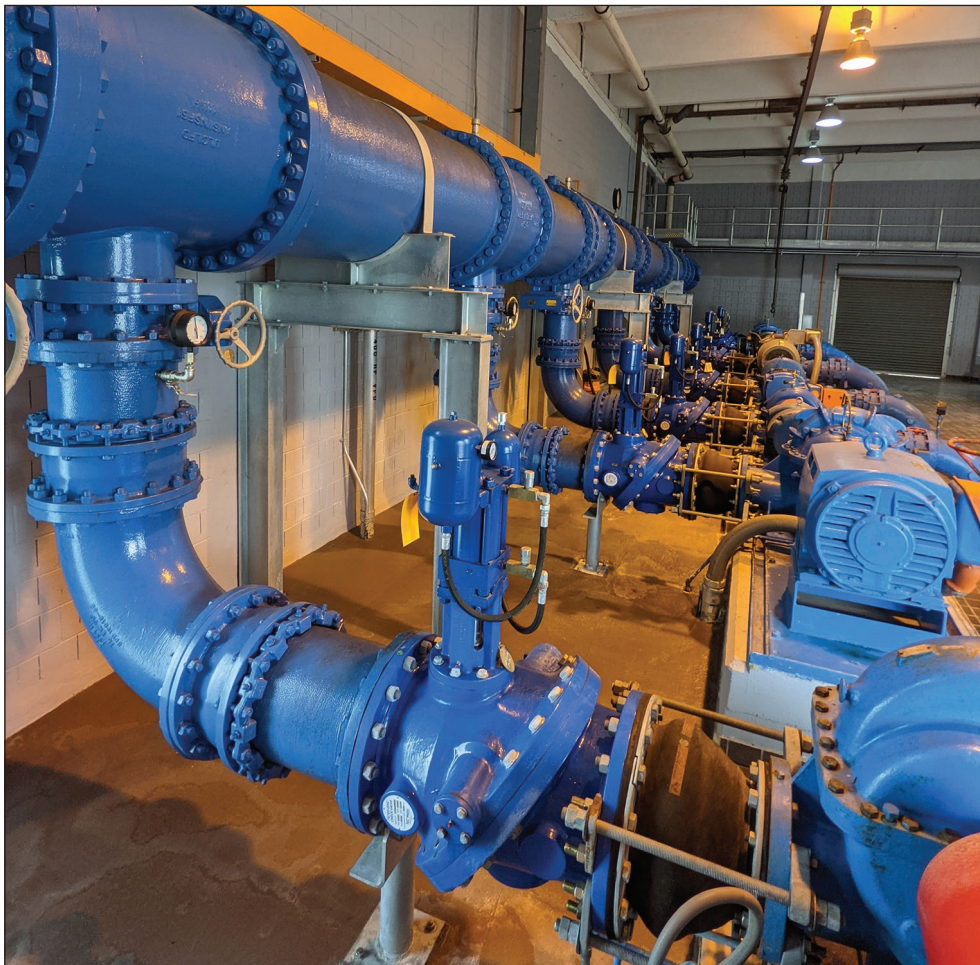
Figure 19. Phase 5 - Completion of the project (side view).
