# Utilizing Nondestructive Testing for Large Ductile Iron Force Main and Air Release Valve Evaluation

Weston Haggen, Emily Staubus Williamson, Mark Burgess,  
Jeremy Waugh, Dan Glaser, and Joel Kelsey

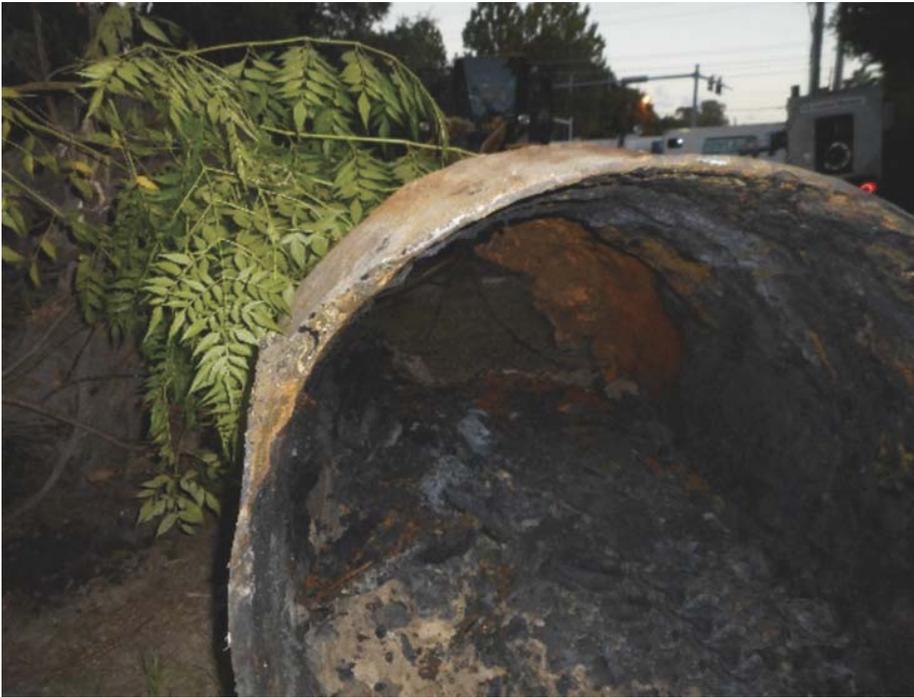
Figure 3. Pipe Corrosion

On Oct. 4, 2016, a 30-in. ductile iron (DI) force main located adjacent to a county pump station experienced a failure that caused a spill (Figure 3). The failure was believed to have been caused by a failed ARV that trapped H<sub>2</sub>S within the DI force main, causing internal pipe corrosion. The spill was quickly contained and temporary high-density polyethylene (HDPE) piping was used to bypass the failed section to allow for replacement of the force main. Due to the failure, the county wanted to evaluate additional portions of the transmission main for similar potential issues caused by H<sub>2</sub>S. This assessment utilized GPR and test holes to determine the horizontal and vertical profiles of the force main to identify high points. Smart-Ball, an inspection tool from Pure Technologies, was used to identify the presence of any gas pockets or leaks, which indicates locations that are vulnerable to corrosion, and UTT to identify the extent of any corrosion of the pipe wall.

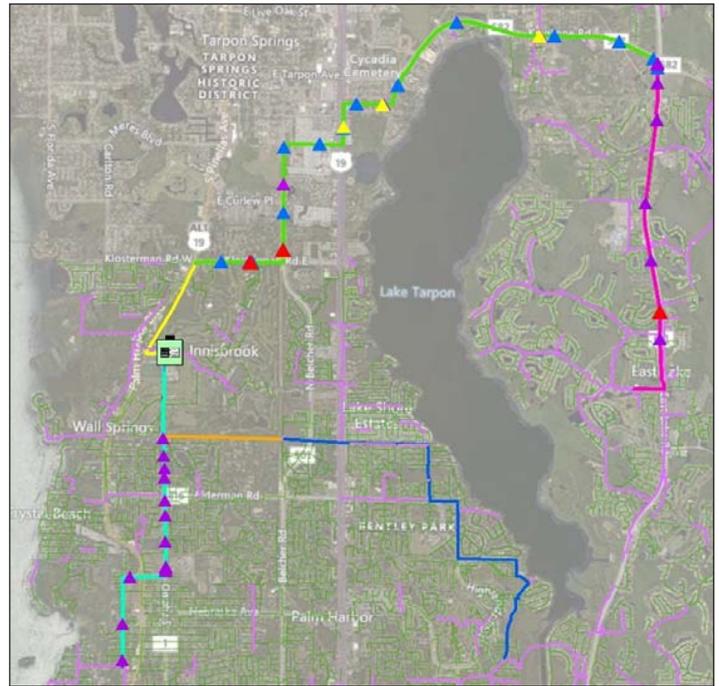
Figure 8. Ultrasonic Thickness Testing Results

Remaining thickness was also compared to ANSI/AWWA Standard C150/A21.50, with standard thickness for pressure classes. This defined the minimum thickness required to meet a specific pressure class. The results of all assessments are shown in Figure 8 and detailed further.

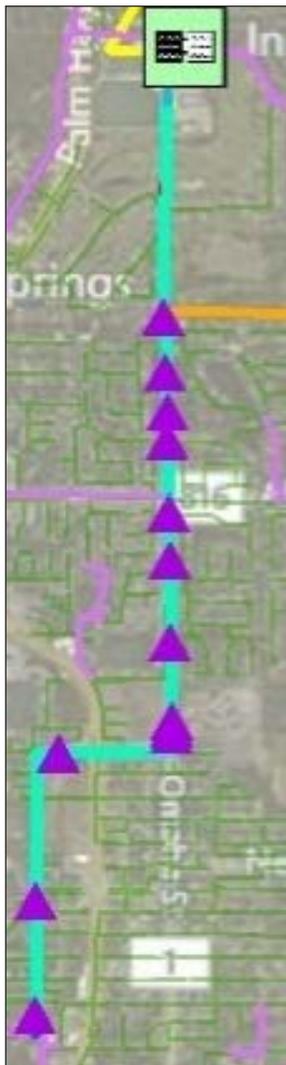
Figure 9. Wall Thickness Results

UTT locations on the 20-, 24-, and 30-in. portion of the force main had remaining wall thicknesses above 70 percent, with a range of 0.379 to 0.590 in., indicating that they are in good condition (Figure 9). Table 1 indicates that 12 of the tested locations have a pressure rating of above 250 pounds per sq in. (psi).

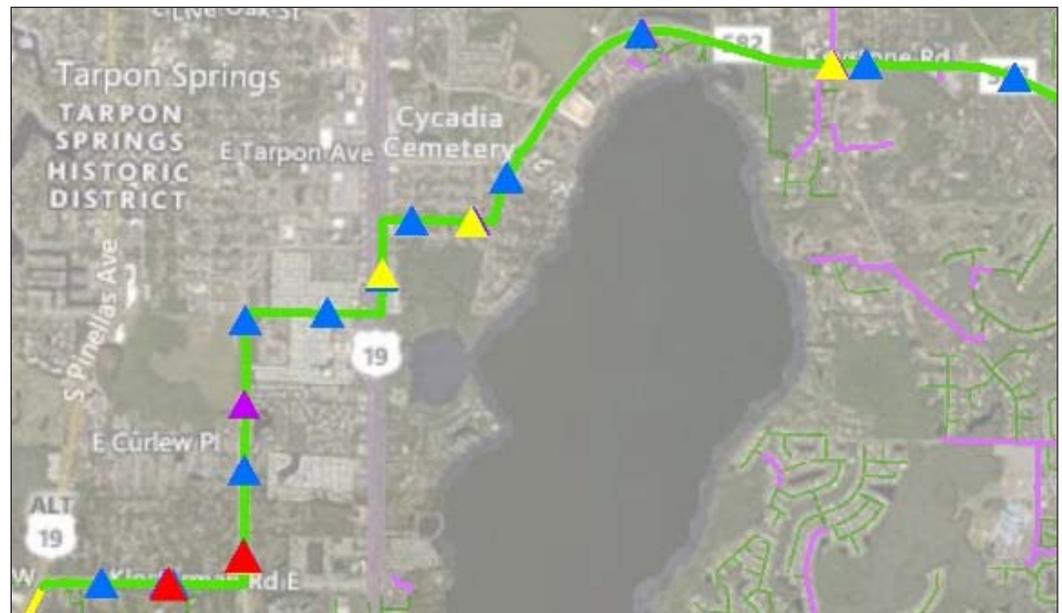
Figure 10. Keystone Road Results

The results of the UTT, shown on the map in Figure 10, show that three of the UTT locations are in critical condition, as the pipe section loss results in a pipe with a calculated (interpolated) pressure class of approximately 50 psi or less (0.153- to 0.239-in. remaining thickness) detailed in Figures 11 and 12. Five of the UTT locations are in a calculated pressure class between 101 and 150 psi (0.313- to 0.327-in. remaining thickness). Twenty-nine of the UTT locations are in a calculated pressure class between 151 and 250 psi, and the remaining UTT locations are in a pressure

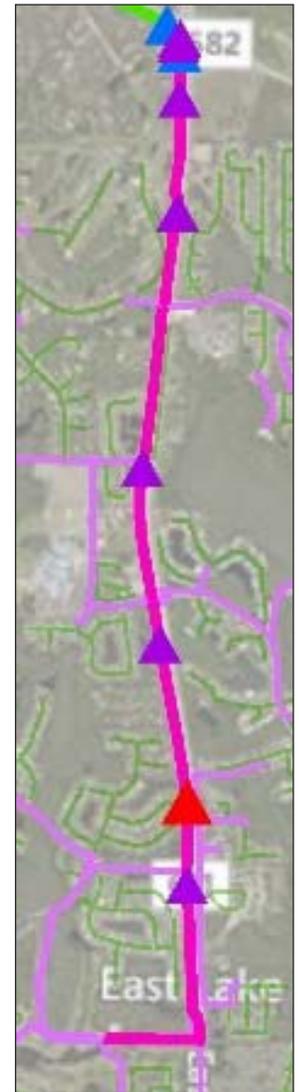
Figure 13. East Lake Road Results

The third force main assessment, currently underway on the 24- and 30-in. force mains on East Lake Road (Figure 13), connects upstream to the previously assessed section of the 30-in. force main. The force main has five ARVs, with the northernmost ARV tested with the previous project.

Eight locations have been tested to date using the UTT procedure, including all five ARV locations and three additional locations selected using preliminary survey data of the force main elevation and record drawings provided by the county. Six of the eight locations had a good remaining wall thickness and a pressure rating of above 300 psi, and one of the locations had a pressure rating of 250 to 300 psi (Table 3). One location (specifically at an ARV) had low readings, with a remaining wall thickness of less than 50 percent

and a pressure rating of less than 100 psi. This location will have additional testing performed upstream and downstream of the ARV to determine the extent of any corrosion beyond the initially tested location. If the extent of corrosion is large, replacement of the section of pipe will be recommended.
