Overcoming Hydraulic Limitations of the Integrated Fixed-Film Activated Sludge and Moving Bed Biofilm Reactor Process

Joshua P. Boltz , William R. Leaf , James P. McQuarrie , Adrienne Menniti, and Glen T. Daigger

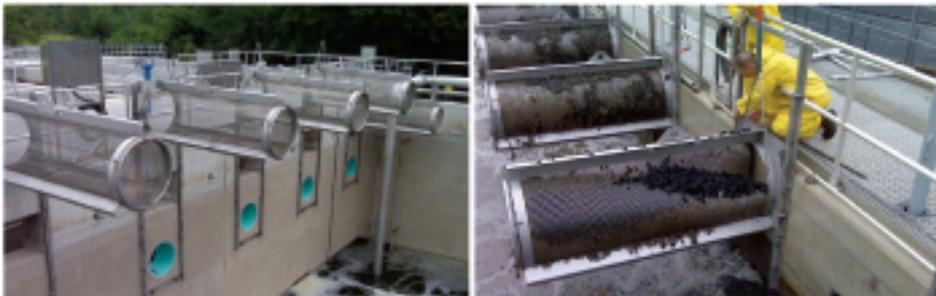
A unique design feature of the biofilm carrier retention screens was the ability to extract the submerged screens from the bioreactor by guide rails, as depicted in Figure 5. The second loss of plastic biofilm carriers most likely occurred when the cylindrical screens were dislodged from their fixed position by aeration that exerted excessive uplift forces on the media retention screens. The biofilm carrier retention screens were constructed with “structural support fins” on the cylindrical screens exterior rather than inlaying structural supports on the screen interior. As a remedial action, clips were installed on each screen to lock them in place. If a clip is removed, the screen may be lifted out of the basin for inspection or cleaning.

Figure 5. Plastic biofilm carrier retention screens at the Groton facility before (left) and after (right) a storm event and their structural failure

rapidly. It is plausible that hydrostatic pressure created by a rapid rise in water surface elevation caused the screens to collapse, as depicted in Figure 5. However, screen blinding by plastic biofilm carriers may have contributed to the rapid rise in water surface elevation. Plastic biofilm carrier retention screens must be designed to withstand a load exerted by hydrostatic pressure when the process tank is full. Plastic biofilm carriers flowed, with the effluent wastewater, into the Thames River, and, ultimately, into Long Island Sound. Rows of plastic biofilm carriers began appearing in the wrack line along the island's beaches following the March 2010 failure (Voskamp, 2010).

A Groton facility improvements project to incorporate the IFAS process experienced biofilm carrier loss for the third time in March 2010. The series of hydraulic failures occurred during a two-year period, approximately, and each was the result of biofilm carrier retention screen failure. The first failure resulted from the screen ends caving in, allowing plastic biofilm carriers to flow through circular orifices core drilled in the screen containing wall(s) to the secondary clarifiers. The end was a screen plate that was tack welded to the outside of the cylindrical biofilm carrier retention screen. The tack weld resulted in end cap structural instability. A proper cap weld is located inside the cylindrical screen perimeter to provide required structural support. Ultimately, each biofilm carrier retention screen was removed and the welds were reinforced on the ends before the system was placed back into service.

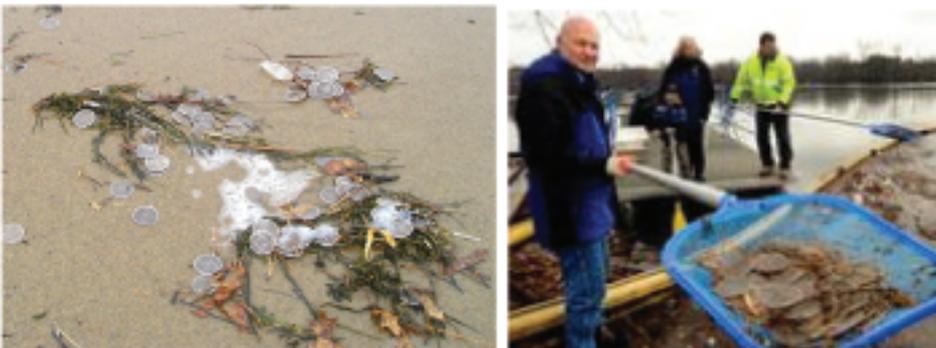
Figure 6. Plastic biofilm carrier clean-up along the New England coastline (March 2011)

plastic biofilm carriers to accumulate around the screens. None of the screens, however, were damaged as a result. Plastic biofilm carriers, referred to as "sewage discs" in local media reports, were found along the New England coastline extending from Hooksett, N. H., to Cape Cod, Mass. (Brooks, 2011; Guilfoil, 2011). Cleanup efforts from this event are depicted in Figure 6.

The incident described above occurred overnight when the facility was not staffed. Since this incident, the facility has installed measures to prevent loss of plastic biofilm carriers. An alarm system, which was under construction during the incident, is now installed and fully operational. In the event of high wastewater levels, operators are notified and pumps are shut down. In addition, all drains and overflow features from the facility property are screened to retain any plastic biofilm carriers. There have been no hydraulic incidents since March 2011, including during the tropical storm Irene, which had more rainfall than the March 2011 storm (Russo, 2011).

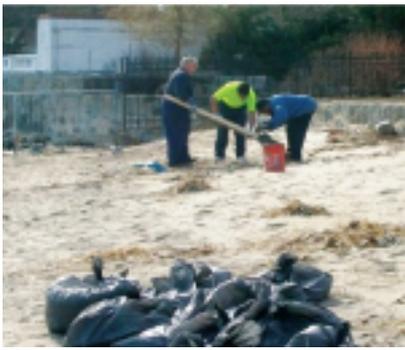
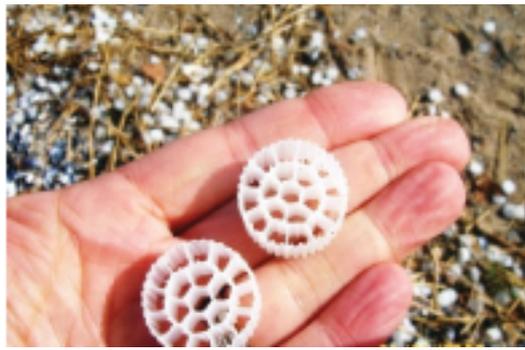
Figure 7. Plastic biofilm carrier cleanup on the Long Island Sound coastline following a hydraulic failure and biofilm carrier loss from the Mamaroneck plant MBBR process (March 2011)

an IFAS system at the Mamaroneck Wastewater Treatment Plant, in Westchester County, N.Y. A peak hydraulic event resulted in plastic biofilm carriers migrating upstream and out of a retrofit IFAS system where they entered the influent stream of a secondary tank that had not yet been retrofitted as an IFAS system. Plastic biofilm carriers were then able to freely flow from the effluent of the not yet retrofit IFAS tank. None of the IFAS equipment or tanks were damaged in the incident. As with other hydraulic failures, this event became highly publicized as a cleanup was required along portions of the Long Island Sound coastline. Kreisman and Marszalek (2011) reported that rings, which started showing up on local beaches and washed in by the hundreds, possibly thousands, had not yet been used, but they had already been placed into sewage treatment tanks, from the fierce rains that washed them into the Sound. Since the event occurred, the retention screens within the aeration basins have been redesigned to improve the hydraulic through-put. Figure 7 depicts the Long Island Sound coastline cleanup.

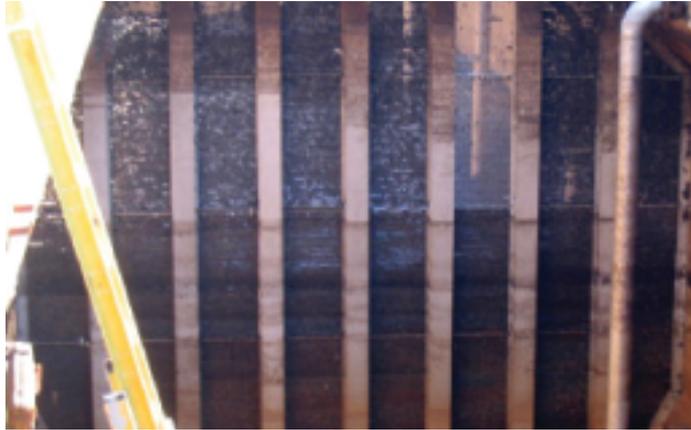
Figure 8. Plastic biofilm carrier retention flat screen with carriers lodged in screen openings

Plastic biofilm carriers are retained in anoxic IFAS and MBBRs by flat screens. Figure 8 depicts a flat screen that has plastic biofilm carriers lodged in the screen openings. A loss of flat screen hydraulic throughput is a mode of system hydraulic failure. This can be caused by the accumulation of the plastic biofilm carriers or trash on the screen surface, resulting from excessive hydraulic loading rate or approach velocity. In addition, the absence or inefficiency of an air-scour device can contribute to the retention screen accumulation. Table 1 summarizes modes of (flat) plastic biofilm carrier retention screen failure.
