# A Holistic Approach to Headworks Design: A Case Study of the St. Augustine Wastewater Treatment Plant No. 1 Headworks Rehabilitation

Steve Curmode, Ed Fernbach, Yanni Polematidis, and Chris Cerreta

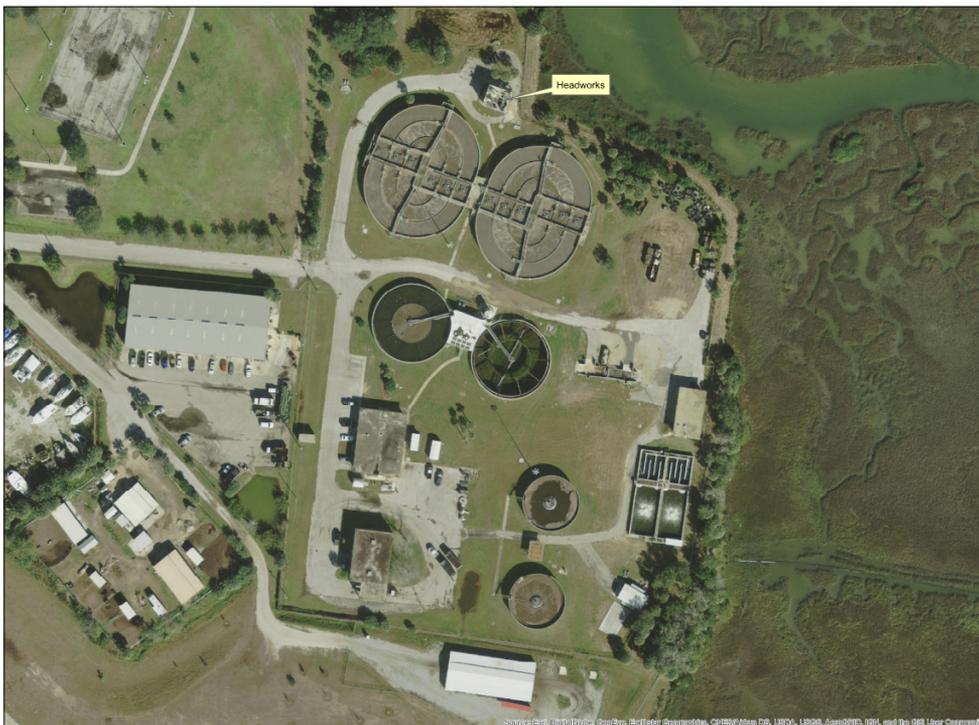
Figure 1. St. Augustine Wastewater Treatment Plant No. 1

The City of St. Augustine (COSA) owns and operates the Wastewater Treatment Plant No. 1 (WWTP No. 1), with a permitted capacity of 4.95 mil gal per day (mgd), as shown in Figure 1.

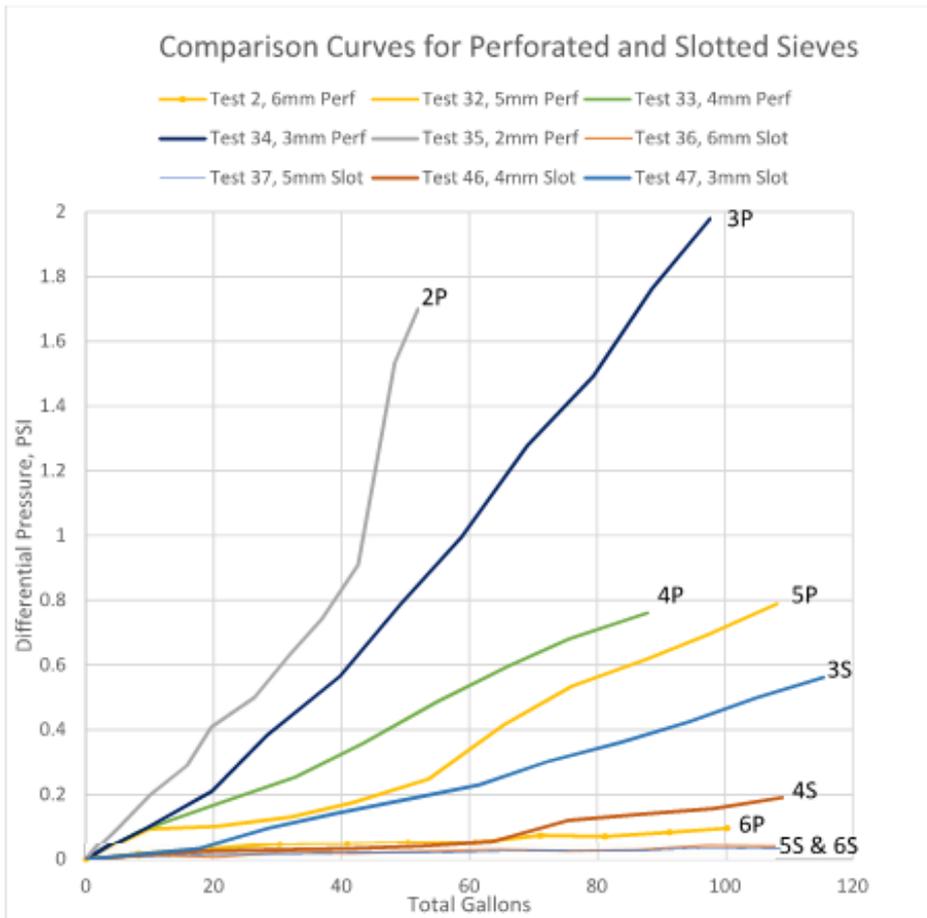
The test began with an influent flow analysis that characterized flow and debris entering the plant. Testing occurred Dec. 19-20, 2018, and included slotted and perforated openings ranging from 3 to 6 mm in size. Partial results of each sieve tested can be seen in Figure 2, where differential pressure equates to headloss across the screen and total gallons equates to flow across the screen. As seen in Figure 2, differential pressure, or headloss across the screen, tends to increase with flow. Smaller openings tend to have a greater increase in differential pressure, as seen by comparing the “2P” and “6P” opening sizes. The screenings capture ratio (SCR) was also estimated by weighing the screenings captured on each sieve and dividing this by the total weight of solids in the waste stream.

Figure 2. Screening Study Test Results

These results were ultimately used to make recommendations on opening size, opening type, and screen style meant to be the most effective at removing debris and inorganics specific to WWTP No. 1, while limiting differential pressure such that hydraulic limitation are met.

Results of the screening evaluation concluded that the existing step screen is achieving poor capture due to the style of screen, which frequently disturbs the screenings mat and negatively affects capture. The results led to the elimination of screens that are typically used for large-debris removal, such as with combined sewers and in lift stations. Given the tight hydraulic grade line, perforated plate screens and very fine screens were also eliminated from consideration.

Upon refinement of the design criteria, it was concluded that for a PHF of 12 mgd (through a single channel), a mechanical center flow with 6-mm slotted openings was most-suitable for COSA. This screen meets the key criteria of simple retrofit (small footprint), low headloss (<11 in.), limited carryover, high capture rate, and proven experience regionally.

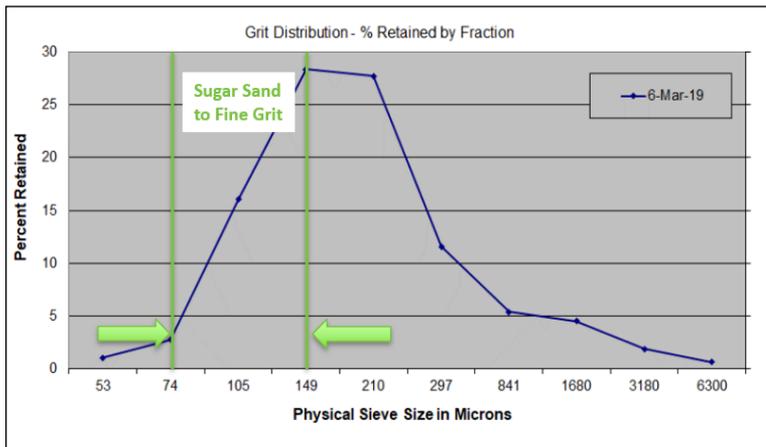
Figure 3. Distribution of Influent Grit at Wastewater Treatment Plant No. 1

Partial results of the grit characterization study can be seen in Figure 3, which revealed that the majority of grit entering the plant is fine, and that just under half is considered to be very fine. This confirms that, without targeting the sugar sand, much of the influent grit is missed by preliminary treatment equipment and subsequently allowed into the downstream treatment processes.

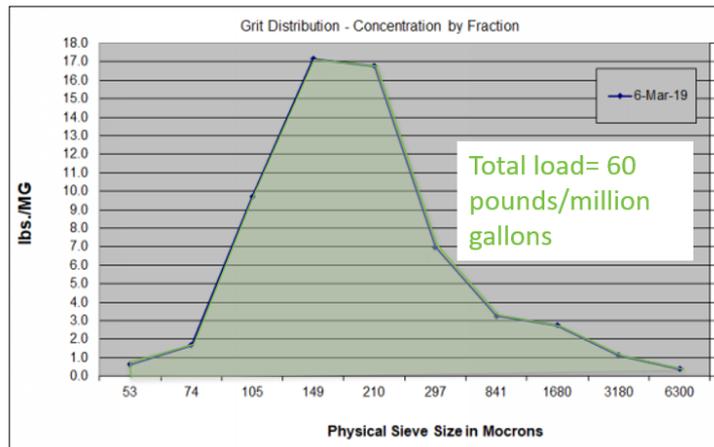
Figure 4. Grit Concentration at Wastewater Treatment Plant No. 1

Additionally, the influent grit concentration at the time of sampling was above the Florida average at 60 lb/mil gal (MG), as seen in Figure 4. Grit loading is known to be greatest during peak wet weather events, particularly during the first flush. Given that the grit concentration was above average during sampling at average flows, it's expected that grid loads will far exceed this value during PHF, further emphasizing the need for adequate removal.
