Some Say Stormwater—We Say Source Water

Bringing Clarity to a Muddy Situation: Assimilation of Reservoir Construction Site Stormwater

Roberto M. Gonzalez, Jue Zhao, William A. Lovins III,
Tim P. Brodeur, Kevin Morris, and J.L. Strickland

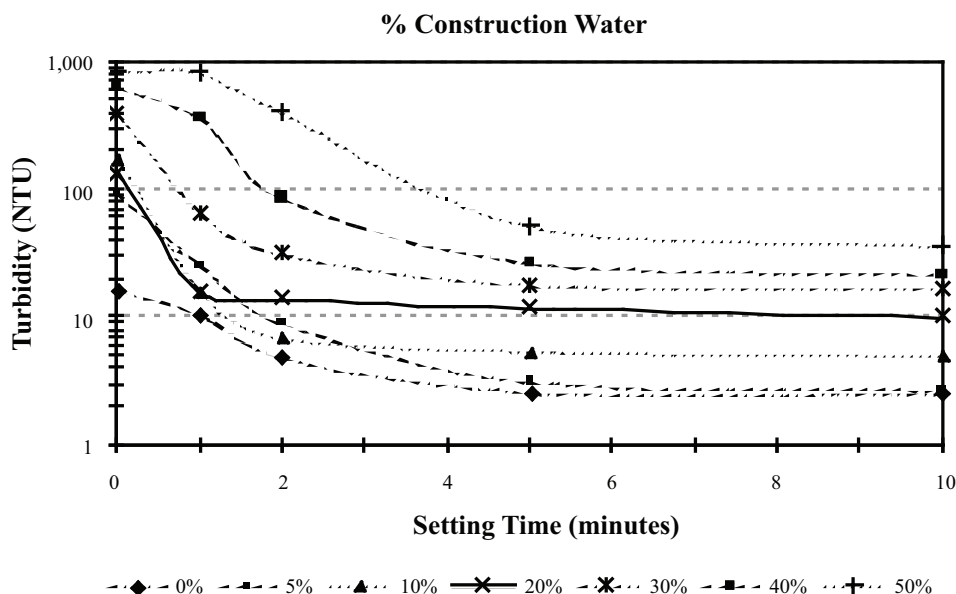
FIGURE 3: Settling Curve for Scenario #1

Scenario #1 – Vary alum dose to achieve constant pH of 5.8 (Figure 3).

- ◆ Increased construction/river-water blend ratios resulted in decreased alum dosages because the construction water lowered available alkalinity to form aluminum hydroxide ($Al_2(OH)_3$) floc. As a result, the low alkalinity/high construction-water blends became cloudy for the lack of available alkalinity.
- ◆ Achieving settled turbidity of <5 NTU was achievable only for construction/river-water blends of less than 5 percent.

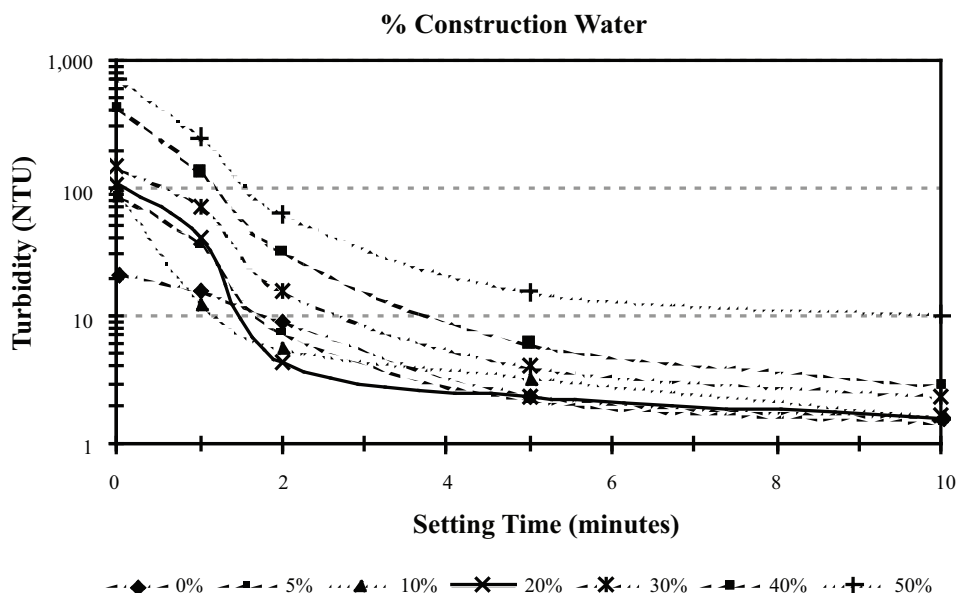
FIGURE 4: Settling Curve for Scenario #2

Scenario #2 – Constant, high alum dose pH adjusted with caustic soda to achieve constant pH of 5.8 (Figure 4).

- ◆ Settled turbidities <5 NTU were achievable for the blends with the exception of the 50-percent construction/river-water blend.
- ◆ Hence, it was decided to dose construction-water blends with a constant high alum

dose of 130 mg/L and adjust pH to 5.8 using caustic soda to provide additional available alkalinity for floc formation.

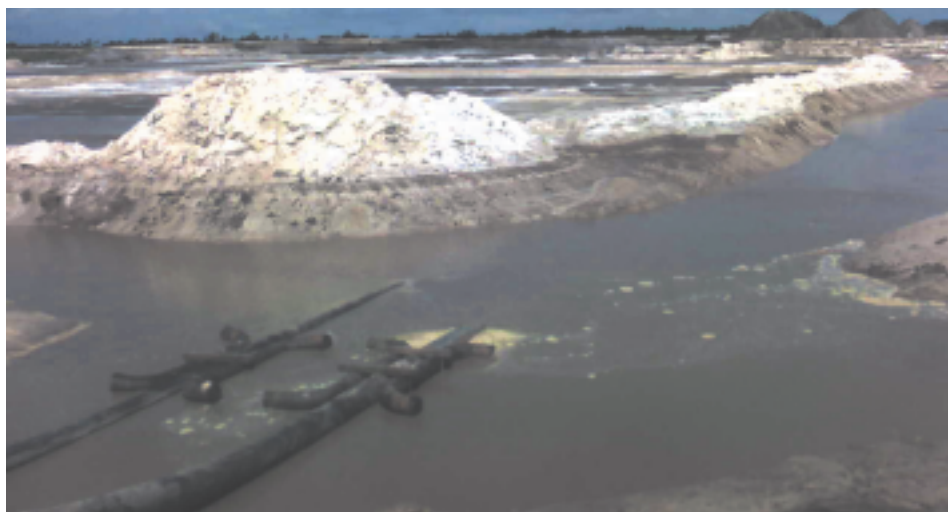
FIGURE 6: Construction Site Stormwater Run-Off Pump Station Inlet (July 28, 2008)

stormwater diverted from the construction site compared with raw surface water pumped from the Peace River. Figure 6 presents a photograph of the main dewatering sump where all the contractor's rim ditches were directed. This sump was a small, quarter-acre pond that was kept pumped down.

The cause of this event was human error. The main site dewatering station consisted of three 100-horsepower pumps pulling out of a small lake about one quarter acre in size. One pump ran continuously and the pumps were alternated every few days.

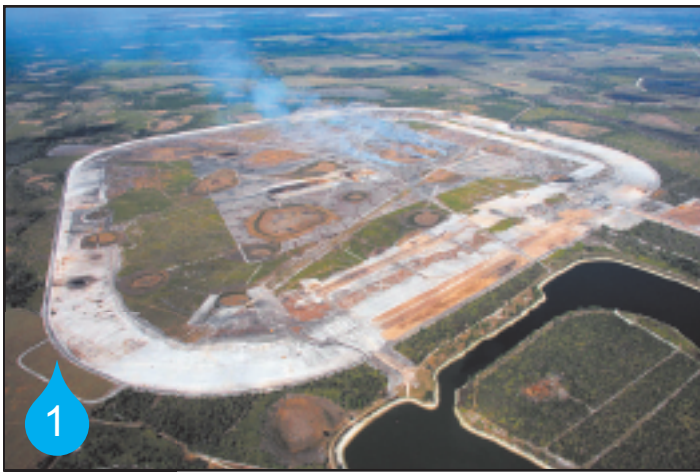
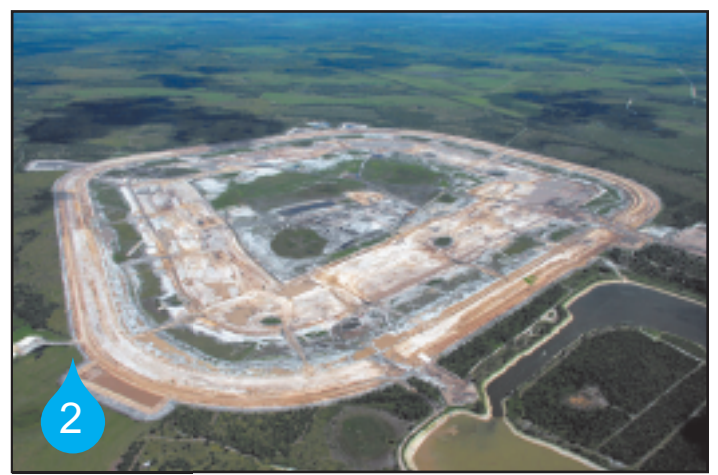
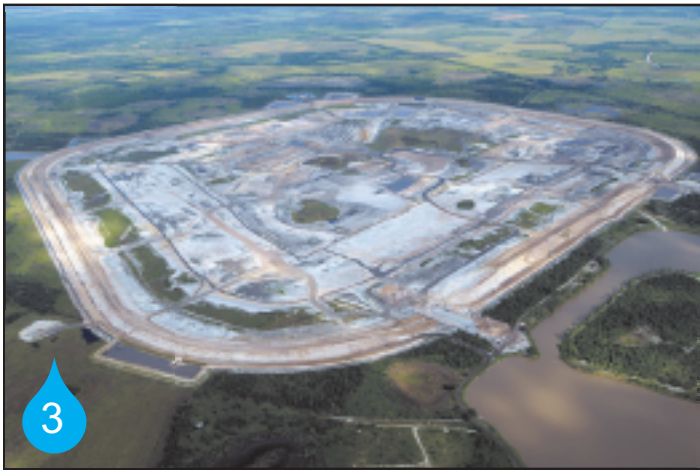
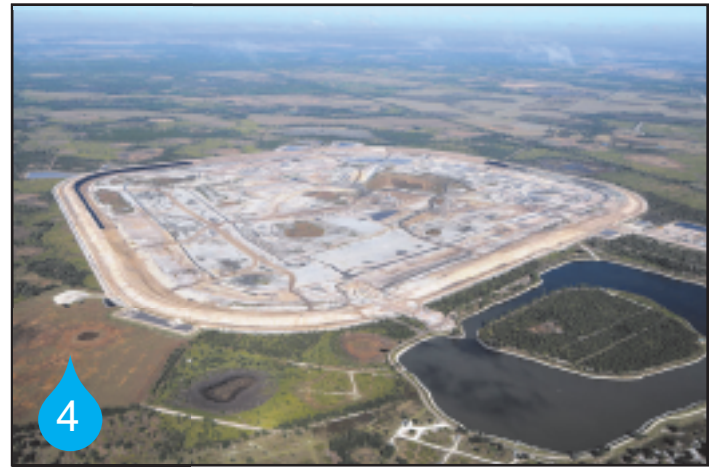
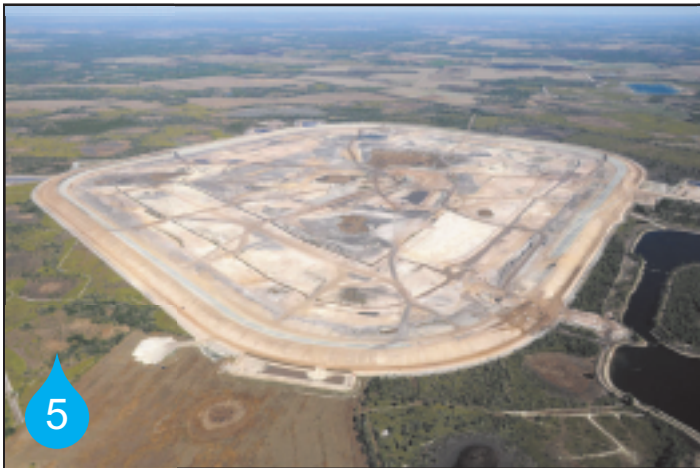
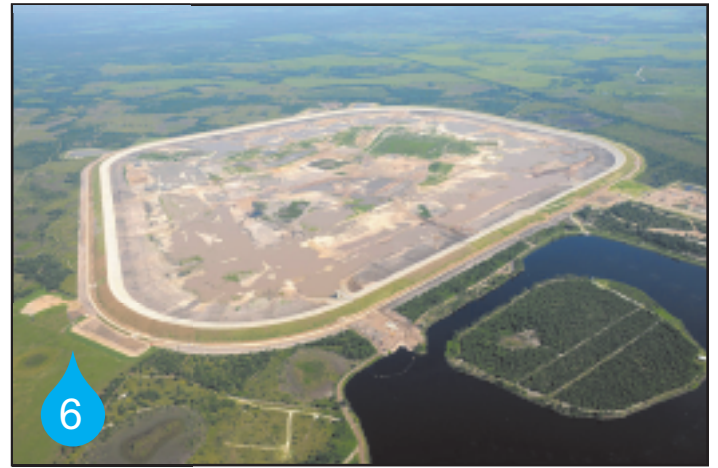
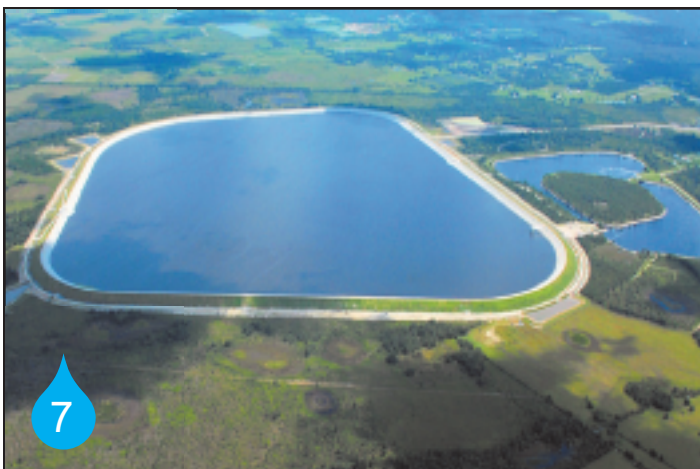
Figures 9 through 15 present aerial photographs of the Reservoir No. 2 construction site from the southeast with a portion of Reservoir No. 1 visible in each photo. This series of photographs begins with January 2008 when construction was just getting underway and ends with September 2009, at the conclusion of the project and with Reservoir No. 2 half filled. Note that the color tone of Reservoir No. 1 changes through the seasons in response to muddy construction water diversion

- 1) FIGURE 9: Reservoir No. 1 on January 2008: Only slight Discoloration on South Side
- 2) FIGURE 10: Reservoir No. 1 on April 2008: Major Impact to South Side Evident
- 3) FIGURE 11: Reservoir No. 1 on October 2008: Turbidity has Migrated to Both Sides
- 4) FIGURE 12: Reservoir No. 1 on January 2009: Conditions Clearing Up
- 5) FIGURE 13: Reservoir No. 1 on March 2009: Very Little Construction Water Pumping
- 6) FIGURE 14: Reservoir No. 1 on June 2009: Almost Ready to Fill Reservoir No. 2
- 7) FIGURE 15: Reservoir No. 2 on September 2009: New Reservoir is Half Full

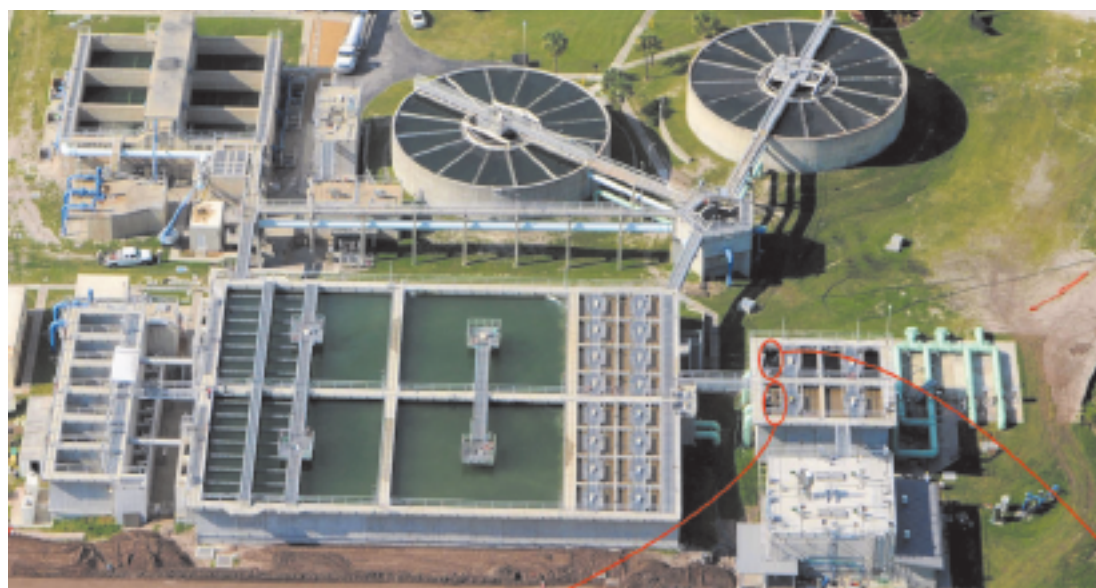
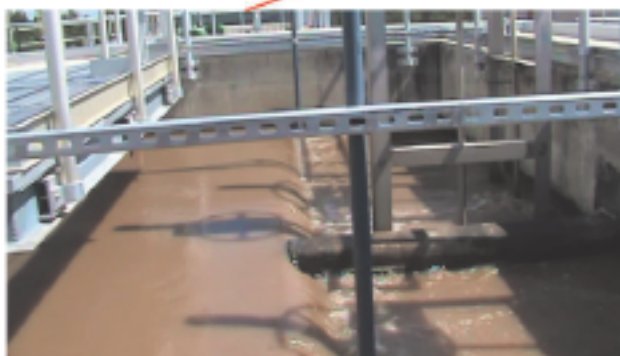
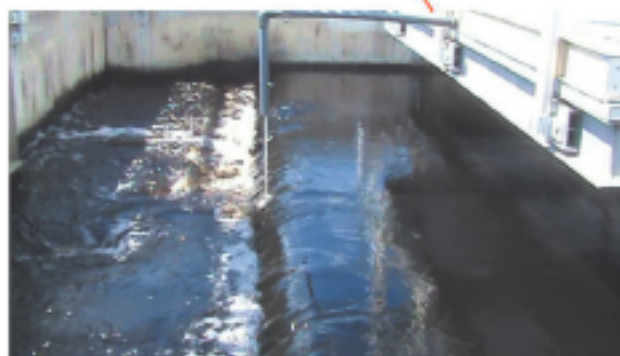
FIGURE 16: Two Water Treatment Plants in One

**Aerial Photograph
from September 2008
Illustrating Treating
Vastly Different Surface
Waters at the Same
Plant at the Same
Time**

Raw water with 400 color and low turbidity directly from the river going through the top basin and the solids contact units.

Reservoir No. 1 water with 500 turbidity going through the lower basin and conventional floccled units.

Eventually, utility staff elected not to use the solids contact units to continue to treat the high turbidity river/construction-water mixture because of the sludge blanket instability issues. Low-turbidity, high-color raw river water was pumped to these units instead, while the muddy construction water continued to be treated with the conventional rectangular basin flocculation/sedimentation facilities (see Figure 16).

The photograph in Figure 16 illustrates an extremely rare event which the authors believe may never have taken place before; that is, the treatment of two vastly different surface waters at the same time at the same water plant. One half of the water plant was treating low-turbidity, highly colored water pumped

directly from the Peace River, and the other half of the facility was treating extremely high-turbidity water pumped from Reservoir No. 1. This remarkable achievement was carried out continuously for three months from September through November 2008 and is a testament to the capability of the facility operations staff and the value of having multiple piping, valve, and pumping options available at a water treatment plant.

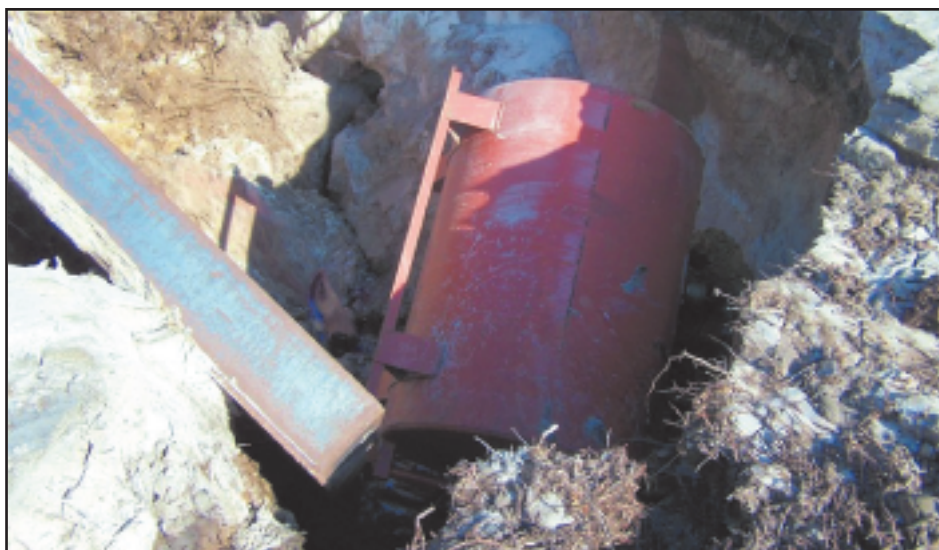
FIGURE 17: Diesel Spill Storage Tank Lying at Bottom of Erosion Gully

Perhaps the single most distressing moment during the entire project came the morning of May 15, 2008, when it was learned that a 500-gallon portable diesel storage tank had been undercut by erosion and had overturned into the rim ditch system (see Figure 17). Fortunately, the rim ditch system was segmented by roadways with submerged culvert pipes, so most of the floating diesel fuel was contained. The main dewatering system also employed a flexible suction pipe that was suspended by floats about two feet below the water surface, which also helped prevent the floating diesel fuel from being pumped to Reservoir No. 1.

Cliff Berry Environmental Services Inc. of Tampa responded immediately and commenced an extensive soil and water cleanup effort over the next several days. The contractor estimated cleanup costs related to this spill were in excess of \$100,000. After cleanup, analyses showed no contamination of Reservoir No. 1 and the contractor was permitted to resume construction-site pumping after all ditches, pipes, and pumps had been cleaned and sampled to verify complete mitigation of all hydrocarbon contamination.

On the night of May 14, 2008, a worker switched pumps but did not realize that someone had opened a valve on that pump's 12-inch diameter HDPE discharge line so that instead of pumping water to Reservoir No. 1, the water was pumped about 200 yards and then ran out the valve opening and right back to the rim ditch system, cutting a deep gully that undercut the pump and diesel tank on its way back to the small lake. Eventually, the diesel tank fell into the gully, along with the pump. If the worker had remained onsite just 10 minutes longer, he likely would have seen the beginning of the return flood and would have been able to close the offending open valve without incident.
