Improving Sarasota County Water Resources: Dona Bay Watershed Restoration Program

Molly Williams

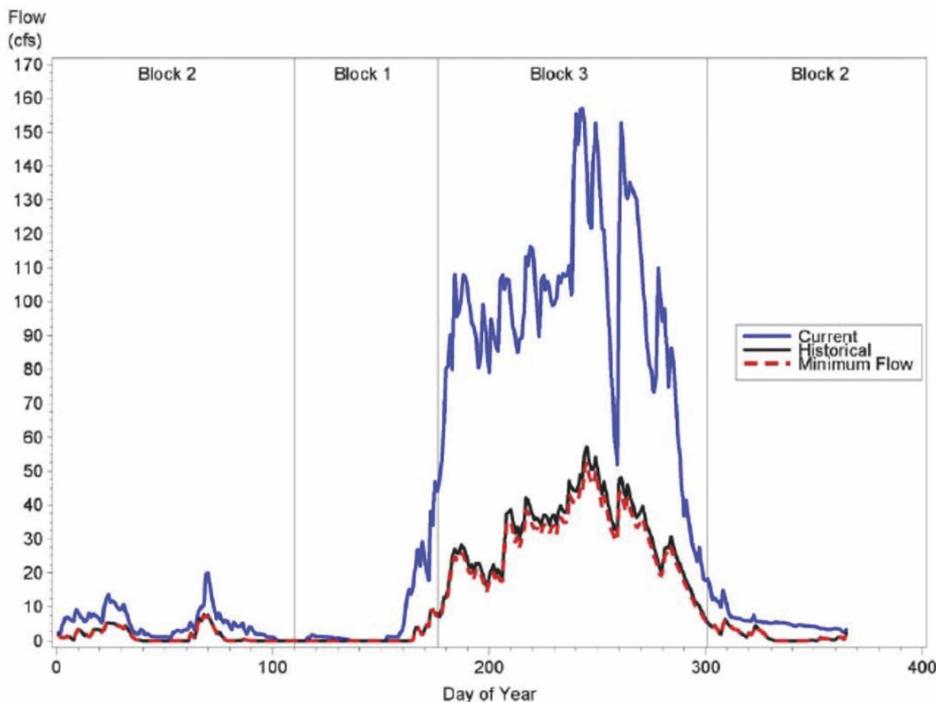
Figure 1 shows the median daily inflow to Dona Bay/Shakett Creek based on the current

Figure 1. Dona Bay/Shakett Creek median daily flow.

flow record (blue line), historical benchmark flow record (black line), and a modified historical flow record derived by removing the maximum allowable withdrawals defined by the proposed minimum flows (red dashed line) for 1985 through 2005. The timeframe is as follows:

- Block 1 – April 20 through June 25
- Block 2 – October 27 through April 19
- Block 3 – June 26 through October 26

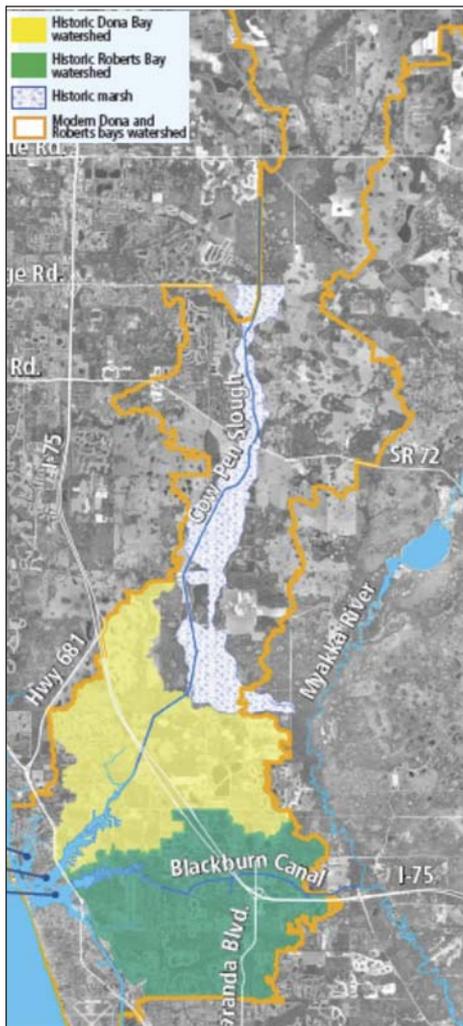
Figure 2. Watershed boundaries.

In the early 1900s, the watershed for Dona Bay was approximately 16 sq mi. Decades of drainage projects used to control mosquitoes, create farmland and pastures, and reduce flooding dramatically changed the flow of runoff to the bay. The most significant of these projects are the Cow Pen Slough and Blackburn Canal (constructed in 1959). These two projects diverted over 60 sq mi of runoff from the Myakka Basin to the Dona and Roberts Bay—more than five times the original watershed.

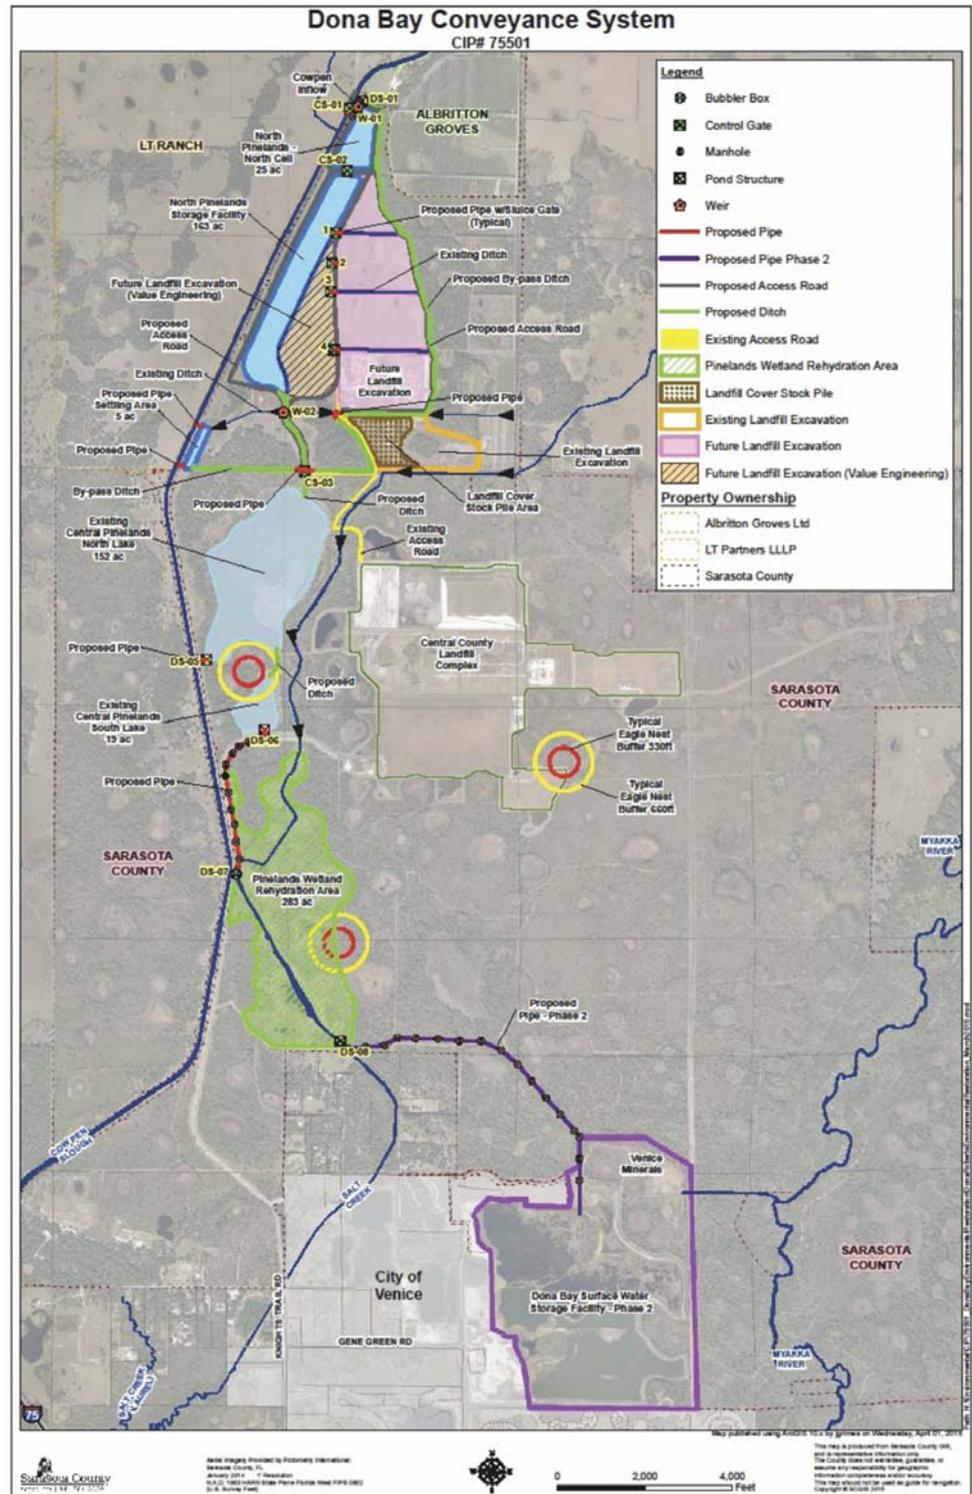
Figure 3. Dona Bay conveyance system.

By connecting the two existing lakes to the system, the treatment train is expanded, and the lakes benefit from fresh water flushing. Over 4,200 lin ft of 72-in. reinforced concrete pipe conveys water from the south lake to the wetlands. The reduction of the runoff peaks (fresh water pulses) to Dona Bay is expected to improve its salinity regime and reduce the impacts on the oyster and seagrass beds.

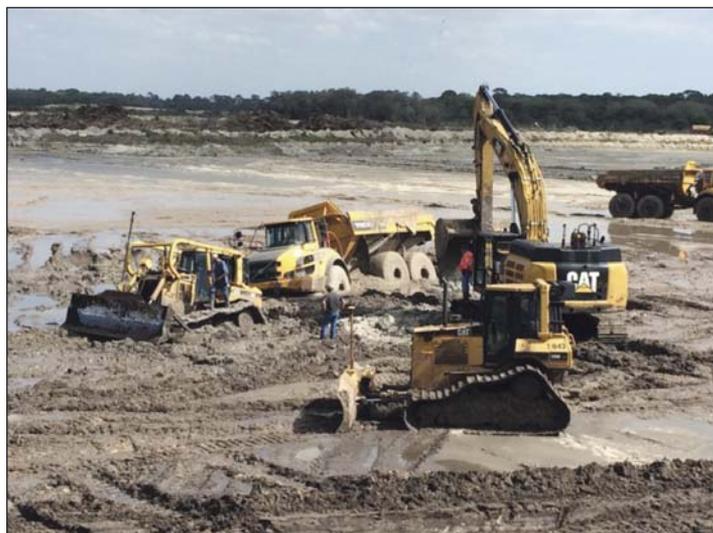
Figure 6. Contractor working in adverse conditions.

During project construction, the project team had to make accommodations for the excessive rainfall during the winter of 2016. The contractor efficiently worked in conditions that created challenges, such as equipment sinking in the mud.

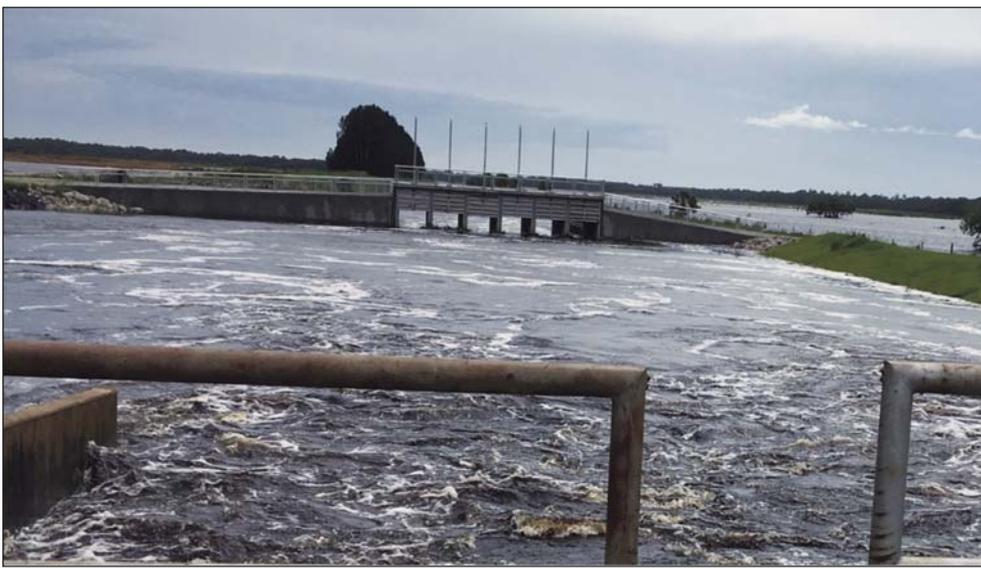
Figure 7. New Control Structure 1 viewed from upstream (old control structure) during Tropical Storm Hermine.

In August 2016, Tropical Storm Hermine hit the county and tested the conveyance capacity of the system, bringing excessive rain. The project site was continuously monitored through the county's automated rainfall monitoring system (ARMS) stations. Prior to the storm event, the contractor shored up the bypass canal at the diversion weir construction location, with extra riprap to prevent erosion and flooding. The effort was an effective measure to protect the incomplete construction of Control Structure 1. The dress-up required after this storm was minimal and all erosion from rainfall and storm events was promptly corrected by the contractor. The management by the project team ensured that the rainfall did not cause project delays or additional expense, and the project should still be completed ahead of schedule.

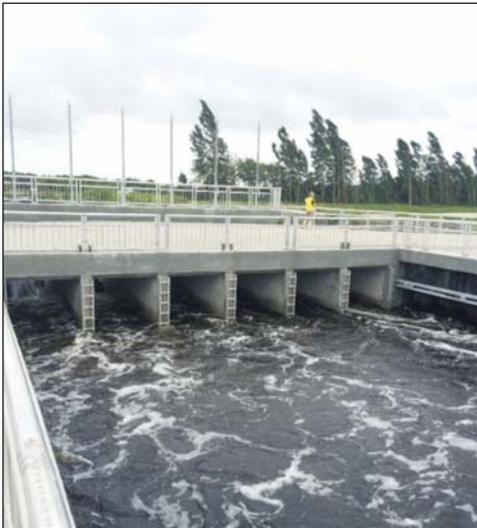
Figure 8. Looking upstream at Control Structure 1 during Tropical Storm Hermine.

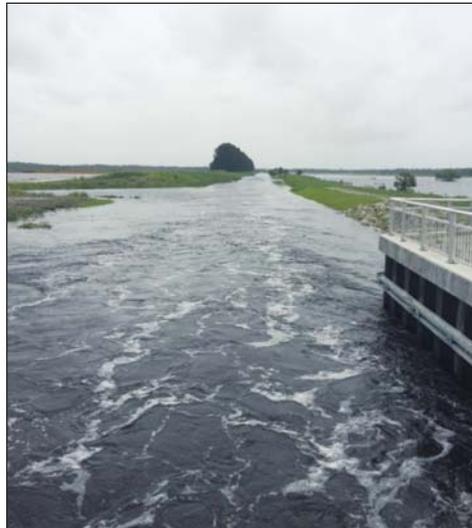
Figure 9. Cow Pen Slough looking downstream from Control Structure 1 during Tropical Storm Hermine.

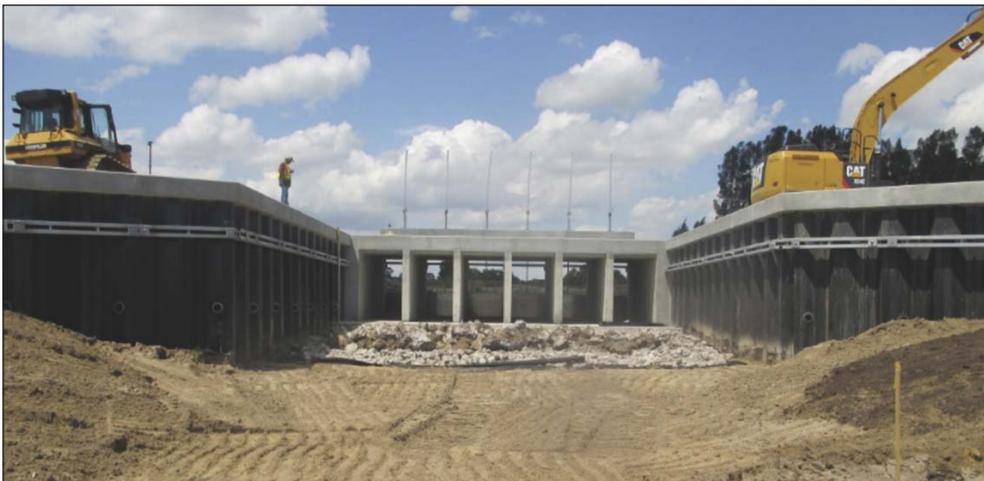
Figure 10. Construction of Control Structure 1.

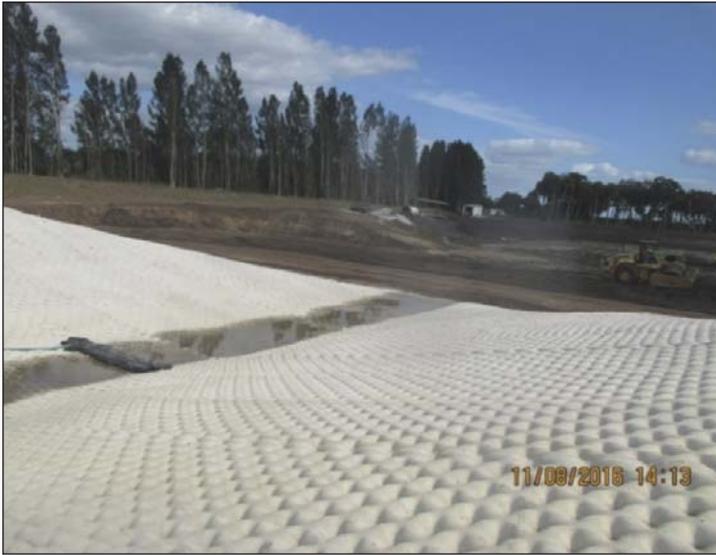
Figure 11. Diversion weir into the Dona Bay Phase I system.

The water quality benefit to Dona Bay and the public began in November 2016 when Phase I of the project was effectively operational, with Cow Pen Slough diverted via the concrete diversion weir through the project.

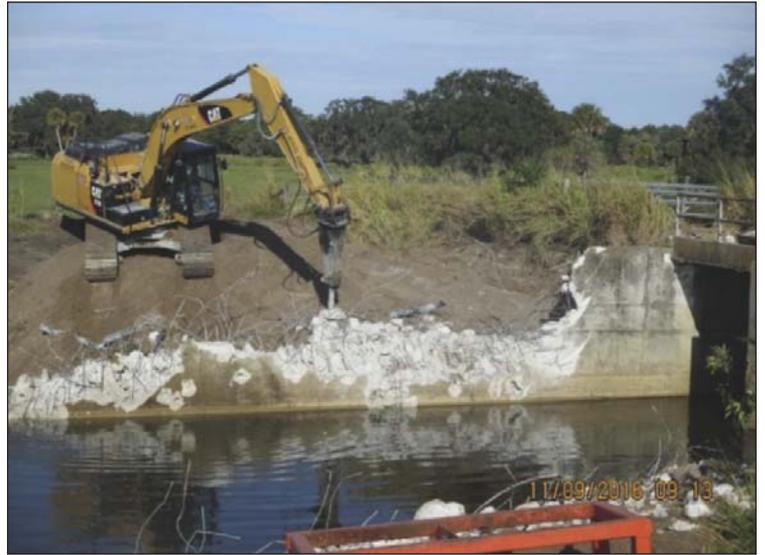
Figure 12. Demolition of the old control structure.

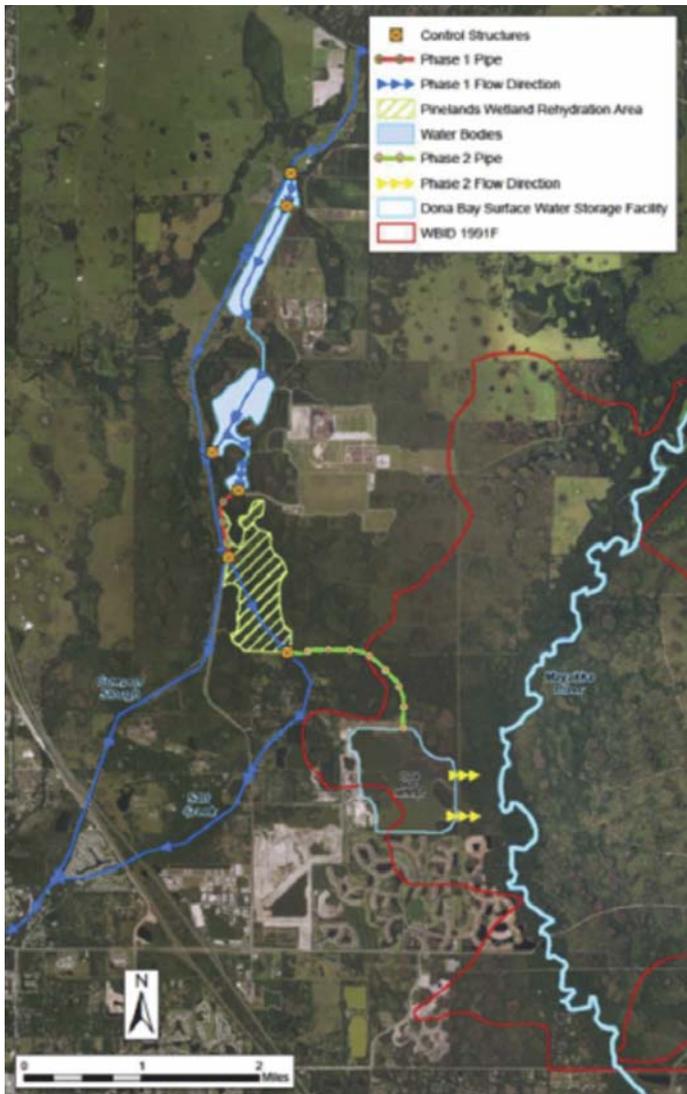
Figure 19. Main features of the Dona Bay Phase II project.

The second phase of the program has been designed, and the construction documents and logistics of dewatering the old Venice Minerals 380-acre lake are being finalized. To continue to reduce the fresh water runoff to this phase of the program, the focus is on the storage and diversion of 3 mil gal per day (mgd) of water to the Myakka River. In a study completed by Environmental Science Associates (ESA), it was determined that the diversion will not create flooding impacts to the Myakka and that the nutrient concentration of the water discharged from the Phase II project is less than the nutrient concentration in the river. Also, the nitrogen loads from the project are just over 1 percent of the estimated nitrogen load for the Myakka River.

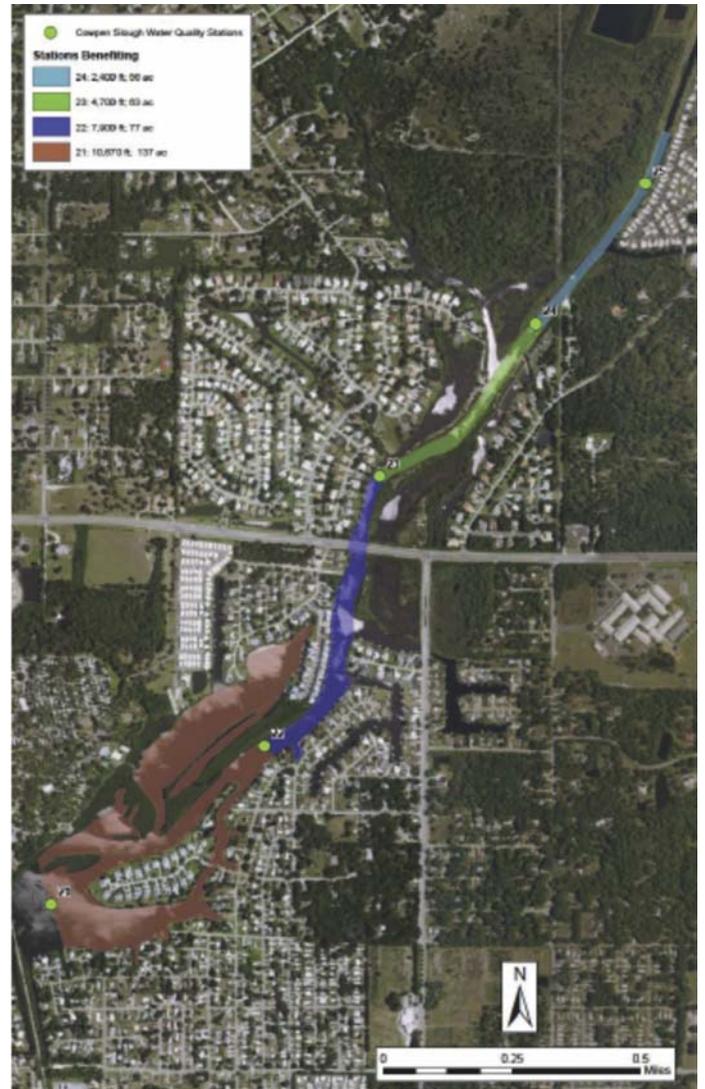
Figure 20. Salinity benefits from diversion.

The study by ESA also provided estimated shoreline and acreage of the creek bottom expected to benefit from increased salinities due to the 3-mgd diversion and from a potential 6-mgd diversion. For the 3-mgd diversion, the annual benefit from the salinities would be 4,000 lin ft and 50 acres of creek bottom; for the 6-mgd diversion, the annual benefit from the salinities could be 7,000 lin ft and 70 acres of creek bottom.
