Investigating Critical Infrastructure With Limited Access

Communities across Florida continue to be challenged with degrading infrastructure, including leaks and breaks in their large-diameter water mains. In 2010, the City of Miami Beach (City) experienced a rupture of one of its water mains near the 63rd Street Bridge. This prompted the City to evaluate the structural integrity of a nearby primary transmission water main from the mainland: the 36-in.-diameter water main that crosses the Julia Tuttle Causeway (Figure 1). The City began to develop a condition assessment and rehabilitation strategy to minimize the potential of this primary transmission main experiencing a similar rupture.

The approach was executed within the City on approximately 3 mi of 36-in.-diameter pipe comprised of prestressed concrete cylinder pipe (PCCP), cast iron (CI), and high-density polyethylene (HDPE). The transmission main traverses a subaqueous route under environmentally

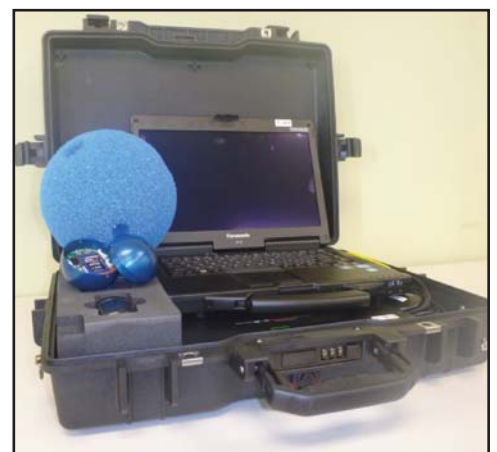
The inspection also included an acoustic-based leak and gas pocket inspection using an inspection unit (Figure 2). The equipment used is a free-swimming, acoustic-based technology that detects anomalous acoustic activity associated with leaks or gas pockets in pressurized pipelines. The unit is comprised of a water-tight aluminum alloy core that contains a power source, electronic components, and instrumentation, including an acoustic sensor, triaxial

celerometer, triaxial magnetometer, global positioning system (GPS) synchronized ultrasonic transmitter, and temperature sensor.

The aluminum core is encapsulated by a compressible protective foam outer shell, which provides a larger surface area by which the device is pushed along by the hydraulic flow of the water, while reducing low-frequency ambient noise that is typically present in the pipeline. The assembly is deployed into the flow of a pipeline, traverses the pipeline, and is captured and extracted at a predetermined point downstream that will also be utilized for the electromagnetic assessment. During the inspection, the free-swimming, acoustic-based technology's location is tracked at predetermined points, typically air release valves or exposed sections of the pipeline, to correlate the inspection data with inspected distance.

Figure 2. Acoustic-Based Leak and Gas Pocket Detection Equipment

Eight anomalies were identified by the leak and gas pocket inspection, many coinciding with the location of wire-wrap breakage.

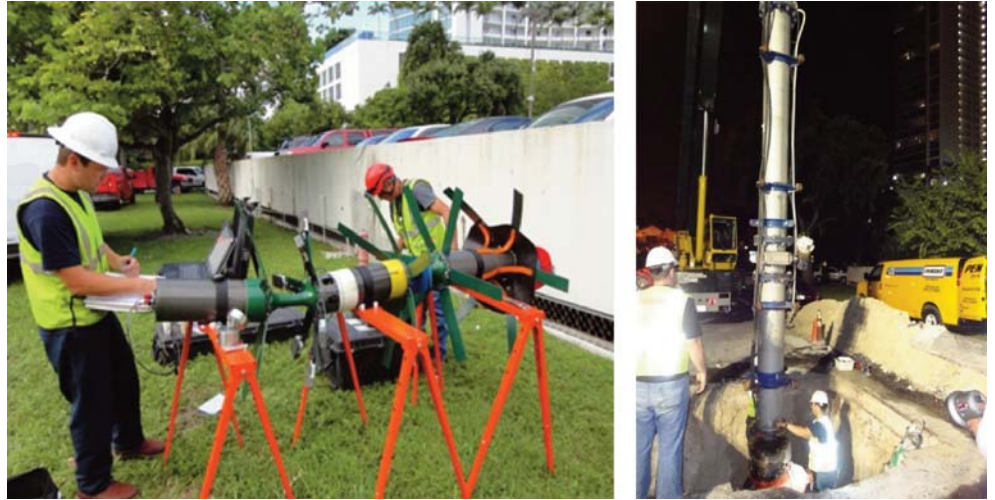
The pipeline was inspected by a specialty consultant using an inserted robotic condition assessment tool to provide data for condition assessment of the PCCP and CI sections of the transmission main. Analysis of impacts to the HDPE section were limited to evaluation by acoustic-based leak and gas pocket detection. The electromagnetic assessment tool is an innovative free-swimming tool

that is neutrally buoyant, with flexible fins that are used to center the tool within the flow of the pipe and provide propulsion with the active flow in the pipeline. Its flexible design allows for navigation through inline valves (like butterfly valves) and bends in the pipeline, while traveling long distances. Data is downloaded and interpreted by the

Figure 3. Assessment Tool Prior to Installation and With Insertion Tube

The electromagnetic assessment tool was inserted into the live pipeline via a hot tap connection and insertion tube (Figure 3). Once inside the line, the tool traveled with the flow of

the water until it reached the predetermined extraction point. The tool's movement and distance traveled is tracked from aboveground via tracking locations, typically at air release valves or exposed sections of the transmission main.
