Innovative Cost-Effective Noninvasive Ultrasonic Testing for Utility Replacement

Weston Hagggen, Ed Gil de Rubio, Marc Cannata, and Matthew Grewe

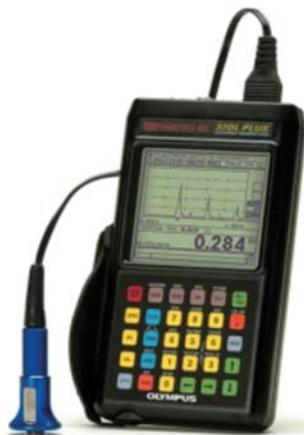
An advanced nondestructive ultrasonic gauge (Figure 3), was used to determine the integrity of the pipeline. This instrument can be used in pipes, tanks, and other metallic structures that have the potential for erosion and corrosion. Additionally, the device is able to measure true metal thickness using a "single backwall echo," even when the metallic structure is painted and/or coated.

Figure 3. Noninvasive Ultrasonic Testing Device

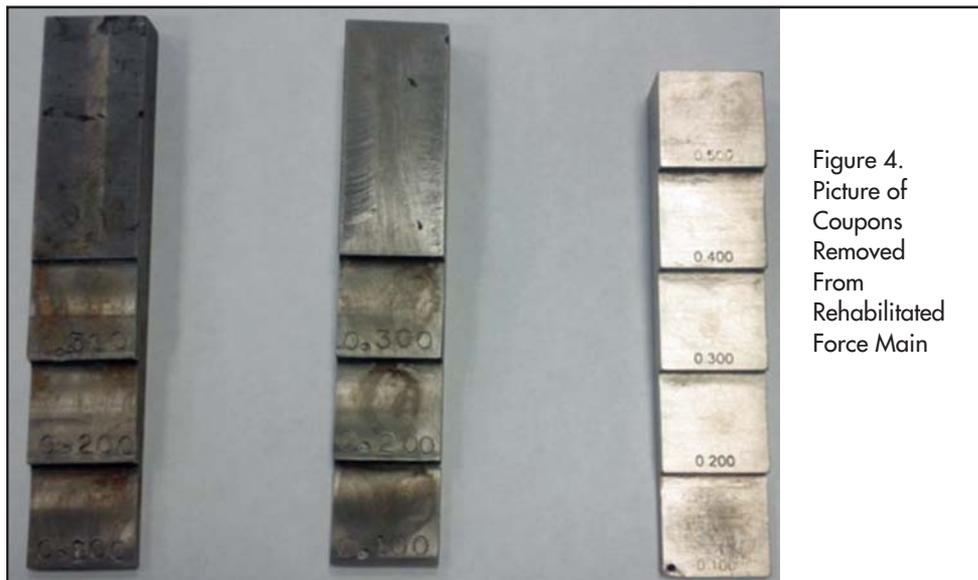
In order to obtain accurate readings, REI obtained coupons (Figure 4) that were removed from previously rehabilitated sections of the Authority's force mains. Those coupons were machined and measured to a tenth of an in., and then used to calibrate the instrument. The validity of the calibration was confirmed by measuring the sample coupons with the testing device and a digital caliper. The results obtained were equal; therefore, it was confirmed that the ultrasonic testing instrument was properly calibrated for field measurements.

Figure 4. Picture of Coupons Removed From Rehabilitated Force Main

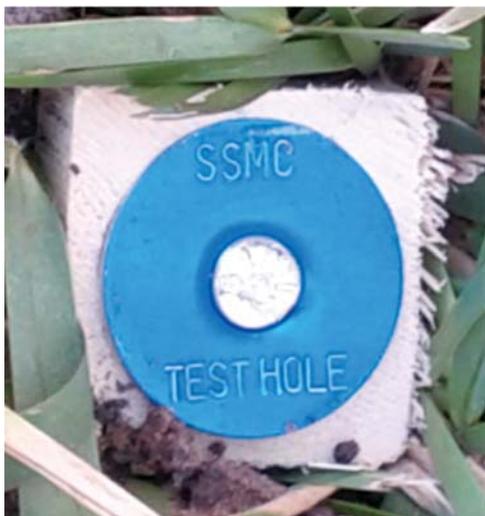
Figure 5. Picture of Disk Marker

- ◆ Temporary stake markers were placed over the force main testing locations at the ground surface.
- ◆ The global positioning system (GPS) coordinates were taken at each testing location.
- ◆ A permanent disk marker (Figure 5) was installed perpendicular to the test location in concrete or asphalt as a means to locate the exact pipe segment tested in the future.
