Lessons Learned in Operation of an Aboveground Reservoir at the Peace River Facility

Mike Coates, Sam Stone, and Noah Olenych

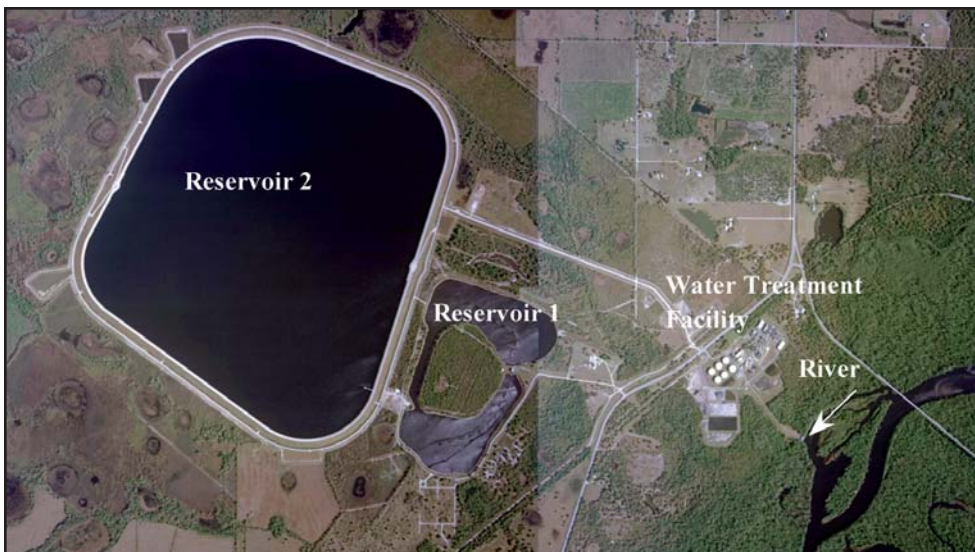
Figure 1. Two Off-Stream Raw Water Reservoirs

The Authority has two off-stream raw water reservoirs (Figure 1).

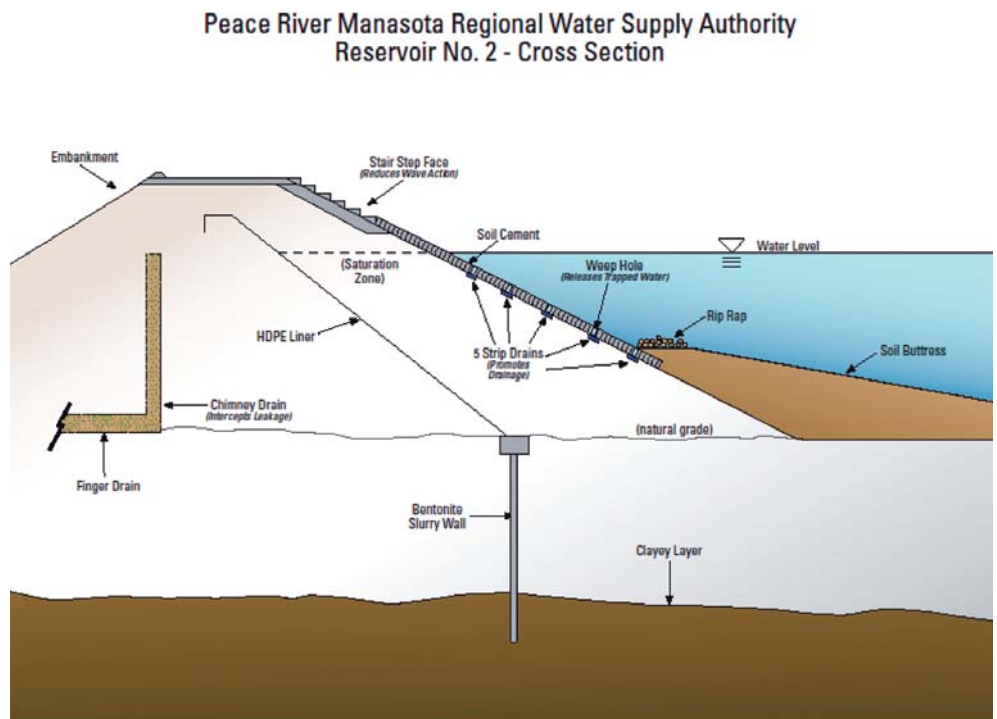
Figure 2. Reservoir 2 Cross Section

Figure 2 shows the cross section of the Reservoir 2 berm, highlighting the engineered

features of the embankment, including soil cement on the interior slope for erosion protection, an 80 mil high-density polyethylene (HDPE) liner and bentonite slurry wall that keys into the underlying Miocene clays (about 50 ft below land surface) on the interior face of the berm to minimize leakage, an internal drainage system to improve safety and stability, and vegetated exterior slope for stability and erosion protection. The embankment (interior and exterior) and immediately surrounding area also includes 105 piezometer stations monitoring water levels in the embankment and shallow perimeter groundwater system, 14 stations monitoring flow in the embankment drain system, five extensometer sites to monitor movement in the soil cement, and 46 survey stations to monitor movement in the embankment.
