Hillsborough County's Innovative Pipe Inspection Program Adds Efficiency and Accuracy

Richard Cummings and Michael Condran

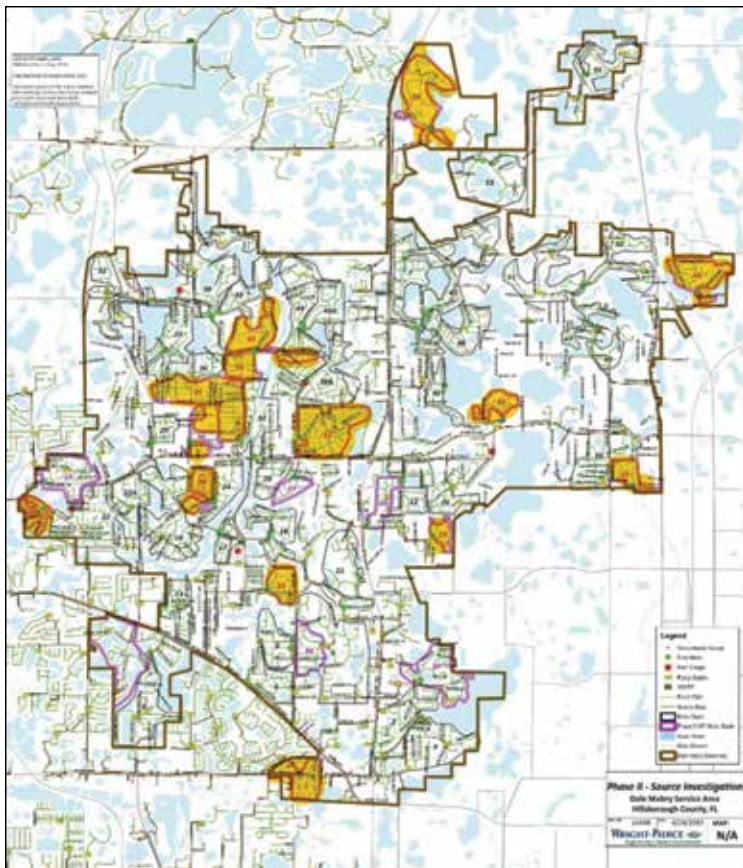
Figure 2. Dale Mabry Collection Basin, indicating 14 sub-basins where focused electrode leak location inspection was performed.

There are 59 sub-basins across the Dale Mabry network. Of these, 14 sub-basins were identified during the county's phase one study, done by a consulting engineer, as first priority for FELL inspection. Figure 2 shows the Dale Mabry basin and highlights the 14 sub-basins where FELL inspection was performed. Several pipe material types were included in the FELL inspection scope, including fold-and-form polyvinyl chloride (PVC), vitrified clay pipe (VCP), and cured-in-place pipe (CIPP). After each scan was complete for individual pipe segments, data were immediately uploaded to a cloud-based processing application for reporting to the county.

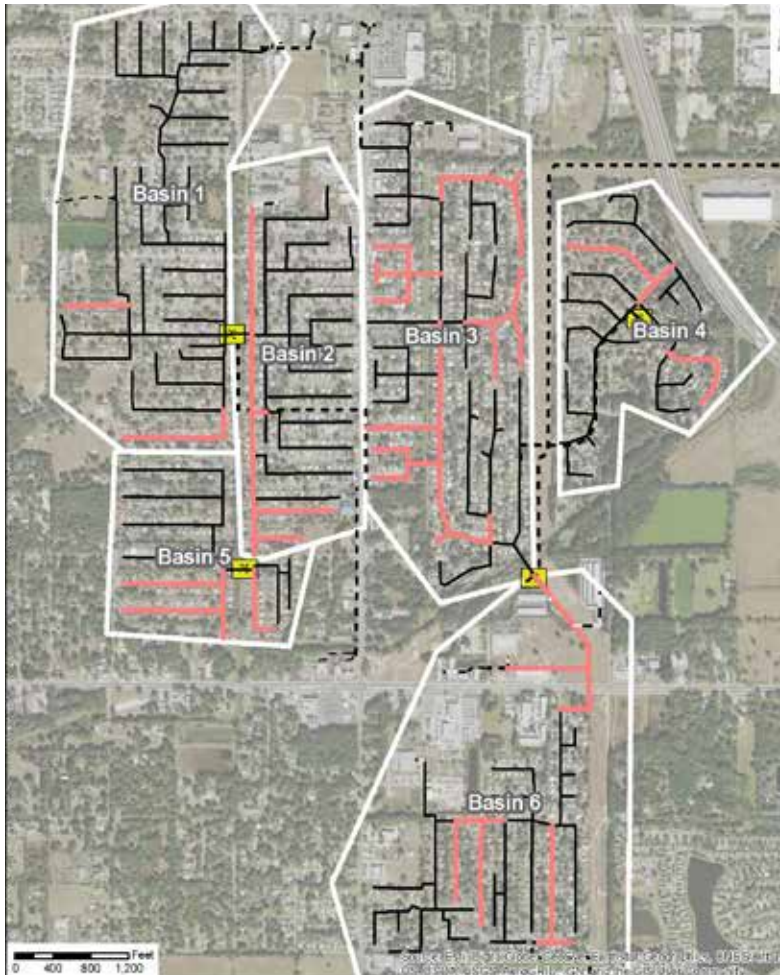
Figure 5. Clair-Mel Collection Network indicating the portion of the network where focused electrode leak location inspection was performed.

Figure 5 shows the Clair-Mel network and the portion of the area where the FELL inspection was performed.
