# Horizontal Directional Drilling an Emergency Water Main Replacement under Matlacha Pass – Challenges & Innovation

Mike McGee, Iqbal Hossain, Brian Dorwart, Jeff Wilson, and Bill Thacher

In October 2005, Hurricane Wilma severely damaged a portion of the existing 12-inch, sub-aqueous water transmission main under the Matlacha Drawbridge, resulting in the water main being breached, isolated at the bridge, and taken out of service. The GPIWA service area east of the bridge was provided temporary domestic potable water via an emergency interconnect from the city of Cape Coral.

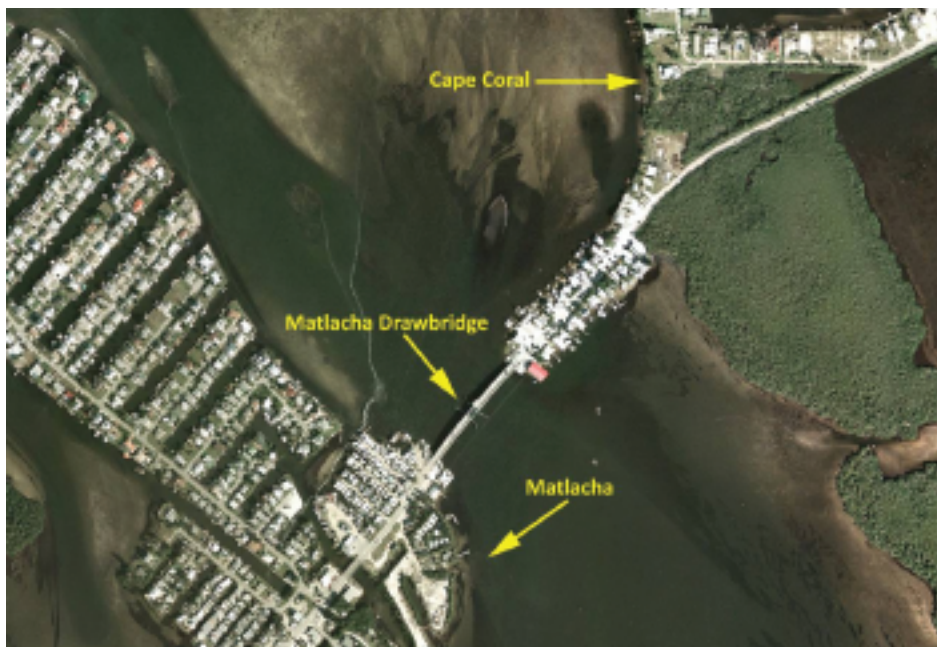
Figure 1 - Project Site Map

The disruption of water flow through this water main created an emergency situation in which the GPIWA was not able to provide adequate fire flow to the Matlacha area east of the bridge and also to its “off-island”

commercial and residential customers on Cape Coral (see Figure 1).
