Proactive Emergency: Replacing Daytona Beach's Most Critical Water Pipe

Scott Richards, Eric Smith, and Mark Abram

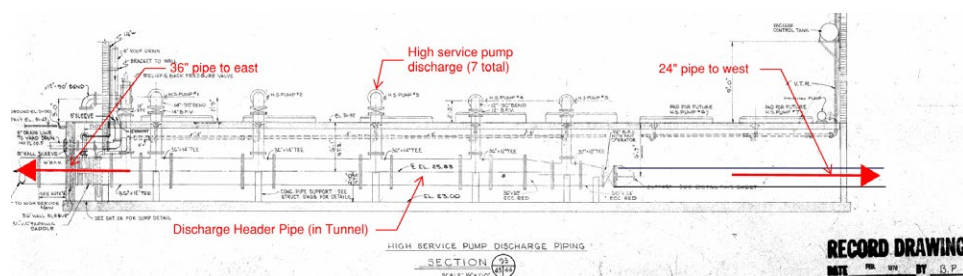
This existing discharge header pipe is a 36-in. ductile iron pipe (DIP), which originally discharged to the east. In a later phase of modifications to the WTP, the pipe was extended to the west, which is a 30-in. pipe that reduces to 24 in. once outside the building (Figure 2). There are seven HSPs that can supply water to the city through the discharge header.

Figure 2. Discharge header pipe record drawing.

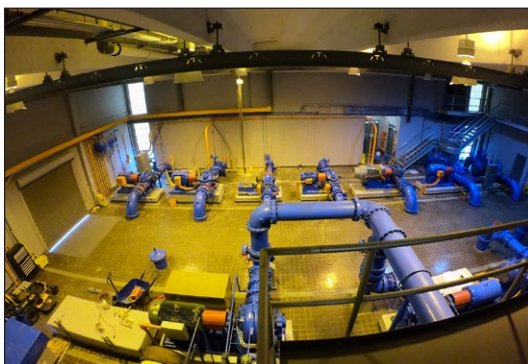
Figure 9. High-service pump station pump room prior to construction.
