# Utilizing Nondestructive Testing for Large Ductile Iron Force Main and Air Release Valve Evaluation

Weston Haggen, Emily Staubus Williamson, Mark Burgess,  
Jeremy Waugh, Dan Glaser, and Joel Kelsey

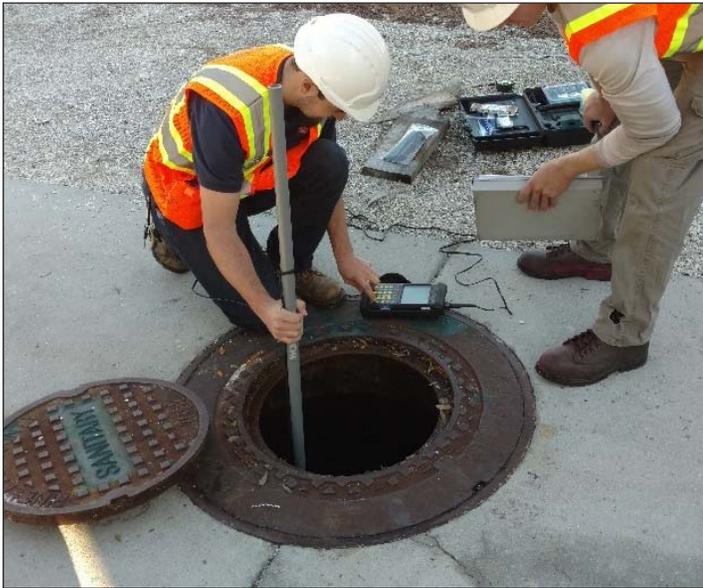
Figure 7. Ultrasonic Thickness Testing

To determine the extent of the corrosion, field investigations using nondestructive ultrasonic testing were performed at various locations along the project corridor (Figure 7). Initially, the overall condition of the pipe was visually inspected near the ARVs to determine the exterior condition of the force main and to identify the feasibility for UTT along the force main corridor.
