A Systematic Approach for Addressing Total Maximum Daily Loads Along the Halifax River

Matthew Goolsby, Danielle Honour, Michael Schmidt, and Judy Grim

Matthew Goolsby, P.E., CFM, is water resources engineer; Danielle Honour, P.E., D.WRE, is principal water resources engineer; and Michael Schmidt, P.E., BCEE, D.WRE, is senior vice president with CDM Smith. Judy Grim, P.E., is road and bridge director with Volusia County.

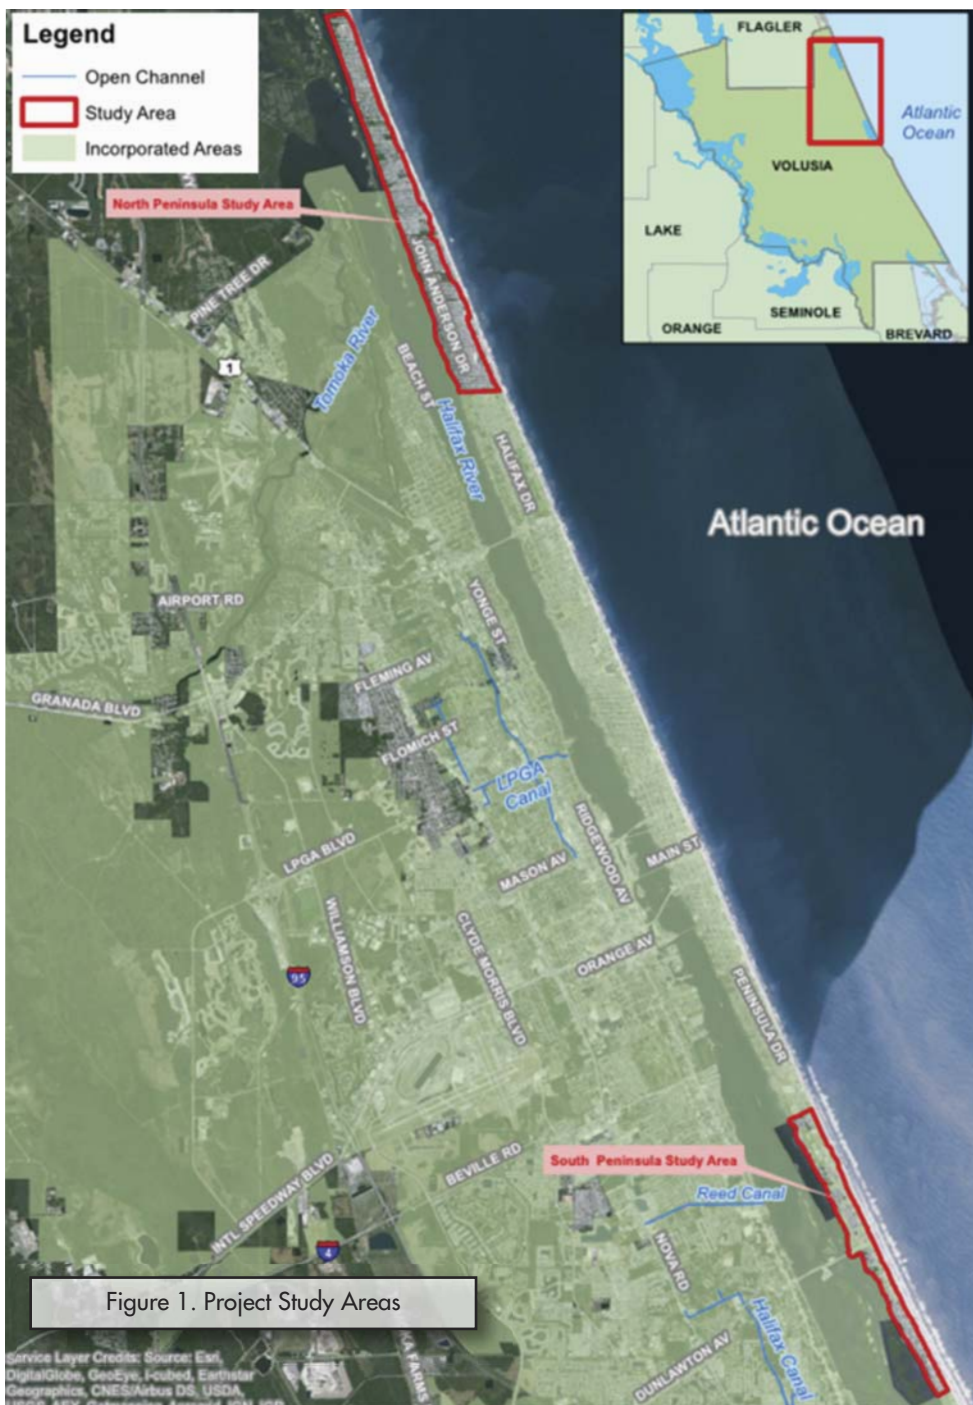
Figure 1. Project Study Areas

This project consisted of a stormwater outfall assessment to identify potential operation and maintenance (O&M) activities and best management practice (BMP) implementation to improve water quality of discharges to impaired waters in the Halifax River. The study area for this project focused on those unincorporated areas of the County with direct outfalls to the river from the Halifax Peninsula area, as shown in Figure 1. The systematic approach for addressing TMDLs included:

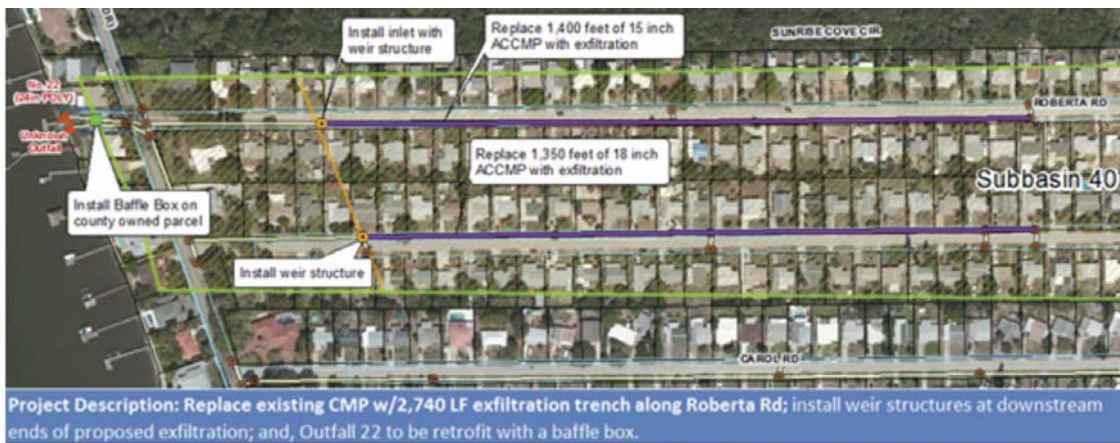
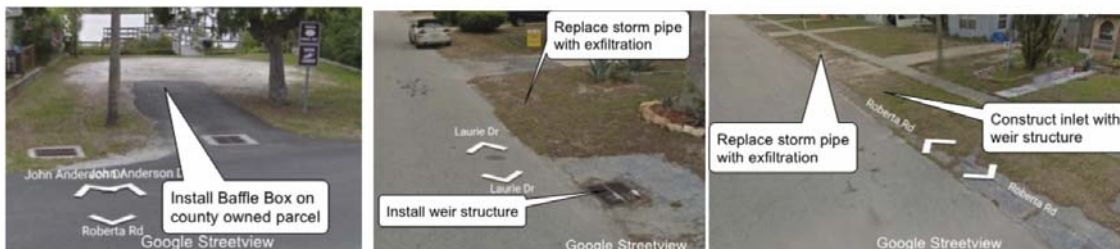
Figure 2. Example Project Summary for Proposed Project Number 10, Roberta Road

Project Description: Replace existing CMP w/2,740 LF exfiltration trench along Roberta Rd; install weir structures at downstream ends of proposed exfiltration; and, Outfall 22 to be retrofit with a baffle box.

Proposed BMP Type: Exfiltration trench and baffle box	Receiving WBID: WBID 2363B
Subbasin Area: 28.5 acres	Water Quality Impairment: Within Halifax River TMDL limits
Estimated Treatment Area: 28.5 acres	TN Load Removal (lbs/yr): 193
Predominant Land Use: High Density Residential	TP Load Removal (lbs/yr): 43
Estimated Conceptual Capital Cost: \$479,000	TSS Removal (lb/yr): 7,132
Estimated Annual O&M Cost: \$7,900	Cu Removal (lb/yr): 3.8
TN Cost-Effectiveness (\$/lb/yr TN removed): \$238	Required O&M: Inlet, pipe, and outfall blockage and cleanout
TP Cost-Effectiveness (\$/lb/yr TP removed): \$1,070	Age/Condition of Existing Infrastructure: Fair

Final Project Rank: 1
Final Project Prioritization: High

crowns, baffle boxes, and/or biosorption activated media (BAM). An example of a proposed project is provided in Figure 2.
